Robert Squires - Squires Consulting LLC
Landowner Advocate

Opening Statement for May 5, 2021 Subcommittee on Civil Rights and Civil Liberties Hearing:
“Pipelines Over People (Part II): Midship Pipeline’s Disregard for Landowners in Its Pathway”

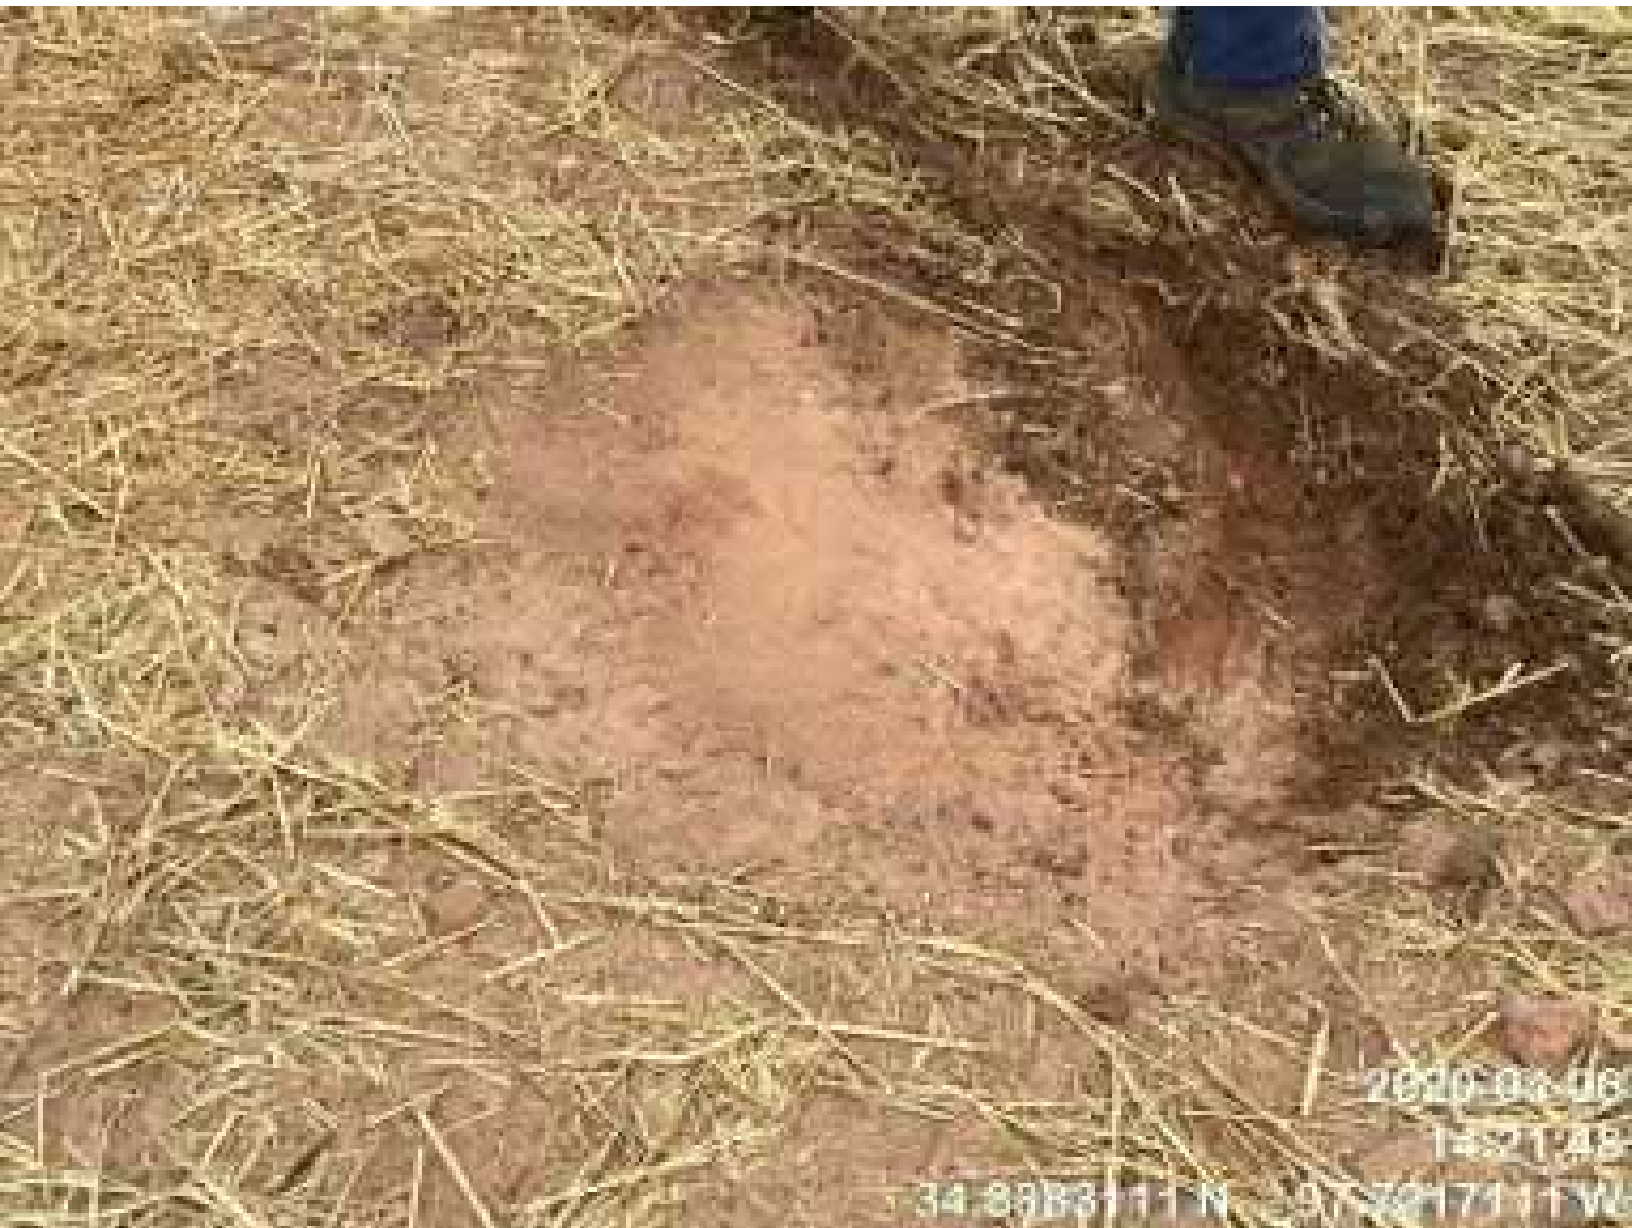
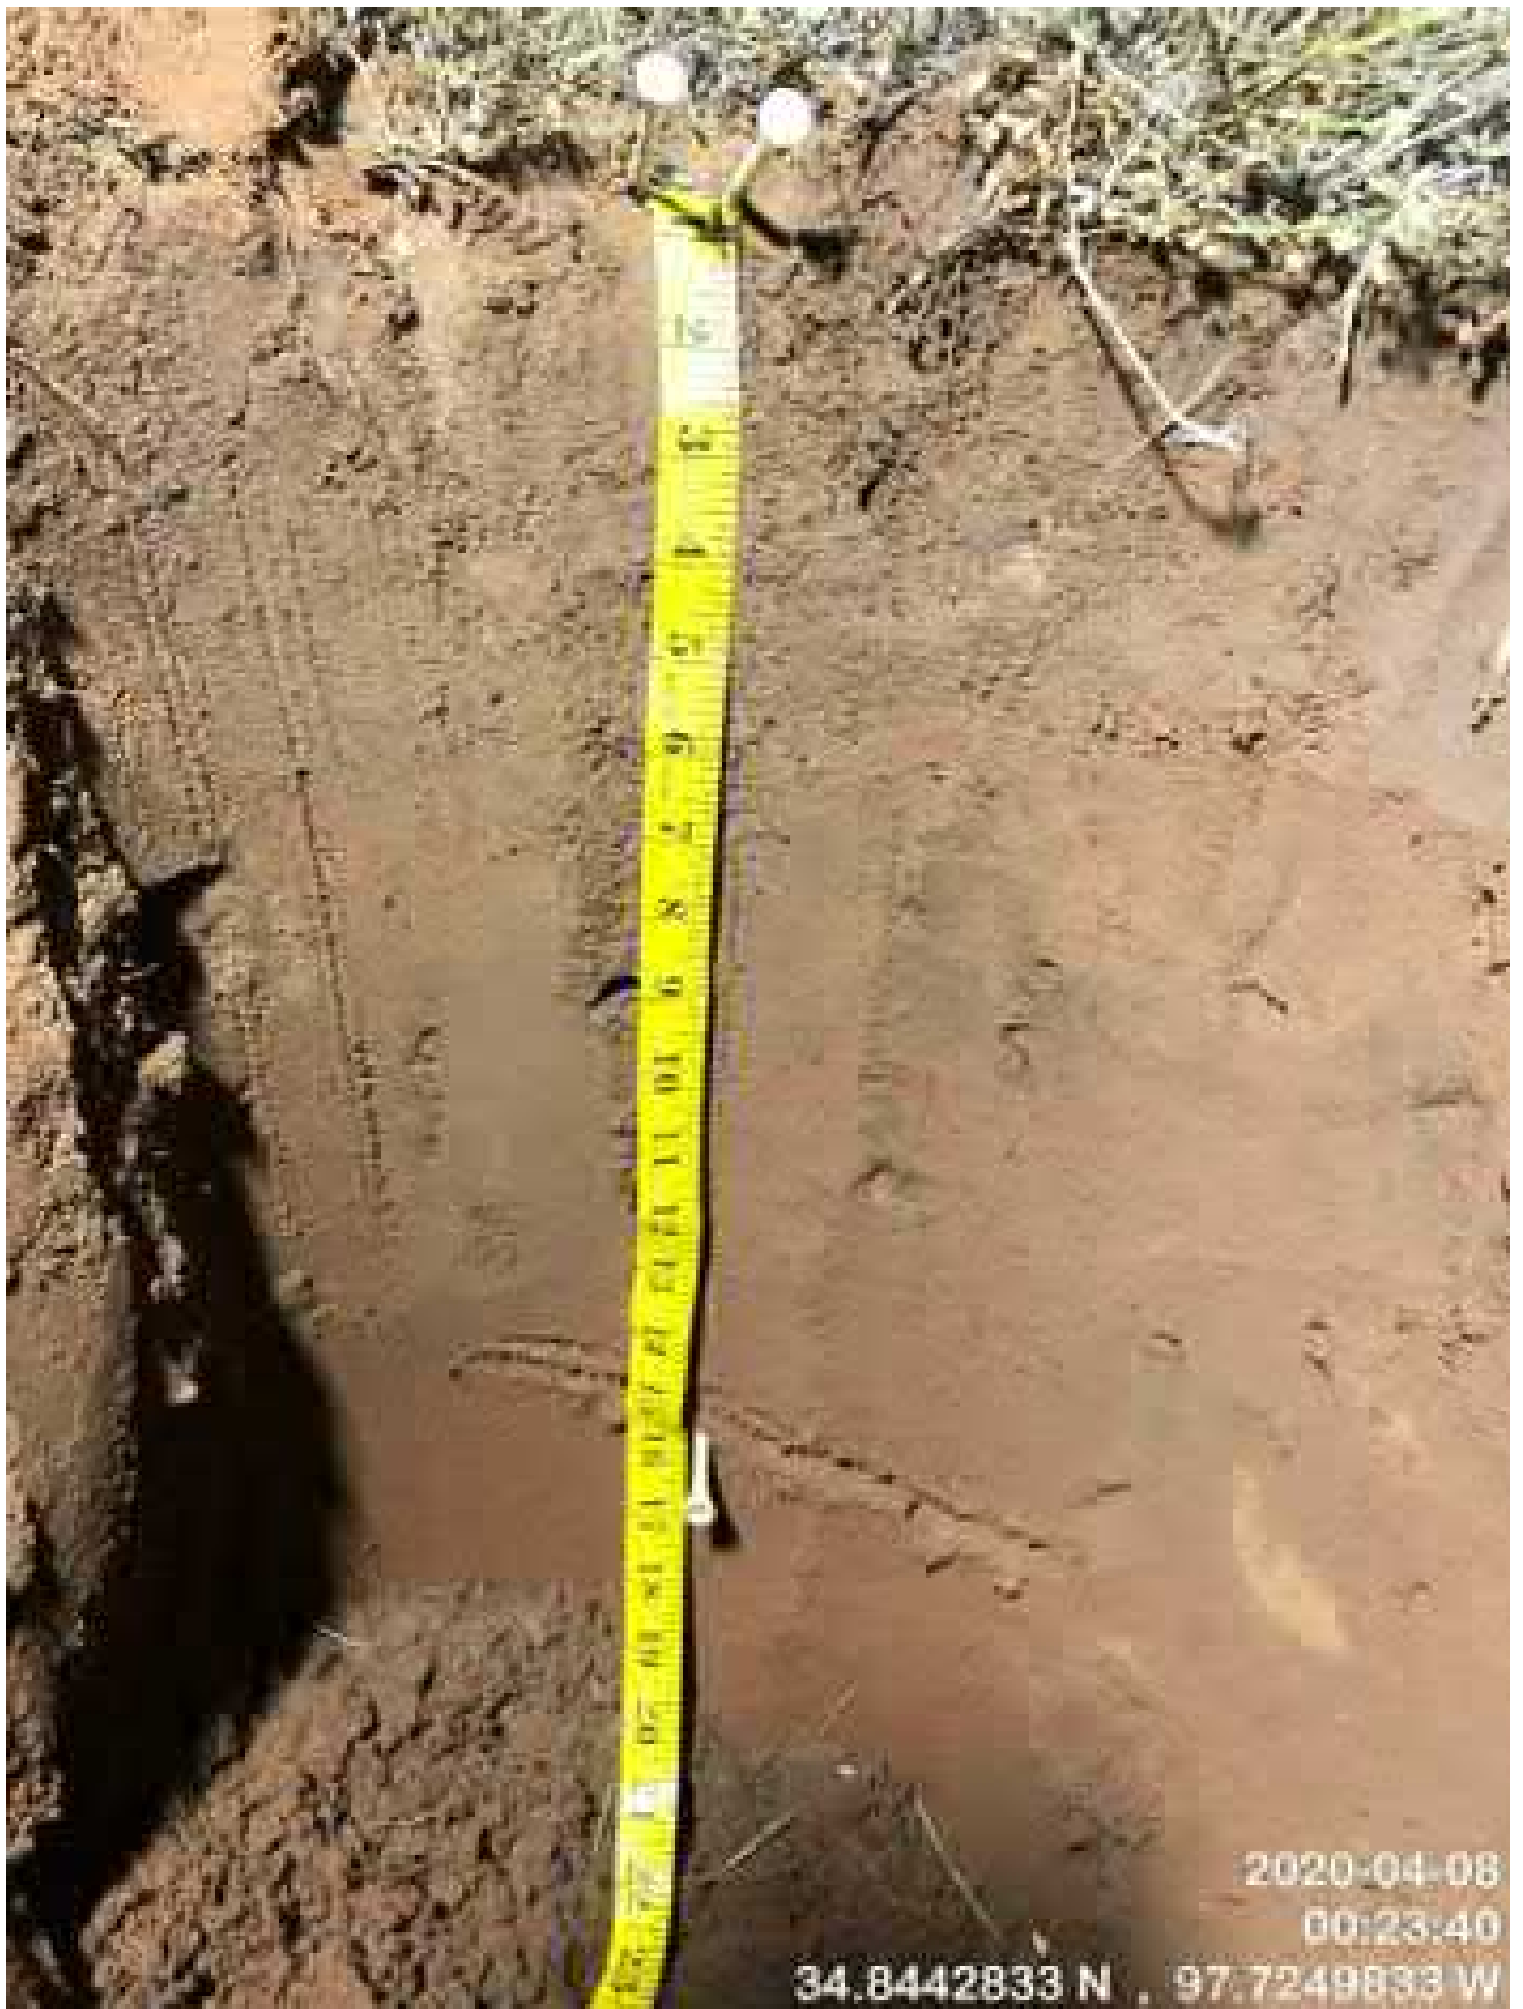
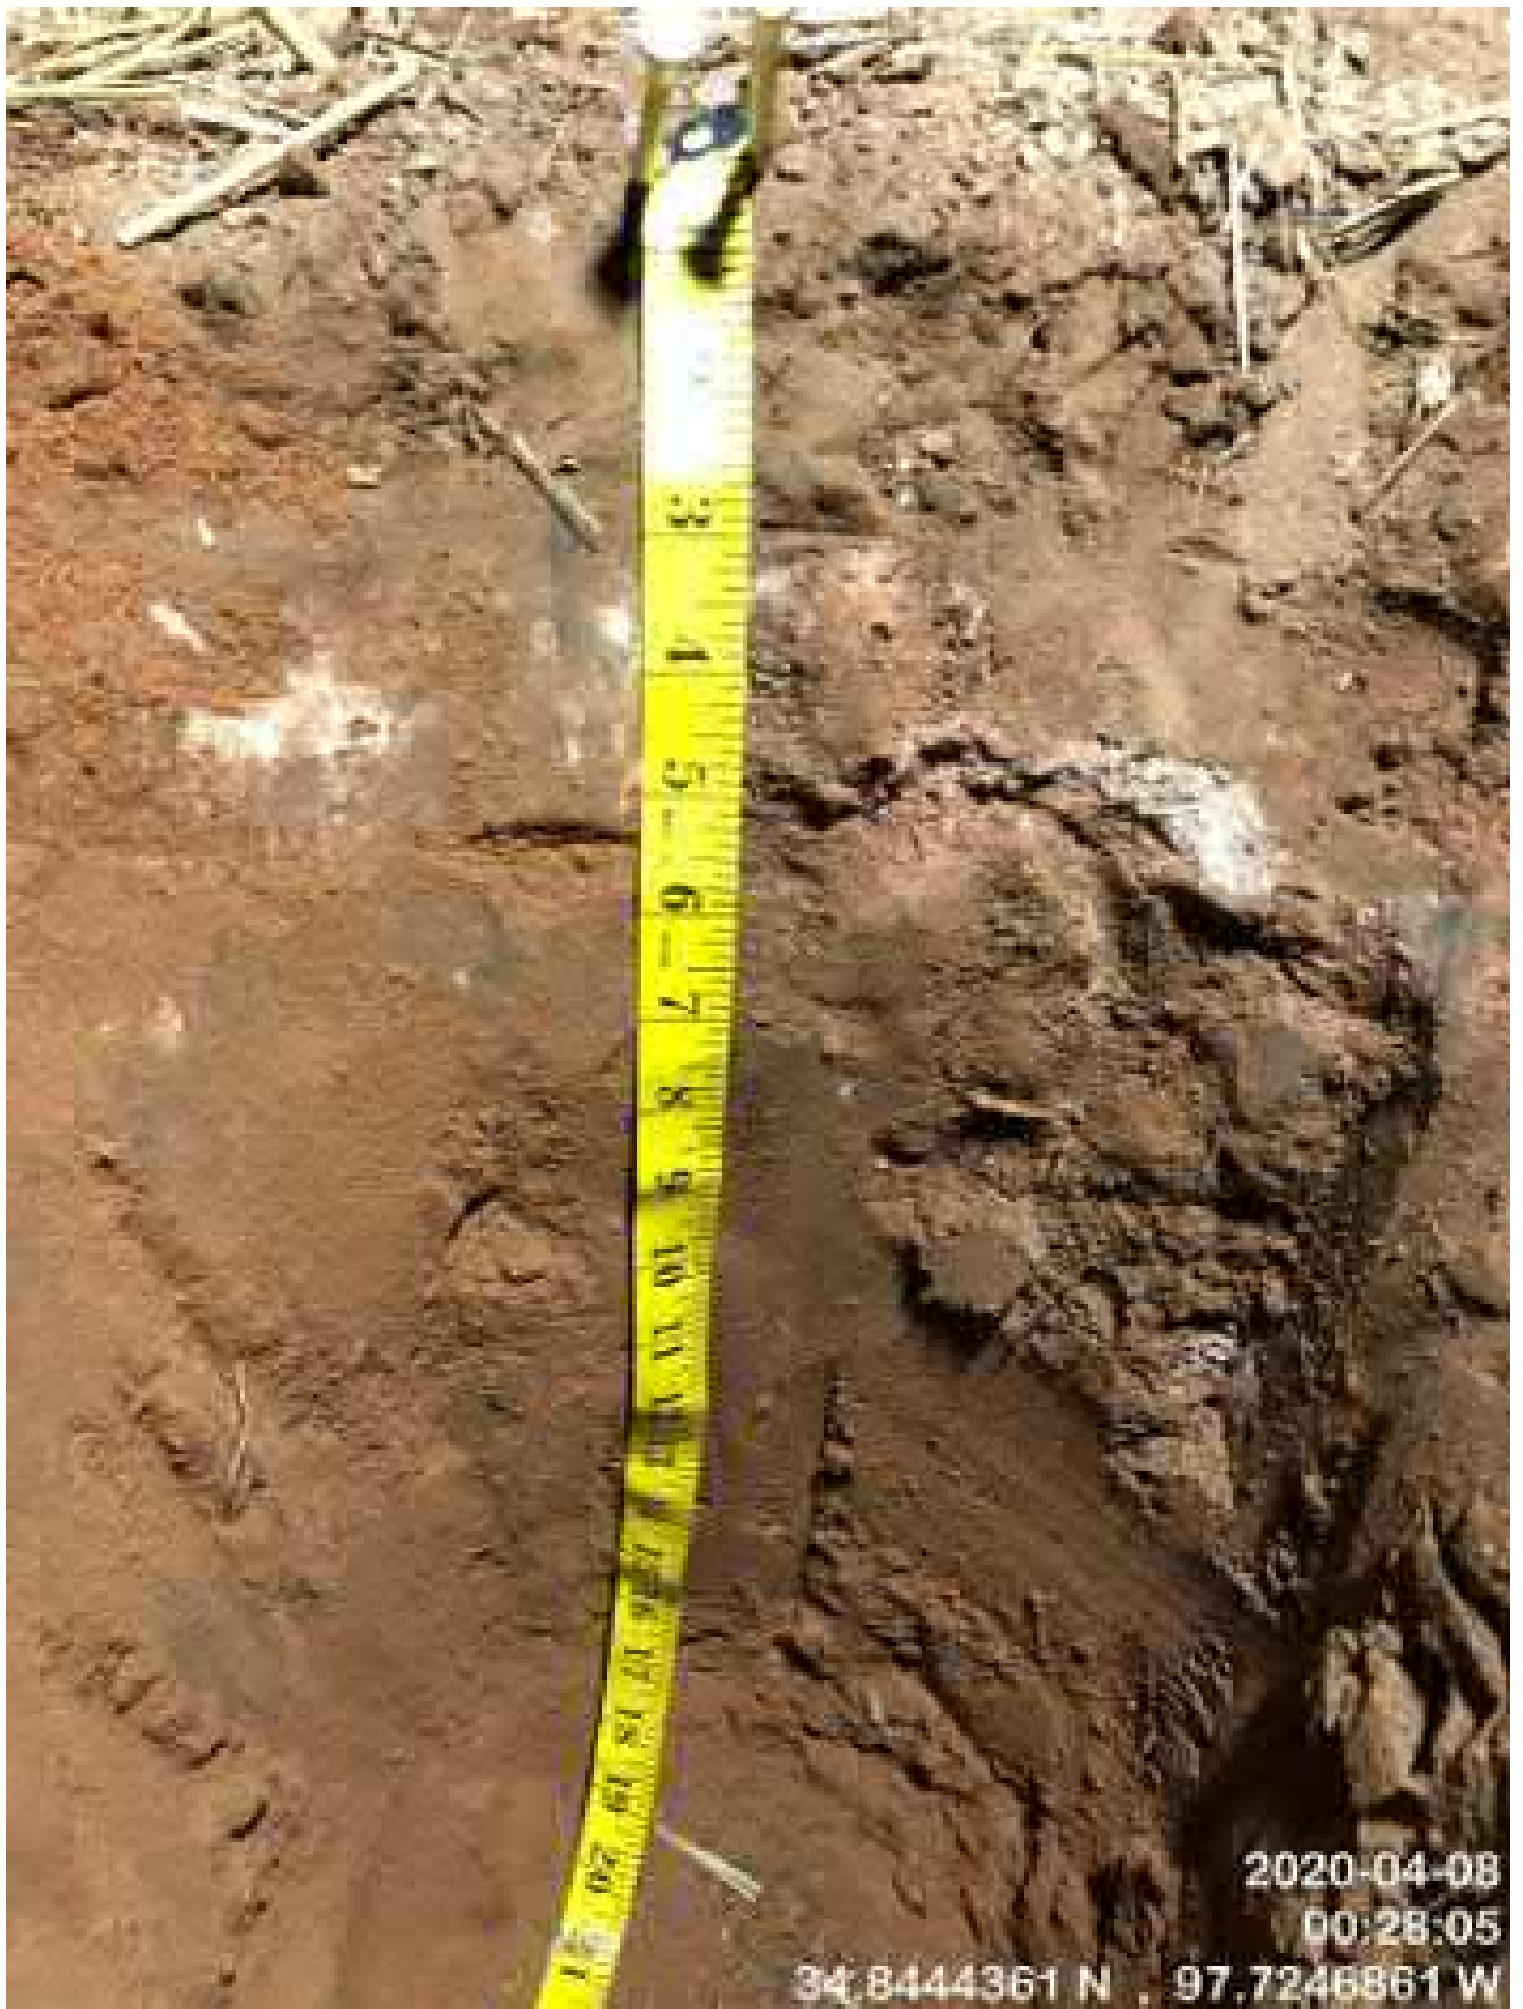
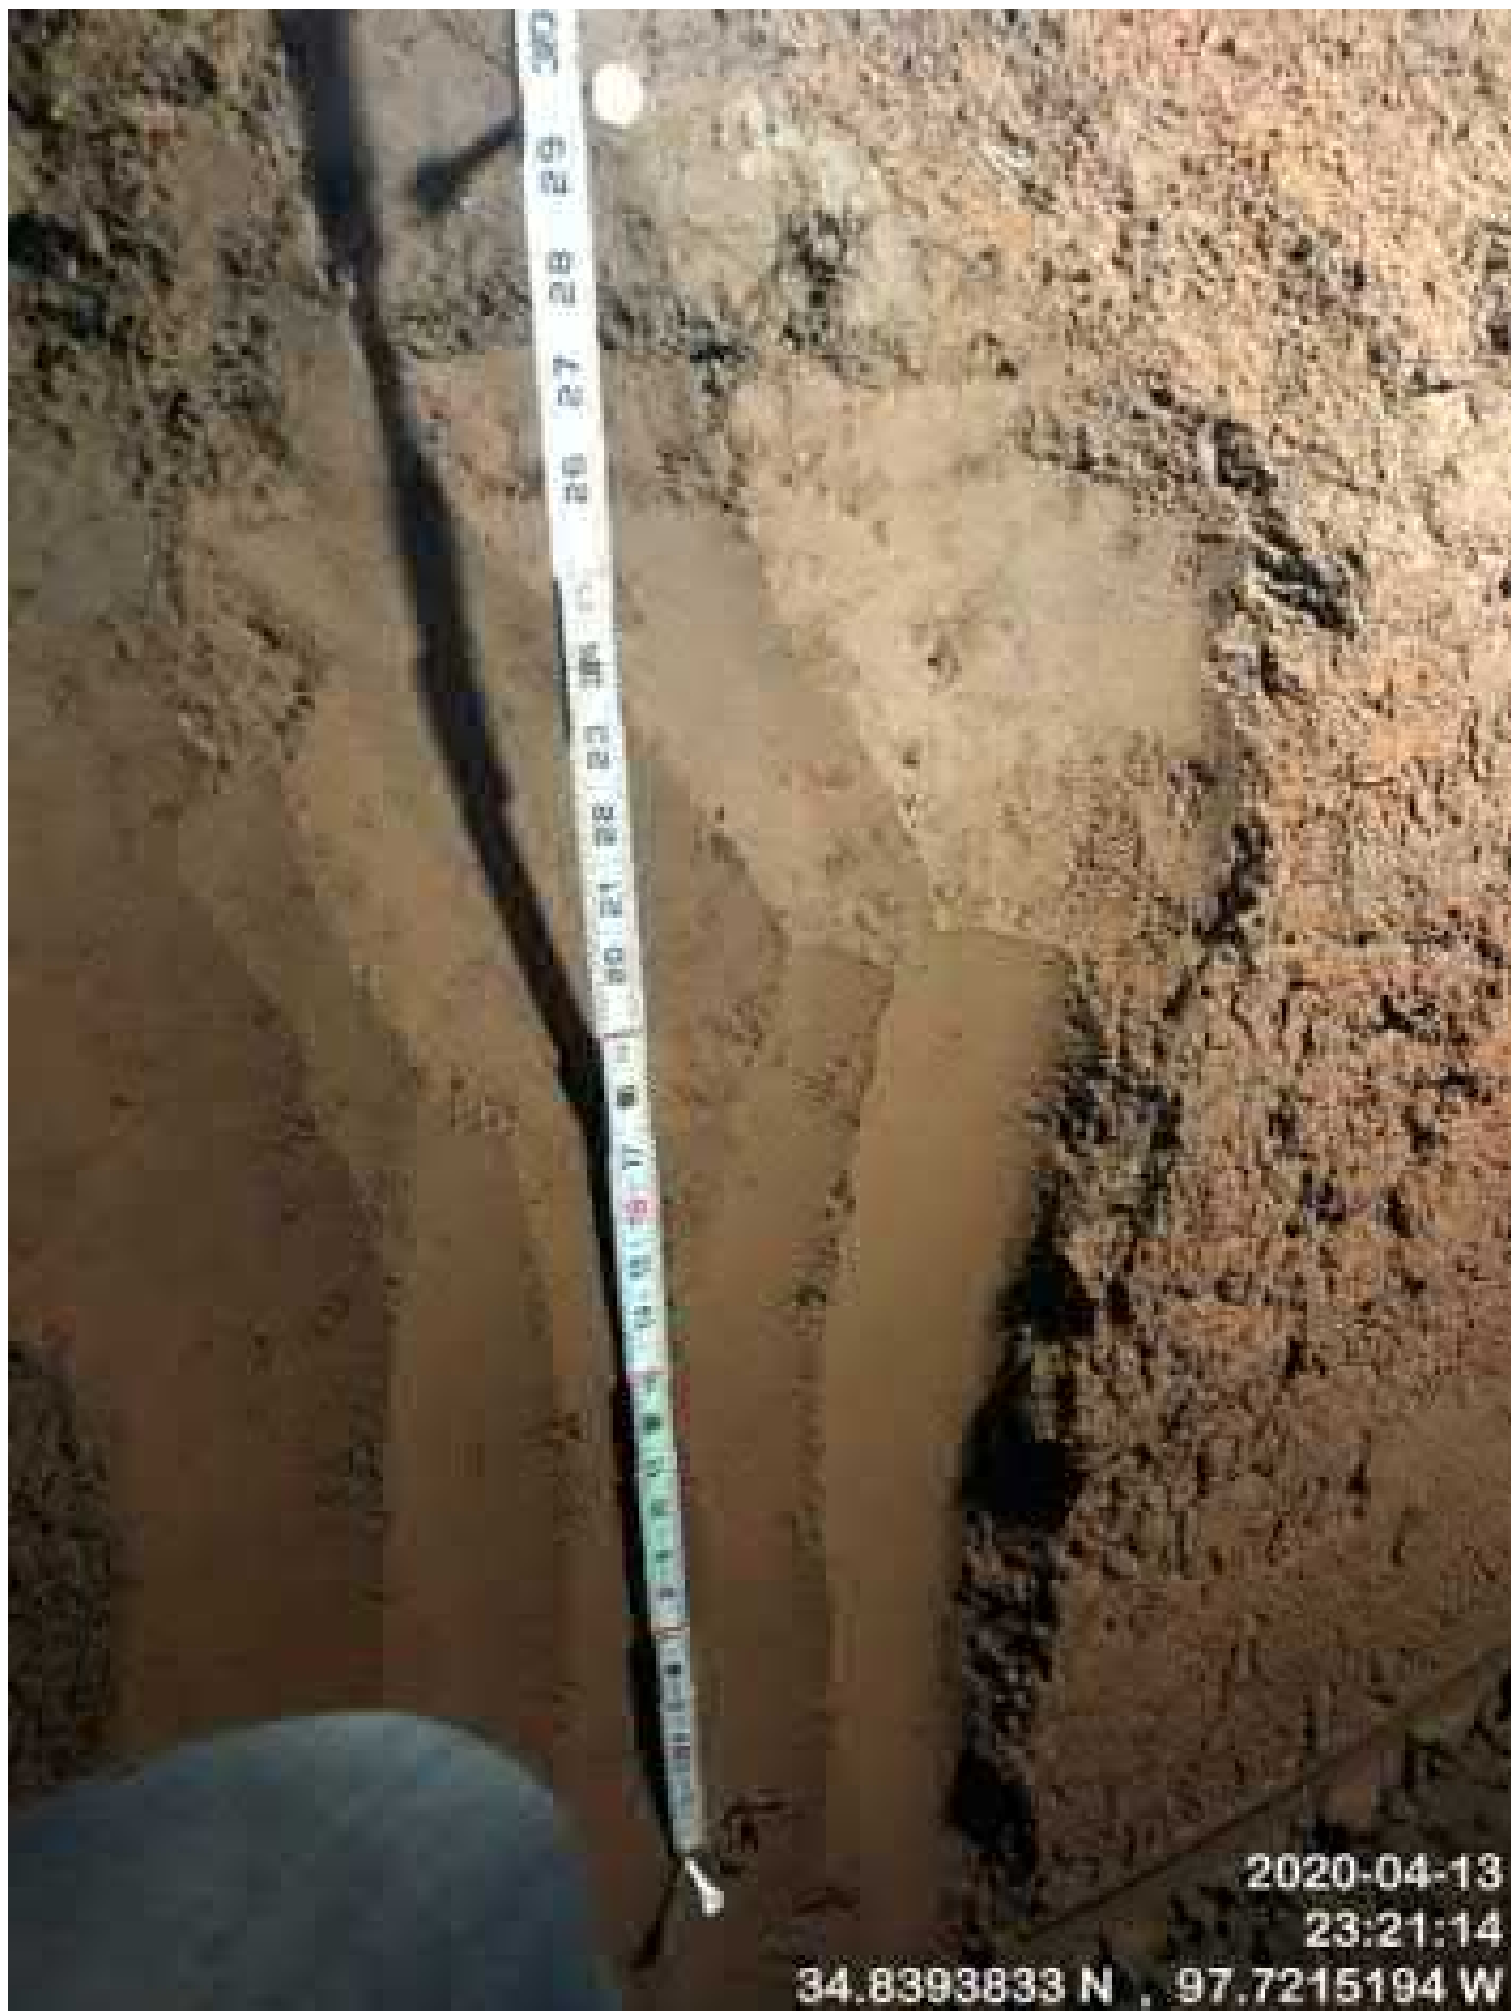
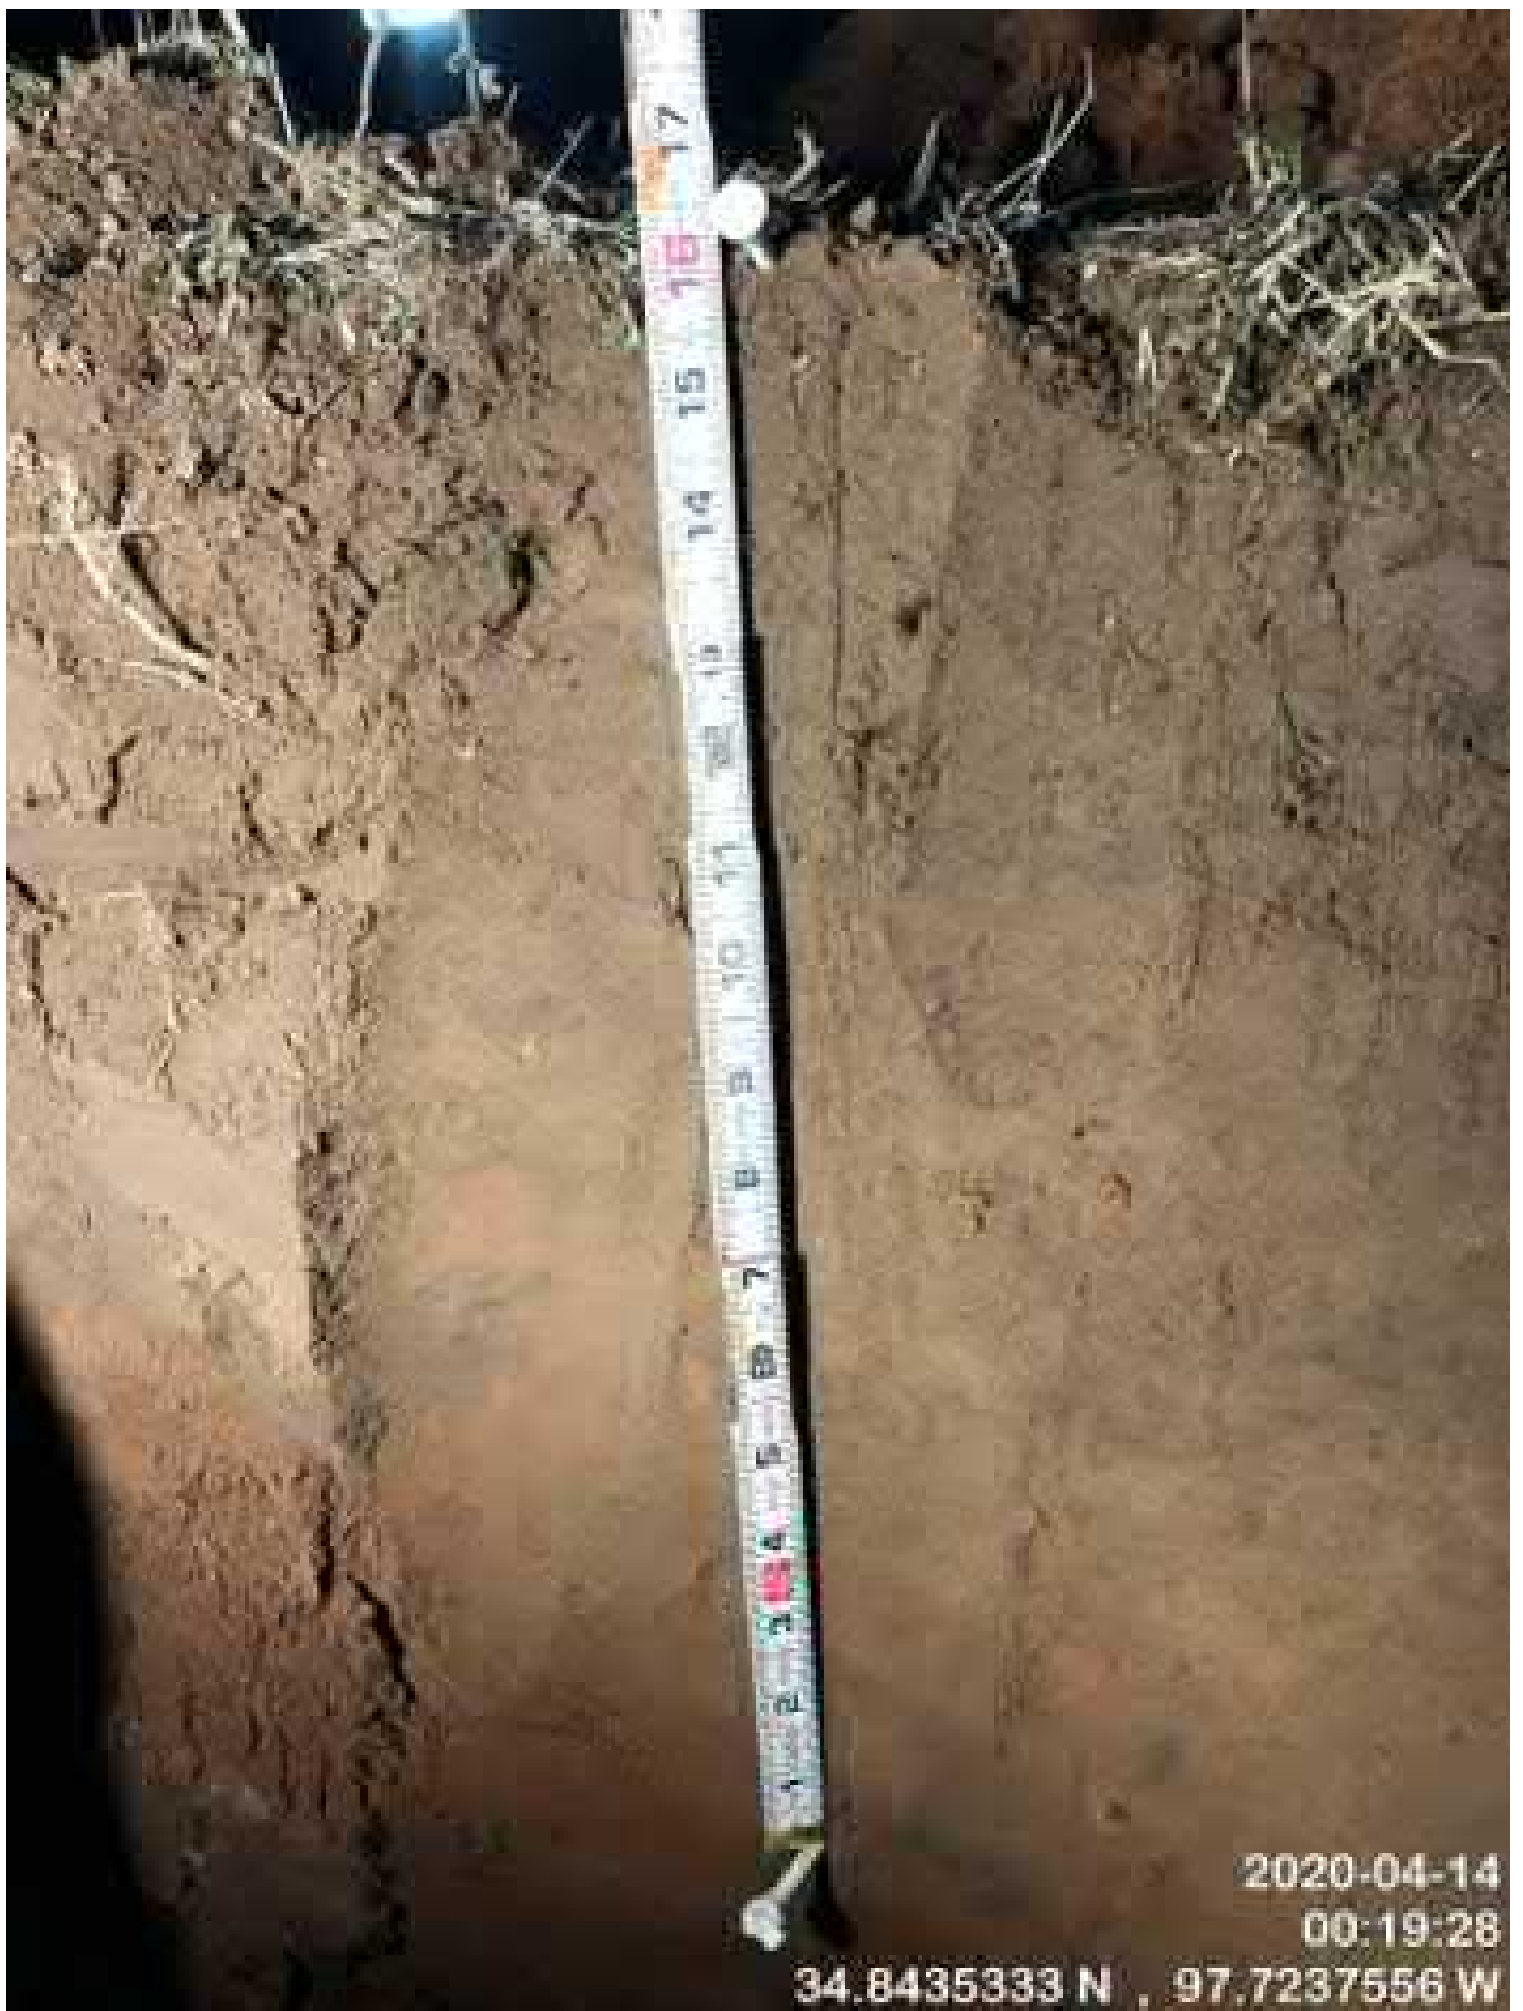
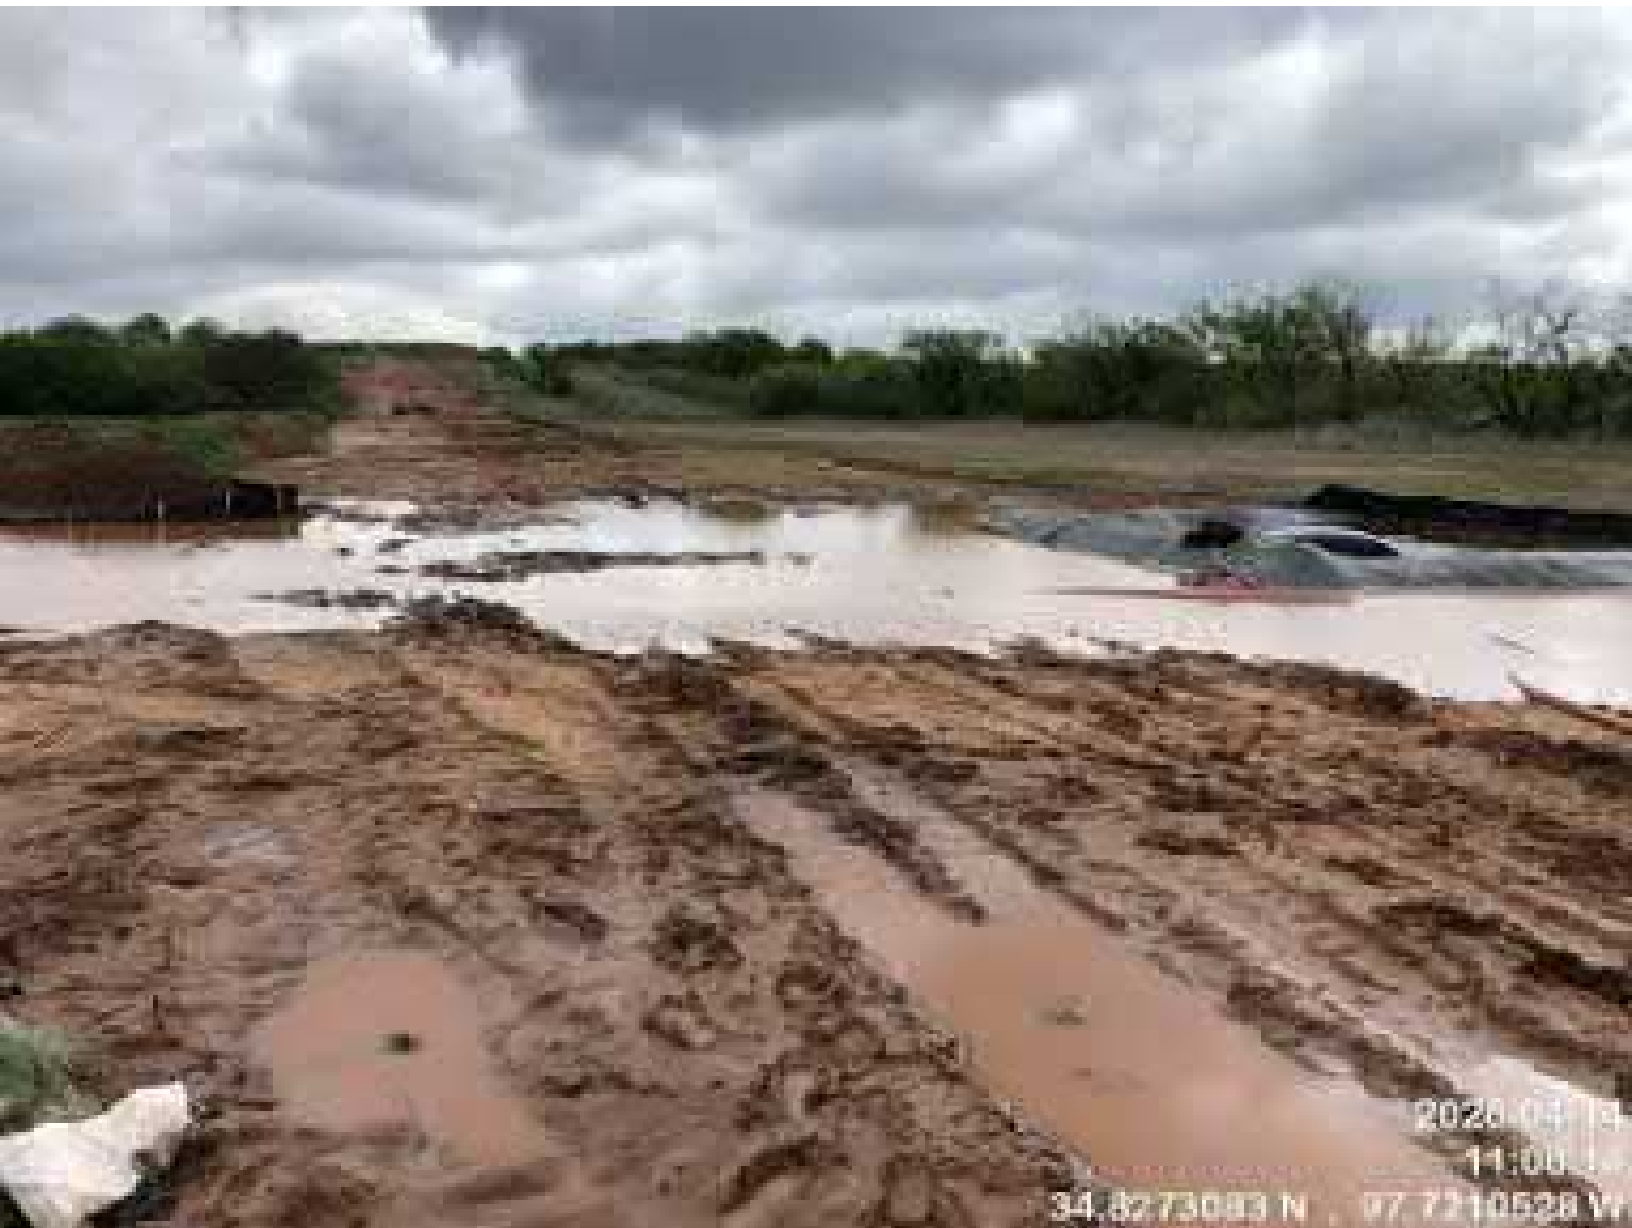
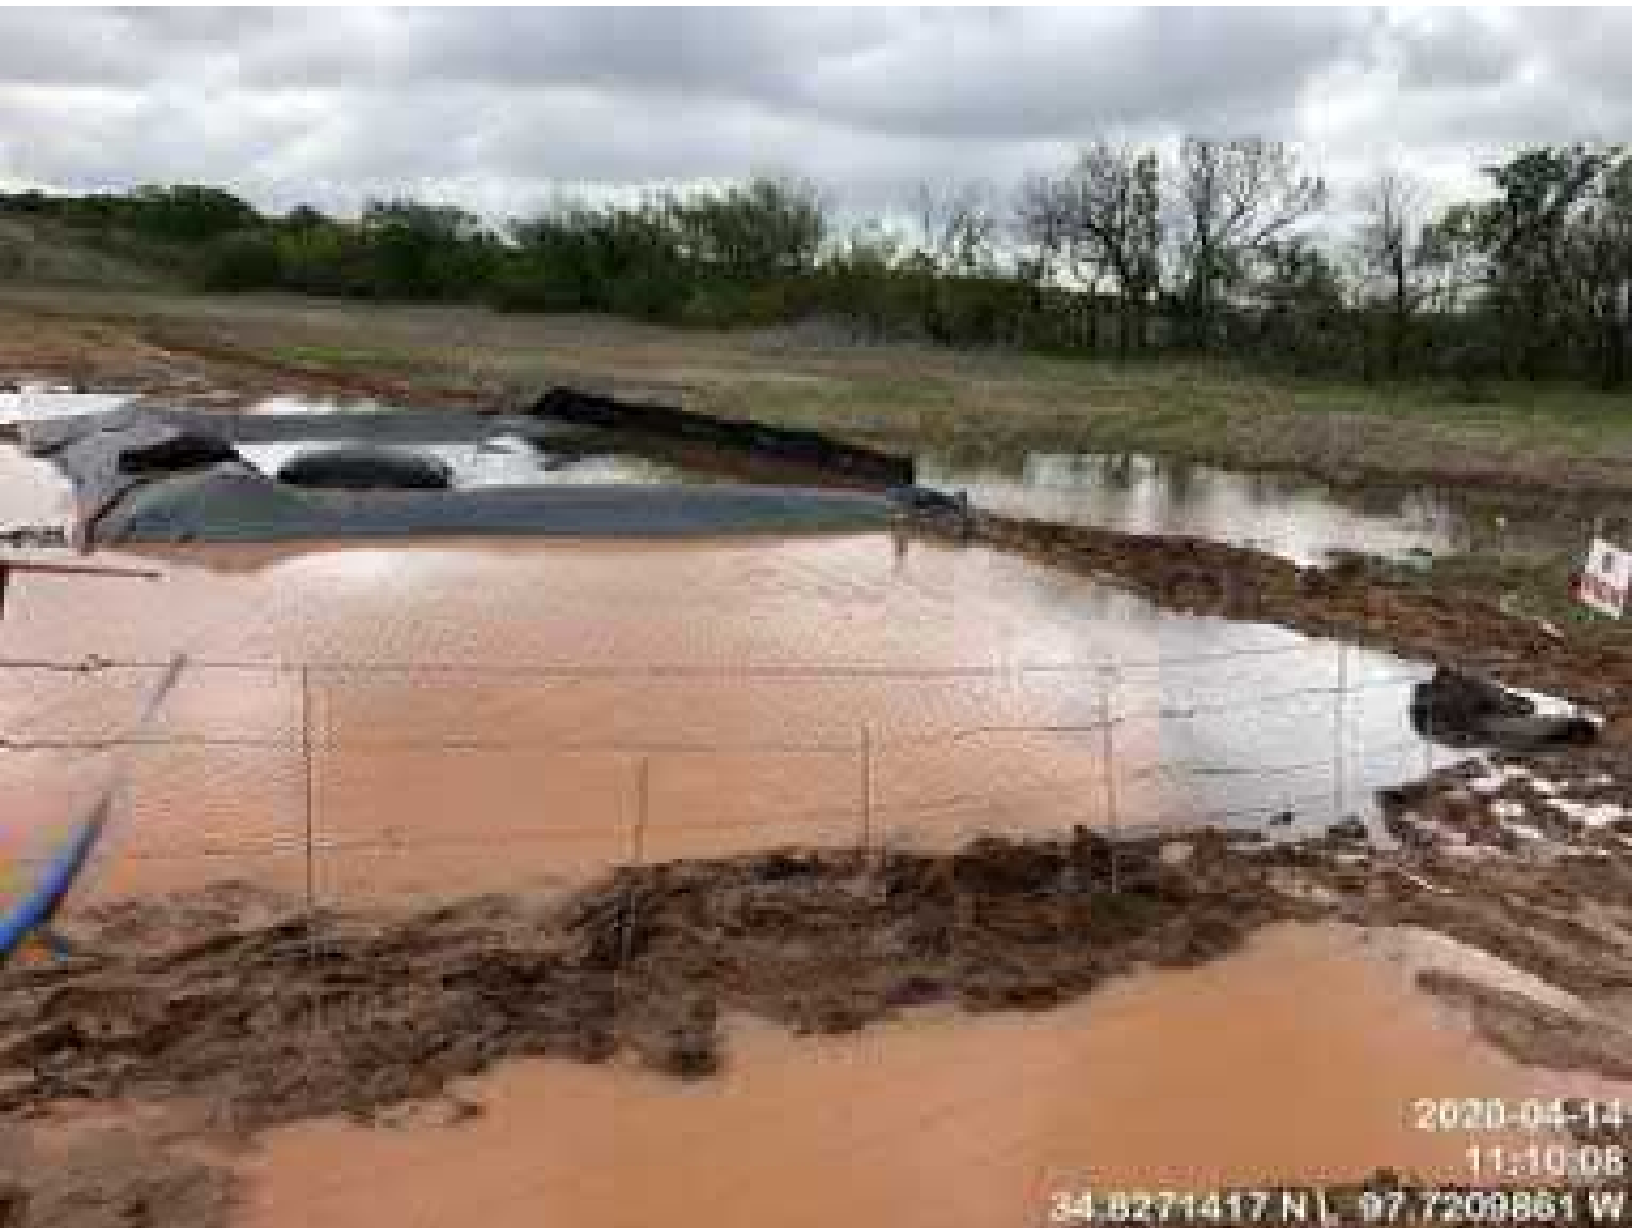
April 14, 2020 Site Inspection
Sandy Creek Farms, Inc.
GR-0336.000, GR-0338.000, GR-0340.000, GR-0340.010
Mile Post: MP 70.75 - 72.5
Grady County, Oklahoma

- 1.) Trenches remain open and full of water on tract GR-0338. No catch basins found on property.
- 2.) Sandy Creek (SGR-008)
 - a. Unfiltered trench water continues to be pumped directly into Sandy Creek. (FERC Procedures: V. B. 11.)
 - b. Banks are unstable and slipping into stream. (FERC Procedures: V. C. 2-3.)
 - c. Sediment deposited into stream have partially dammed stream impeding natural flow. (FERC Procedures: V. B. 10-11.)
- 3.) Importation of 50,000 - 100,000 cubic yards of topsoil for 26.27 acres of ROW (FERC Plan: IV. B. 1-6.)

- a. Off-ROW topsoil: 16-29" (verified by existing NRCS soil surveys)
- b. In-ROW topsoil: 0" found in multiple locations.
- 4.) Soil Compaction (FERC Plan: V. C. 1-3.)
 - a. Off-ROW Penetrometer reading: Around 150 psi in multiple locations.
 - b. In-ROW Penetrometer reading: 300 psi limit exceeded in every off-ROW location.
- 5.) Large rocks and debris mixed into soil and scattered throughout entire property. (FERC Plan: V. A. 3-6.)
 - a. NRCS indicates very little natural rock throughout soils in this area.
 - 1. Affected cropland areas naturally have 0% rock fragments on GR-0338.

- 7.) Extreme flooding, topsoil loss, altered drainage, and Erosion into Sandy Creek; Remove 57 acres of ponding, restore natural drainage, replace all topsoil, and replace irrigation system.
