Robert Squires - Squires Consulting LLC
Landowner Advocate

Opening Statement for May 5, 2021 Subcommittee on Civil Rights and Civil Liberties Hearing:
“Pipelines Over People (Part II): Midship Pipeline’s Disregard for Landowners in Its Pathway”

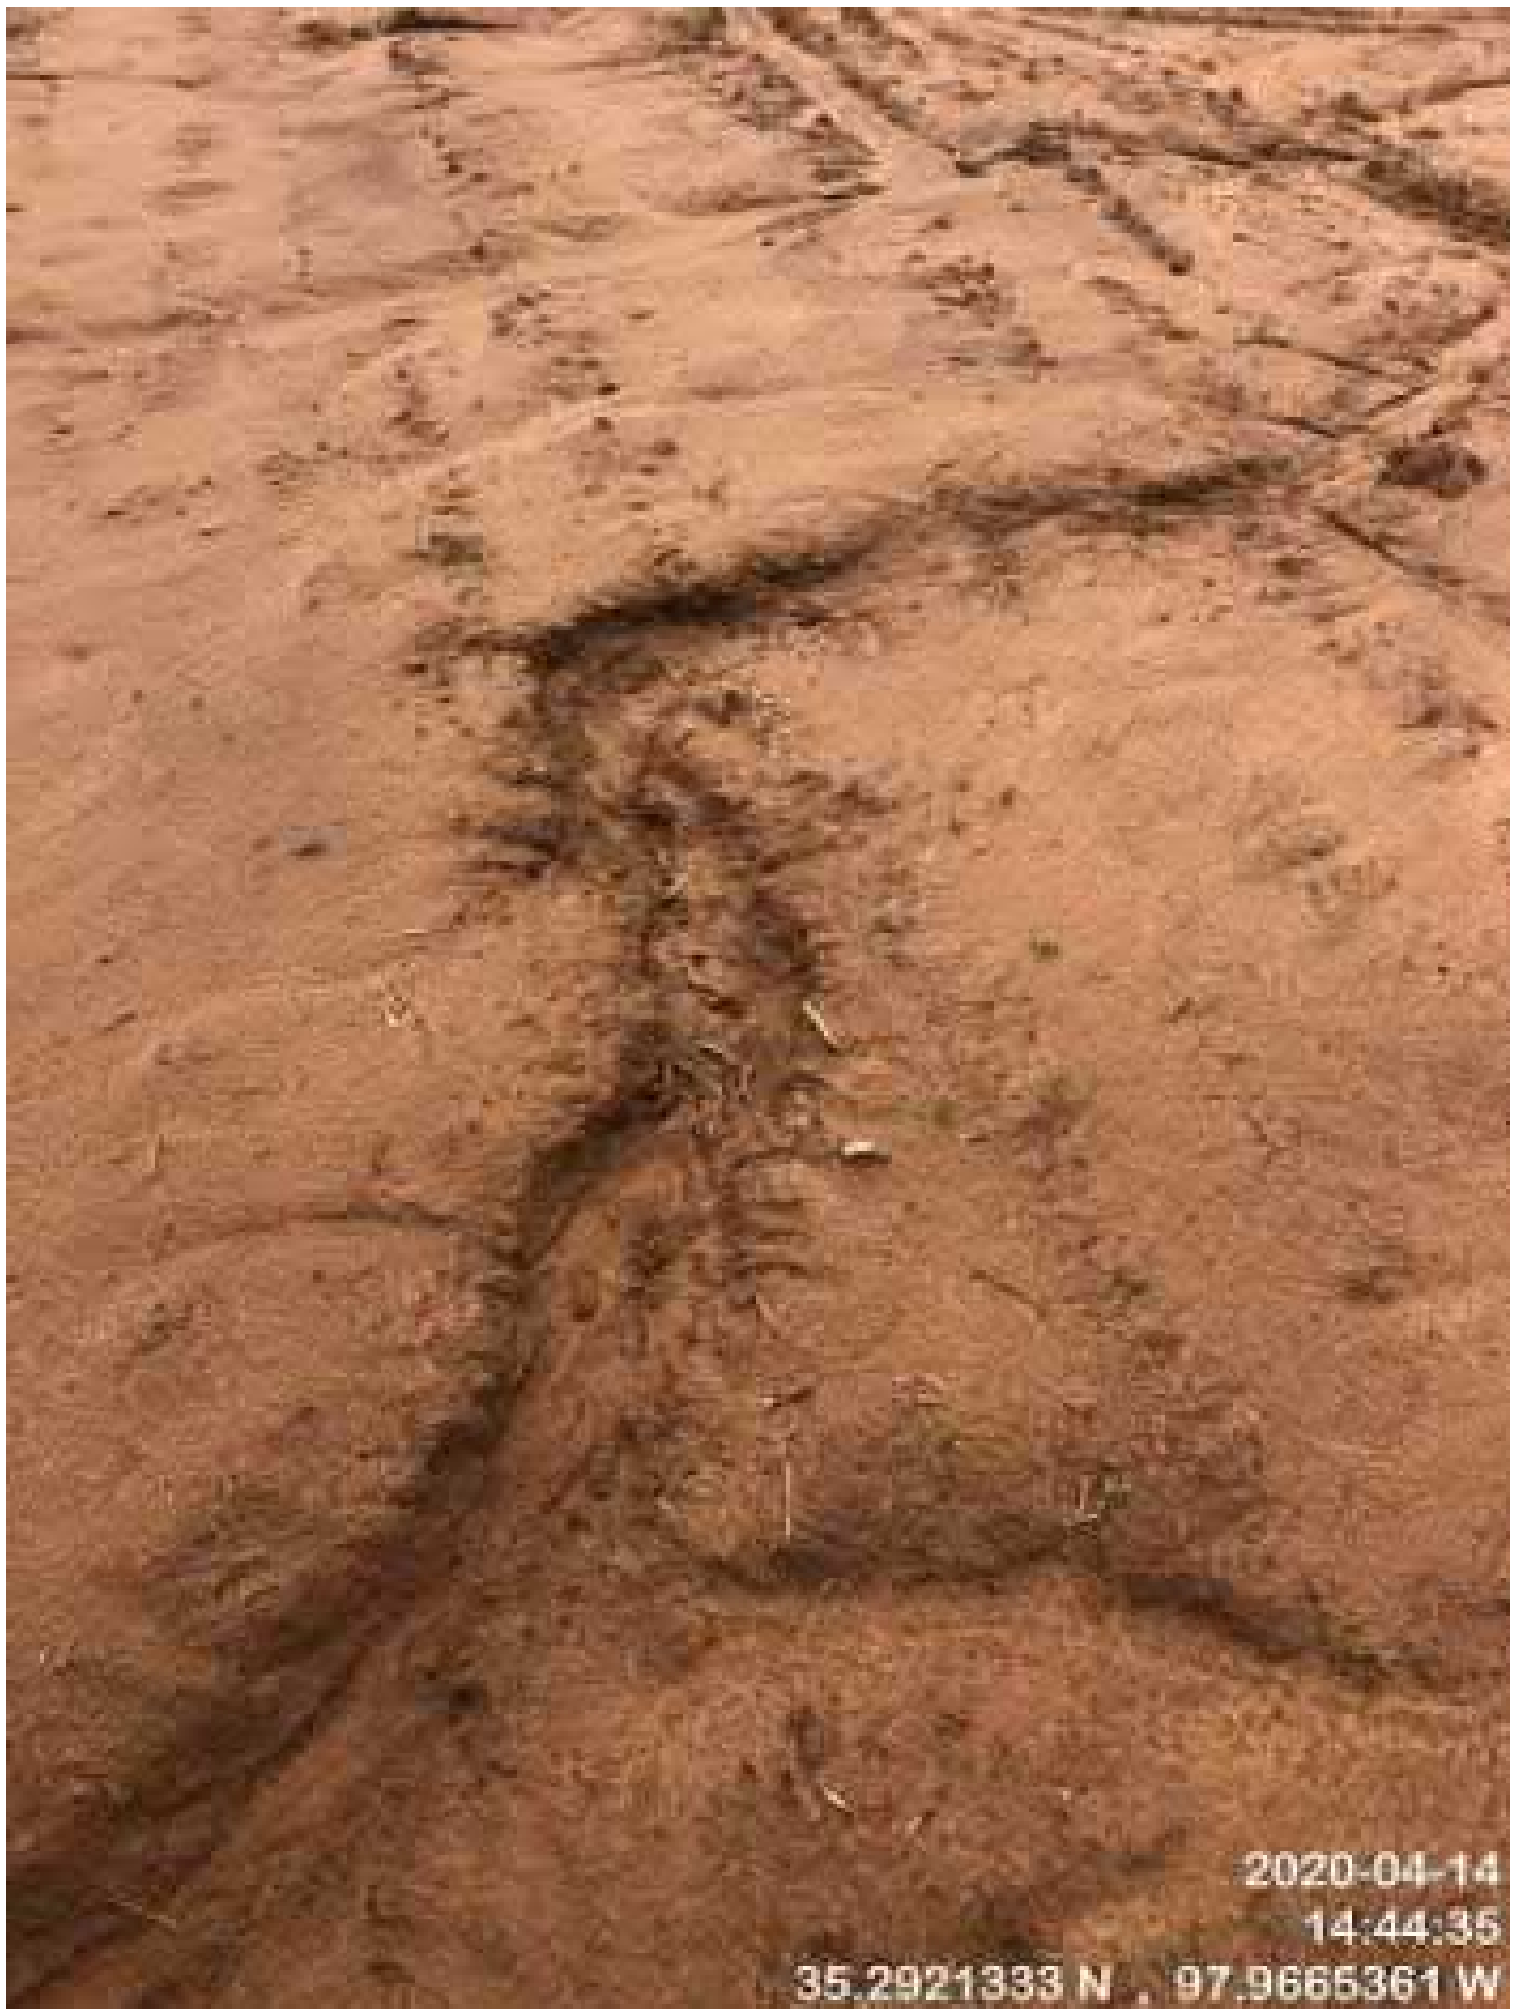
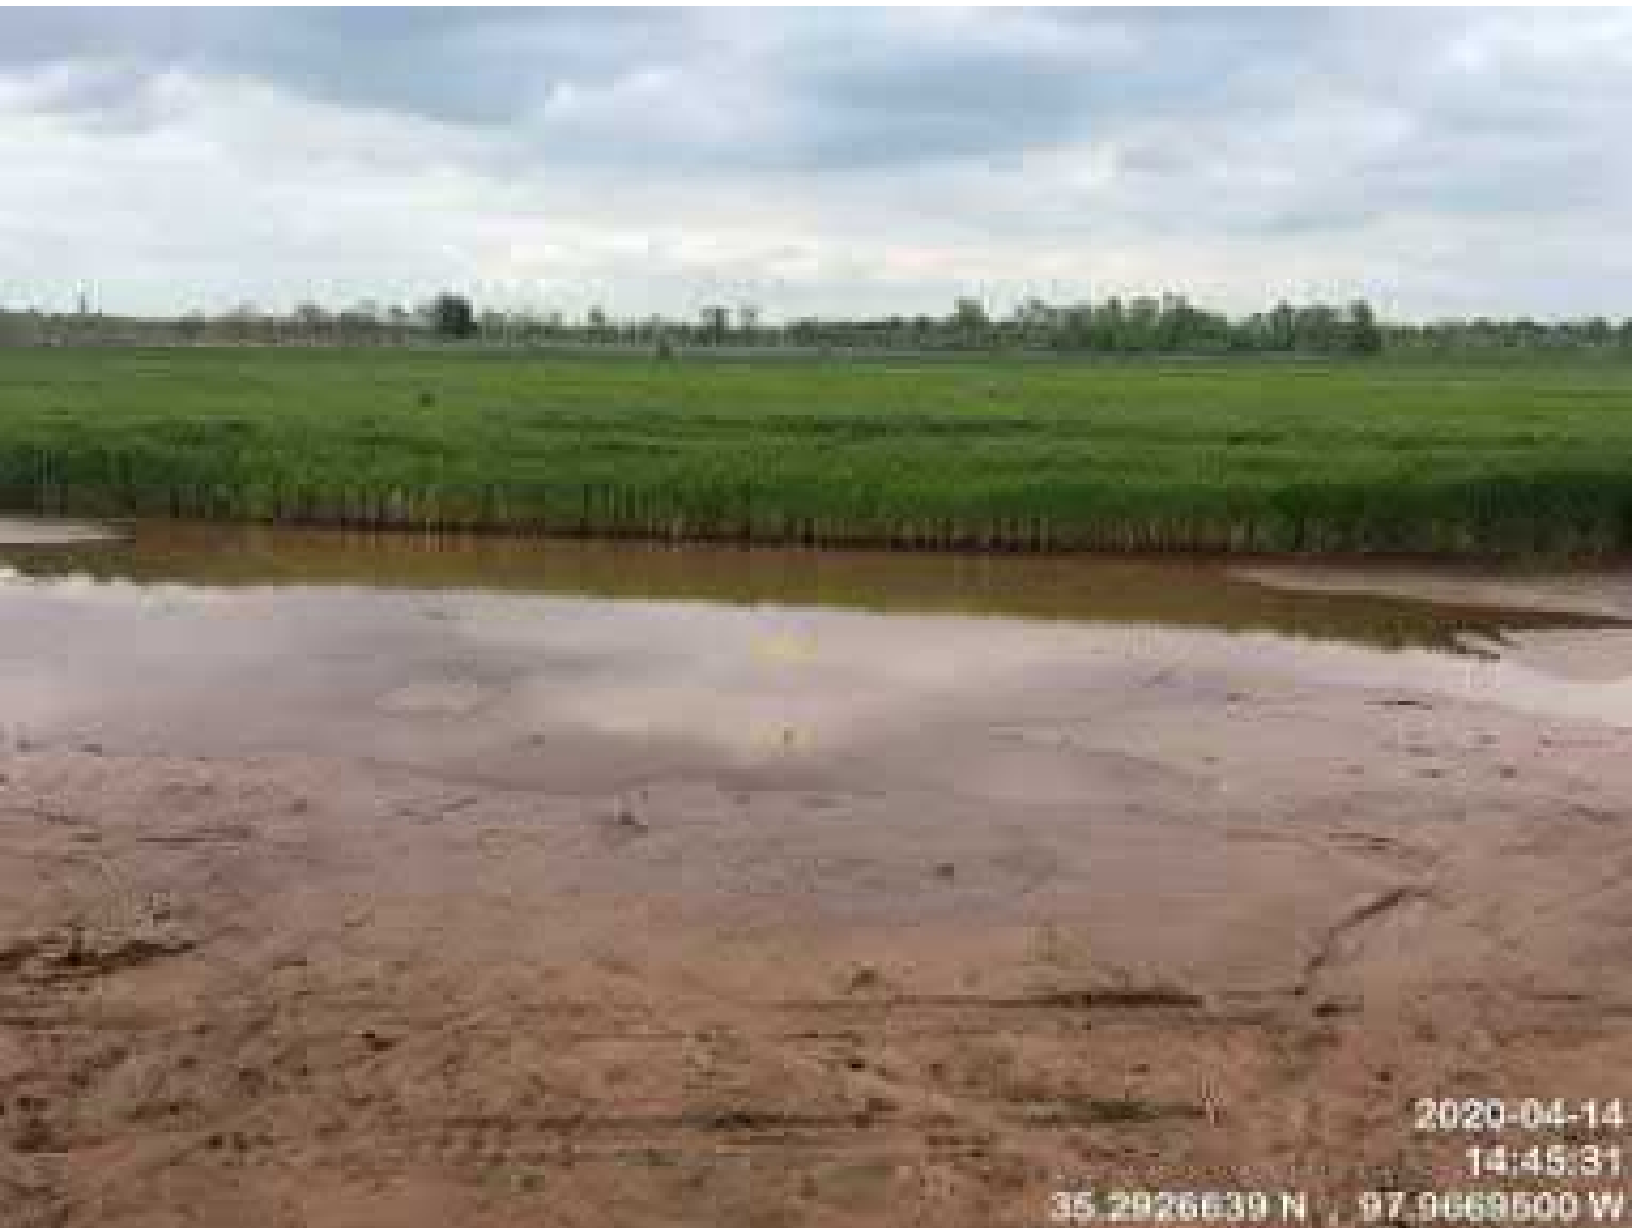
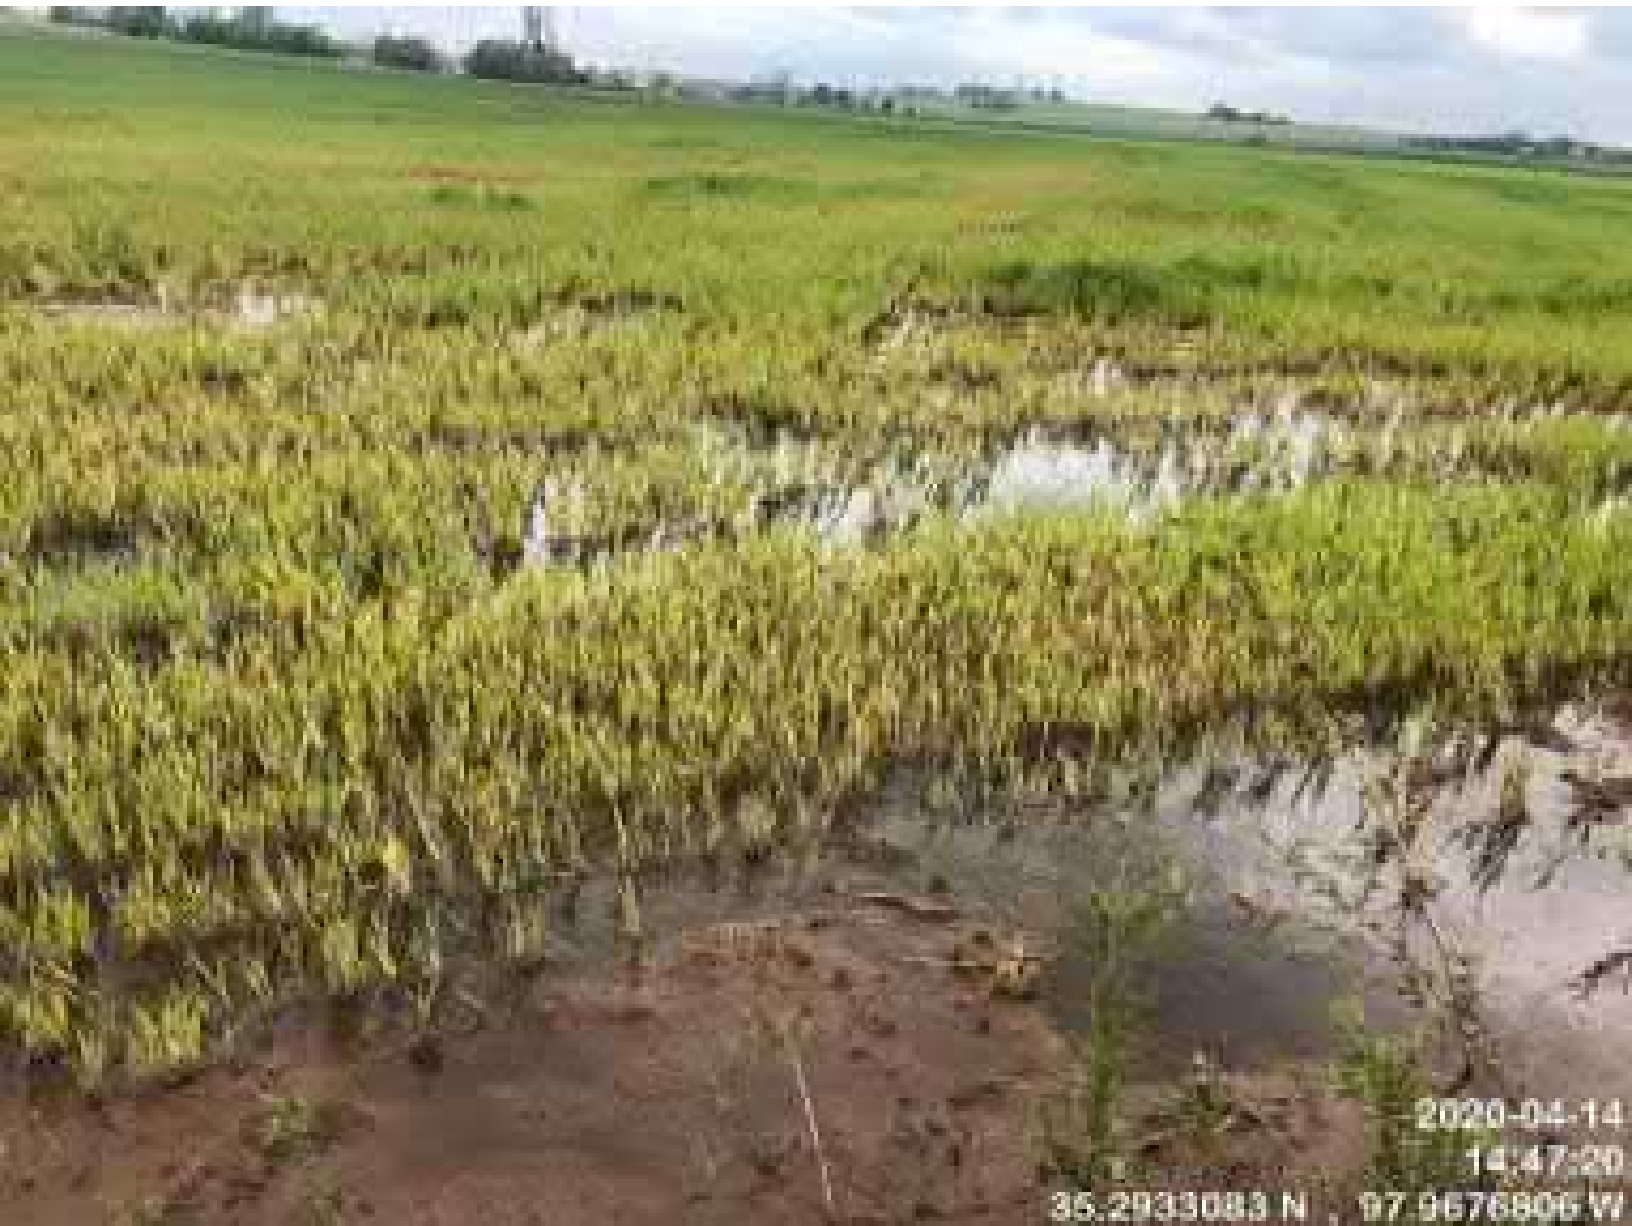
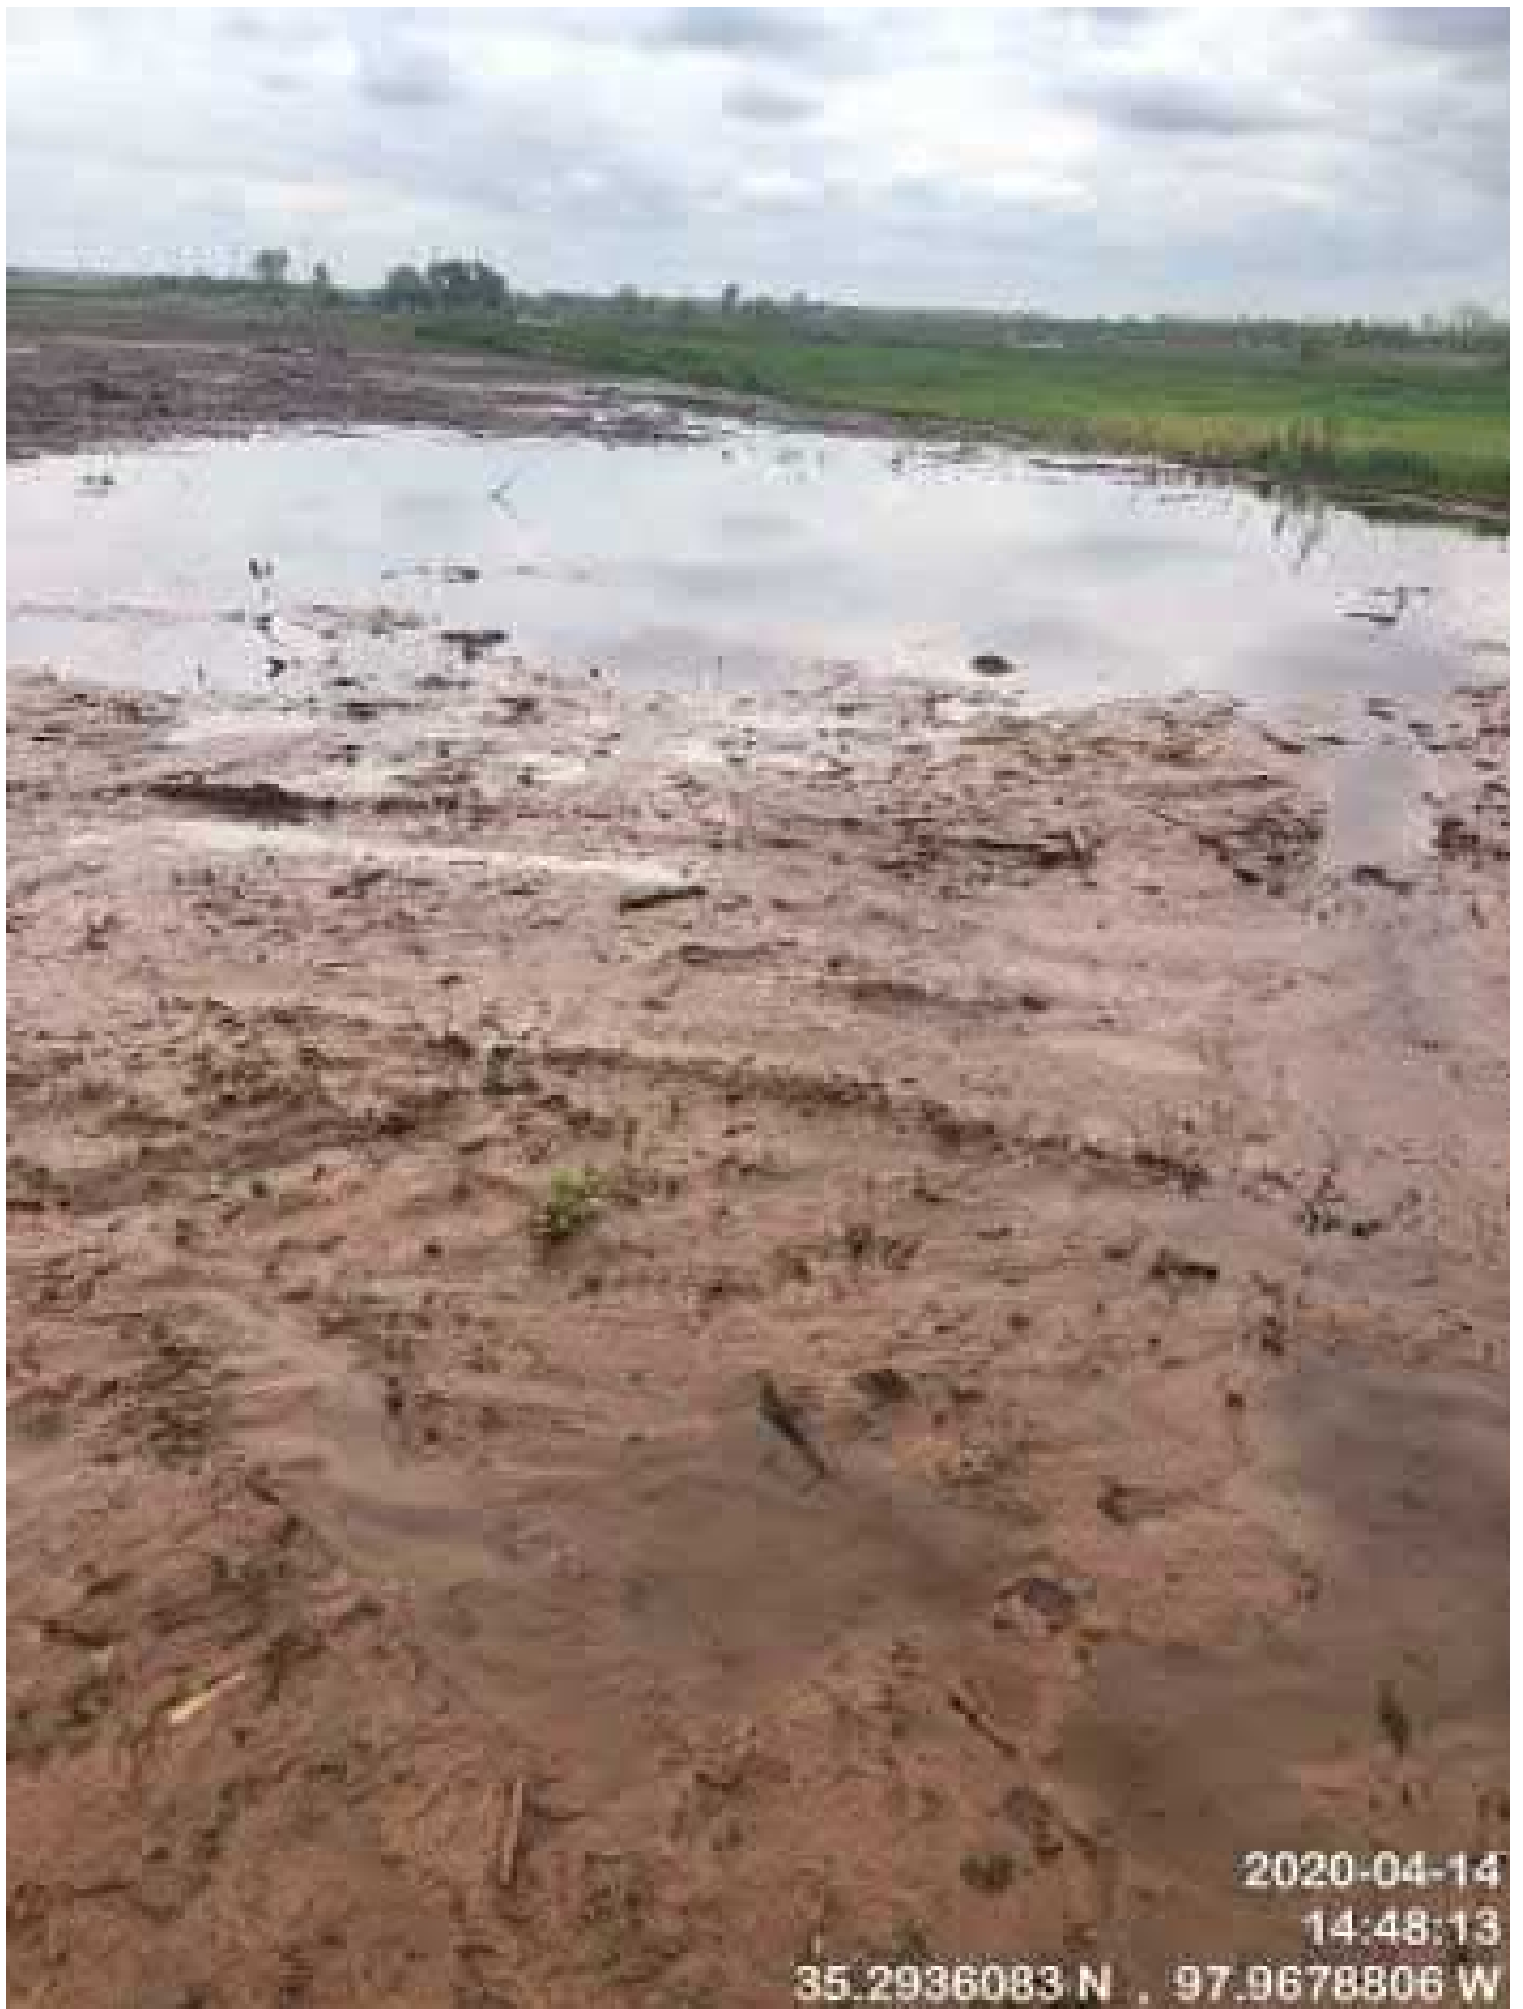
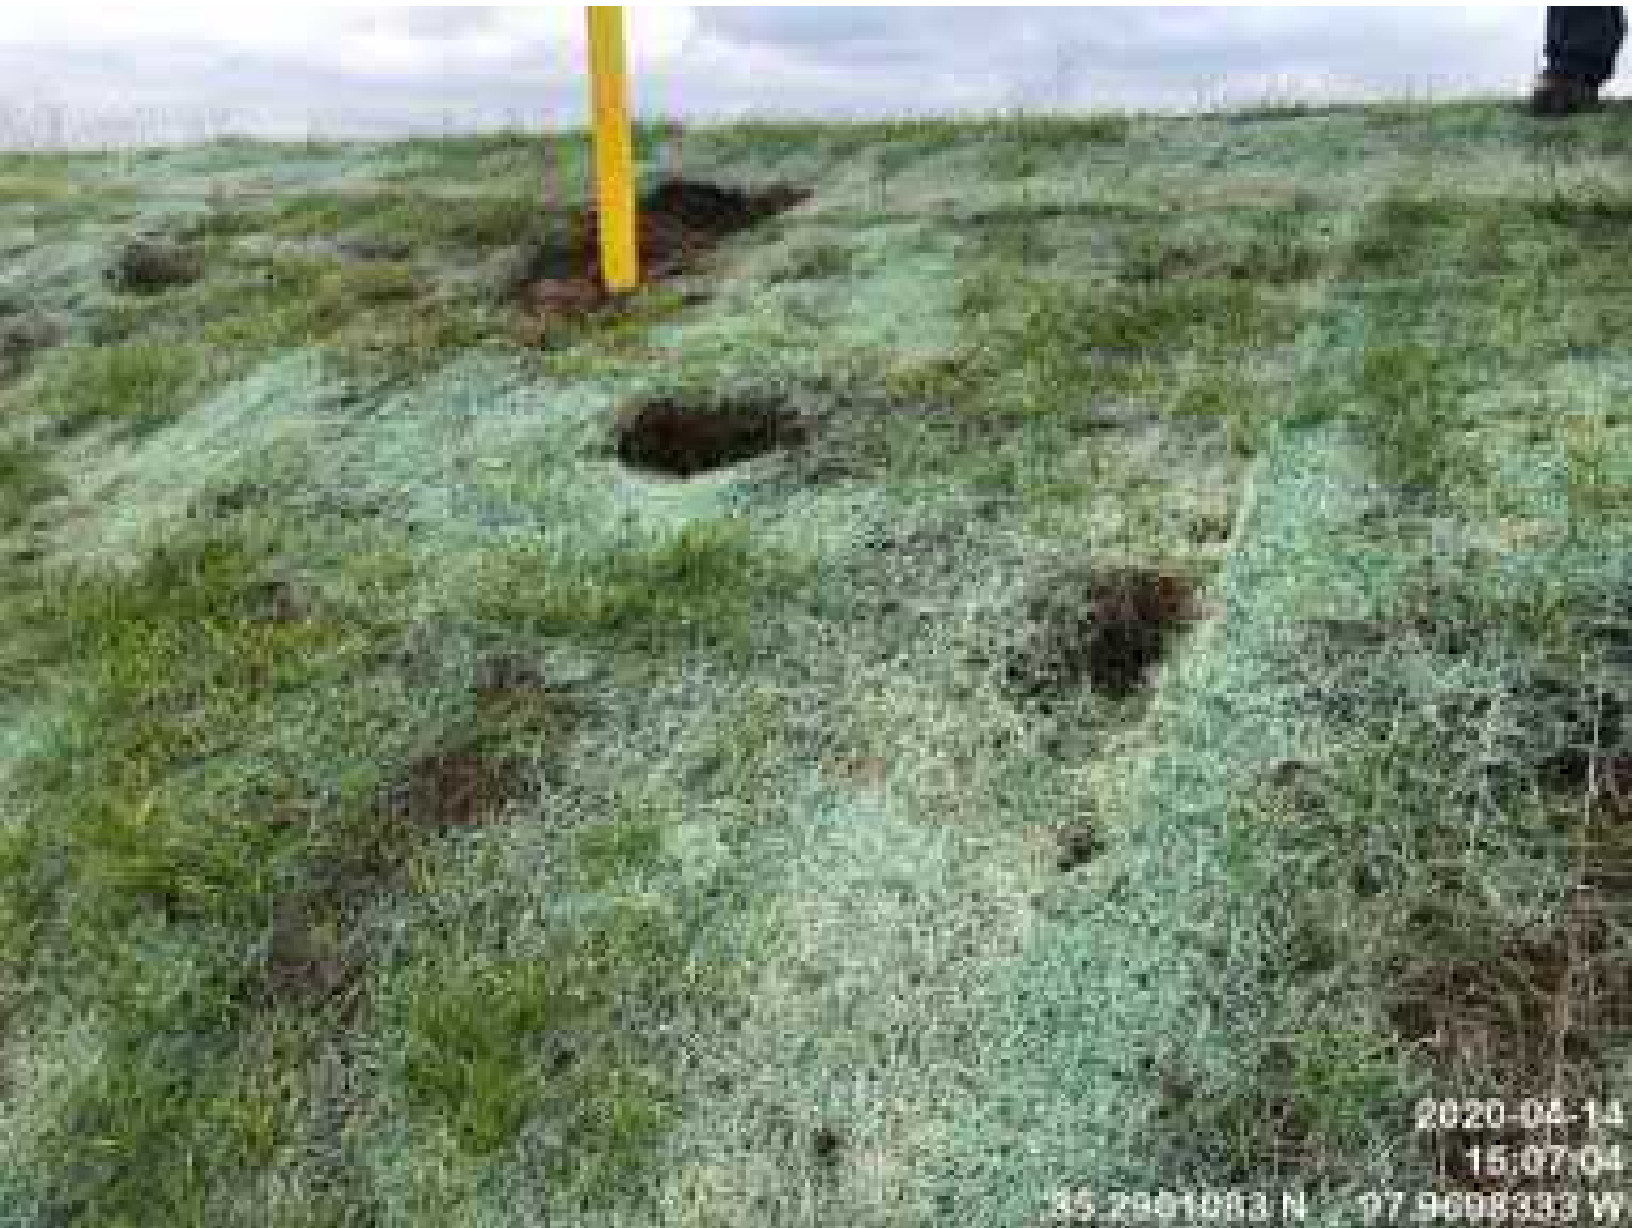
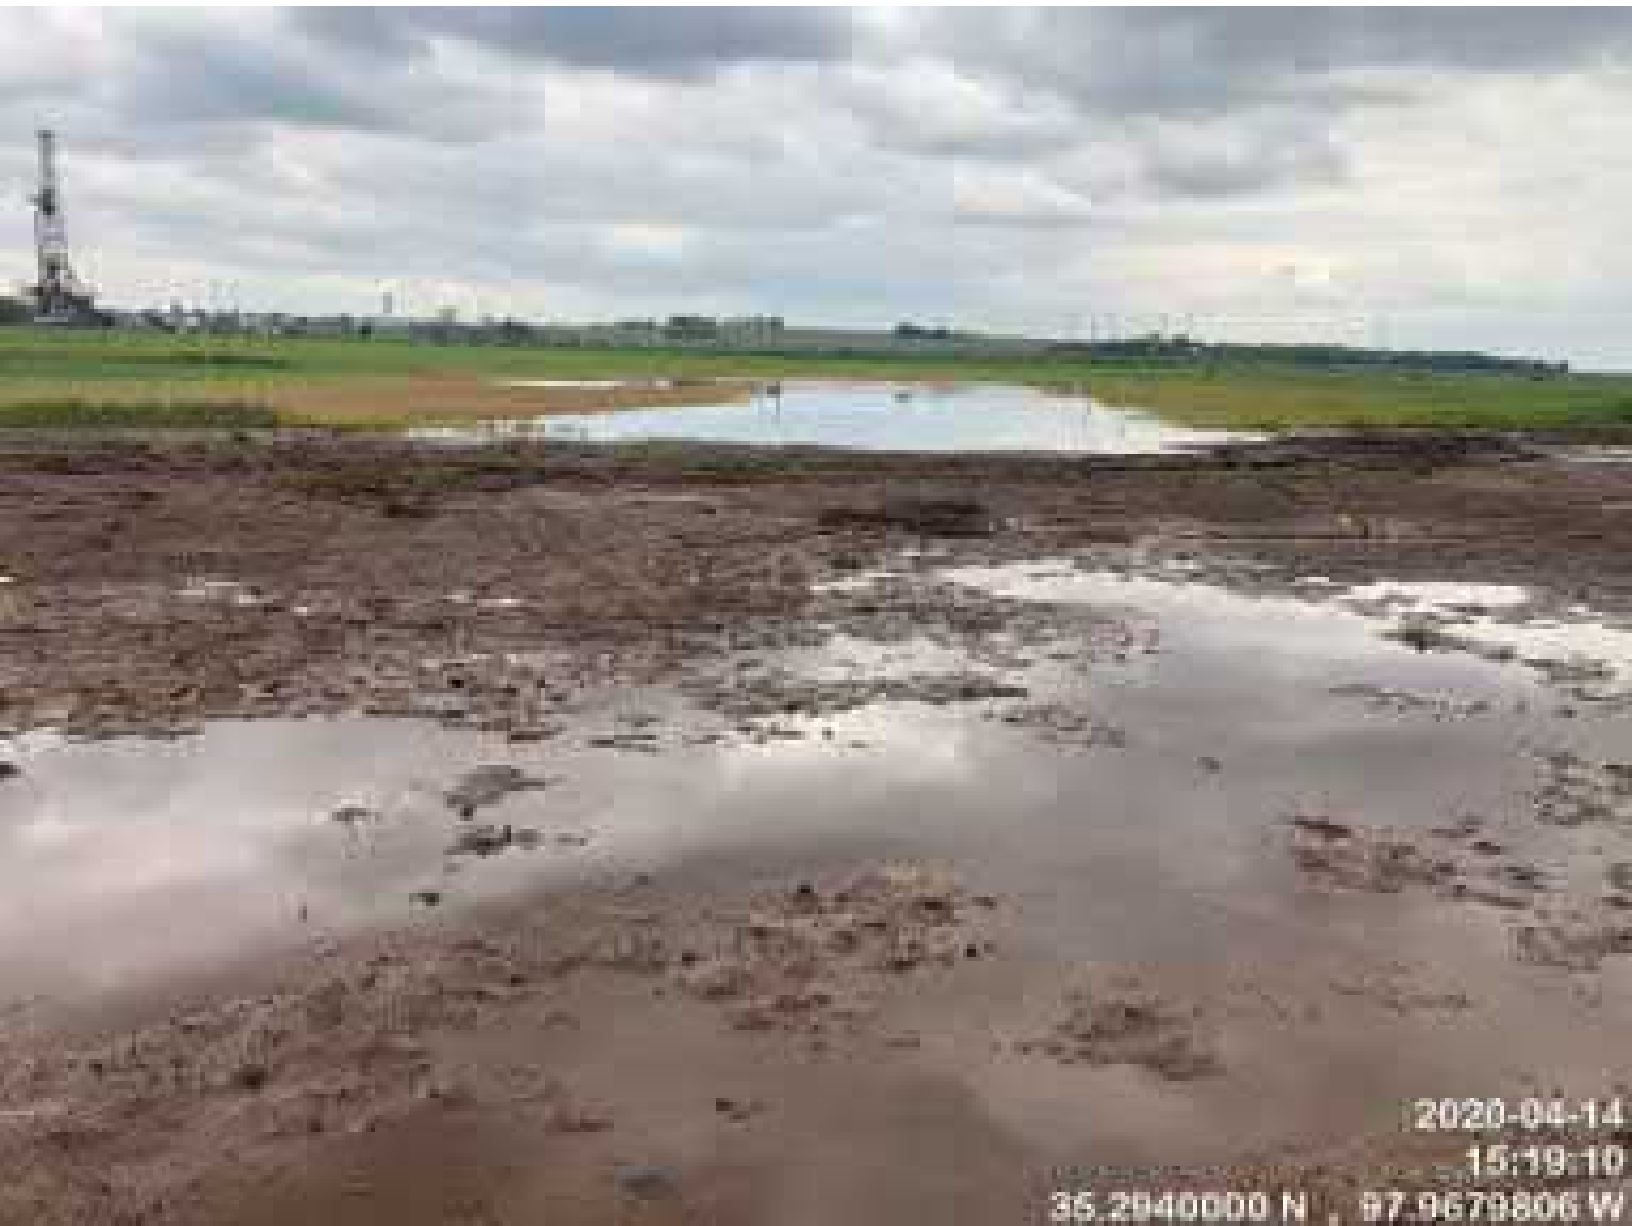
**April 14, 2020 Site Inspection
Wesley & Mary Burchfield
GR-0133.010, GR-0134.010, GR-0135.010
Mile Post: MP 35 - 35.5
Grady County, Oklahoma**

- 1.) No revegetation (FERC Plan: V. D. 1-3.)
- 2.) Erosion rills throughout unvegetated ROW (FERC Plan: IV. F. 1, 3-4.)
- 3.) Ponding inside and outside ROW
- 4.) Holes forming in ROW from soil settlement
- 5.) Soil Compaction (FERC Plan: V. C. 1-3.)
 - a. Off-ROW Penetrometer reading: Around 150 psi in multiple locations.
 - b. In-ROW Penetrometer reading: 300 psi limit exceeded in every on-ROW location.
- 6.) Multiple drain tiles not fixed (FERC Plan: IV. C. 1-4.)

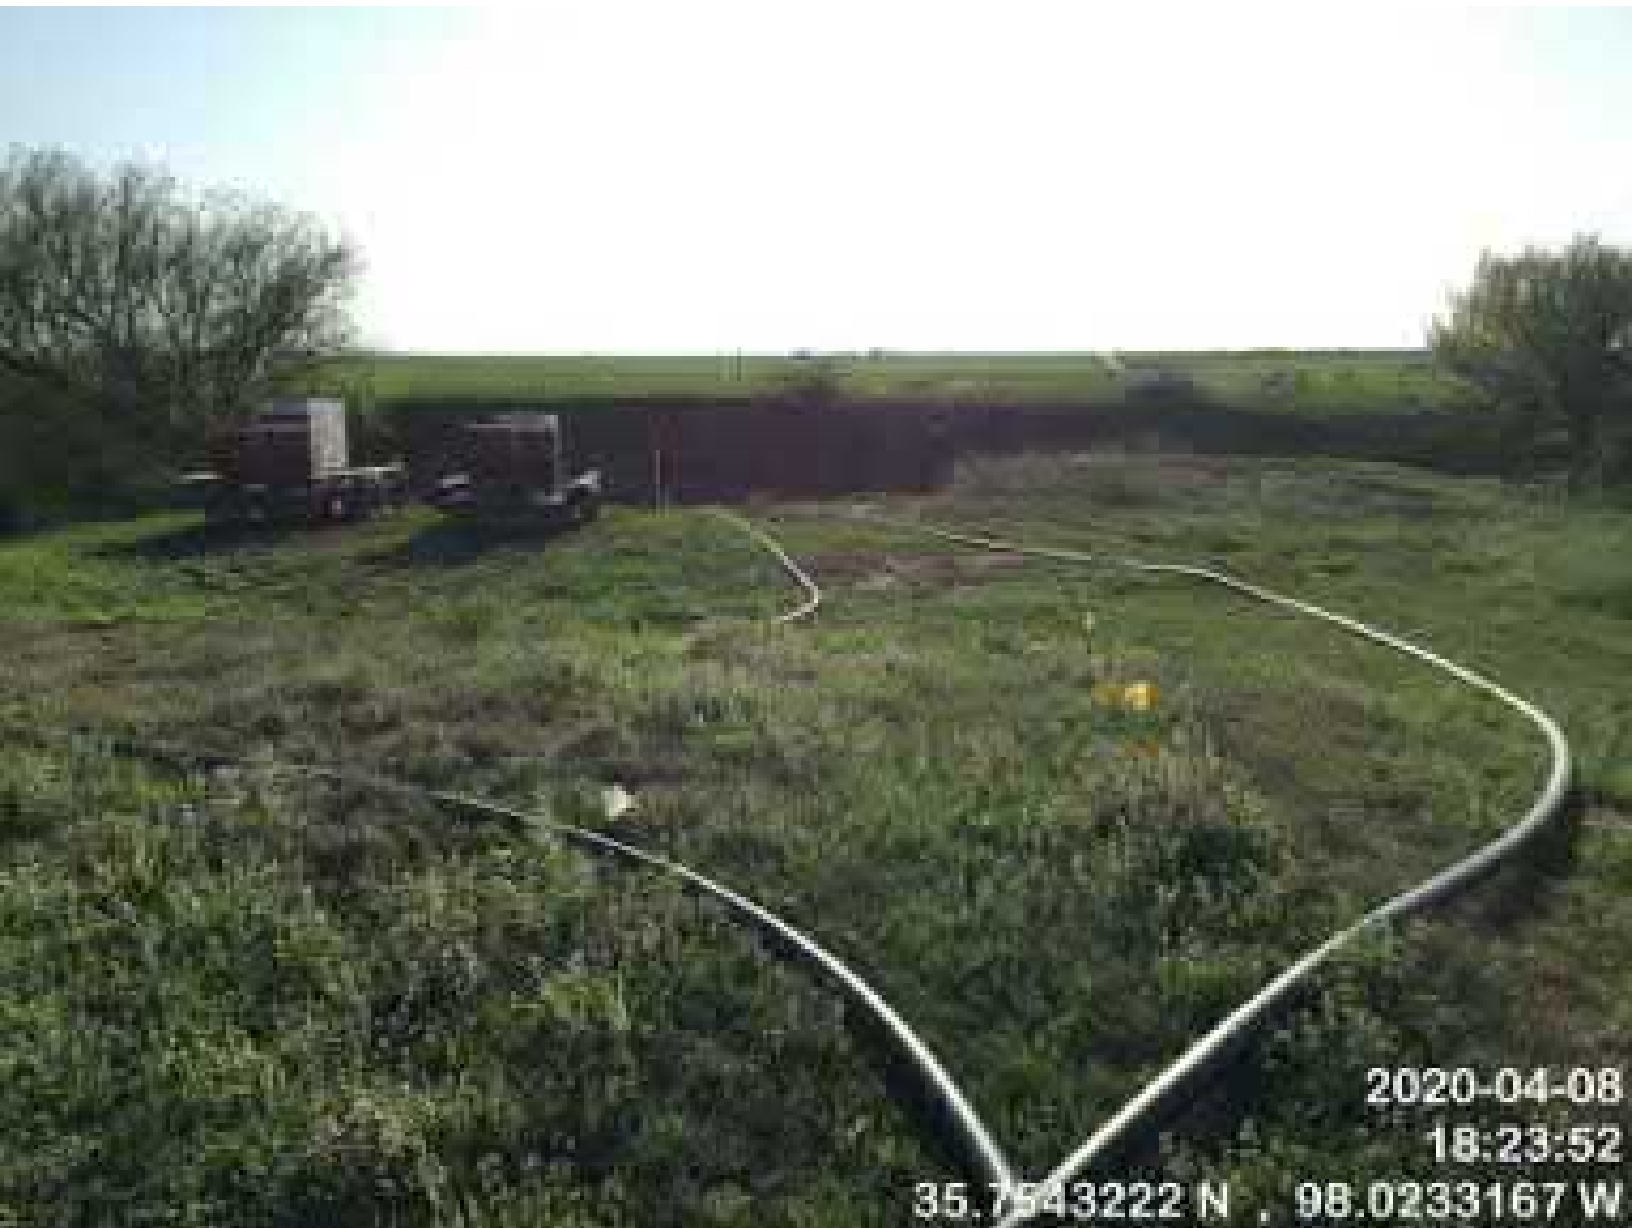
35.7543222 N , 98.0233167 W

- c. Same site is to be bored by Newfield Exploration for upcoming new pipeline
- 3.) Banks of Winter Creek Tributary (SKI-015) are unstable and slipping into creek. Midship cleared vegetation at creek prior to changing crossing methods to HDD. (FERC Procedures: V.C.2-3.)

- 4.) Soil Compaction (FERC Plan: V.C.1-3.)
 - a. Off-ROW Penetrometer reading: Around 160 psi in multiple locations.
 - b. In-ROW Penetrometer reading: 300 psi limit exceeded in every on-ROW location.

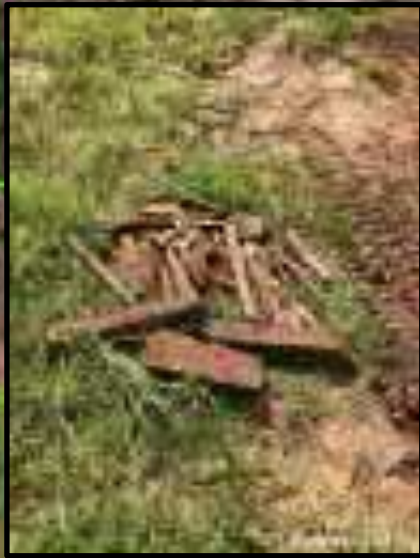
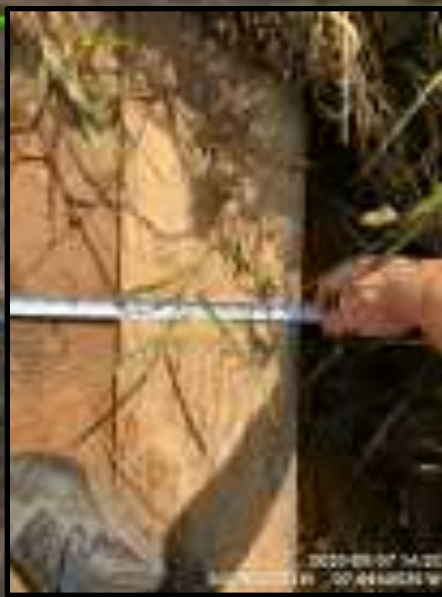
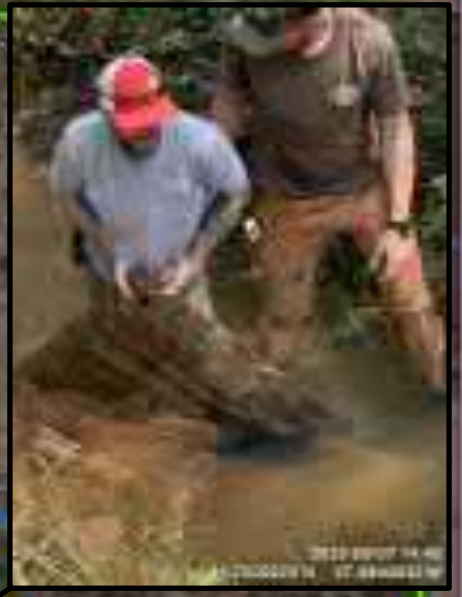
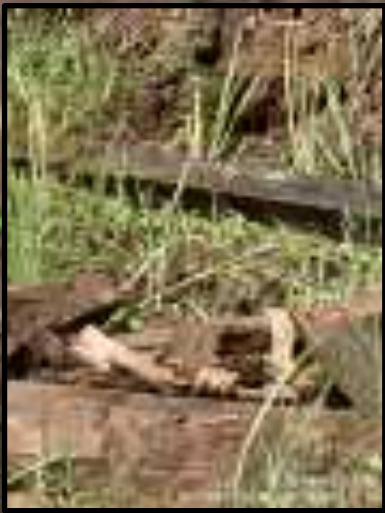
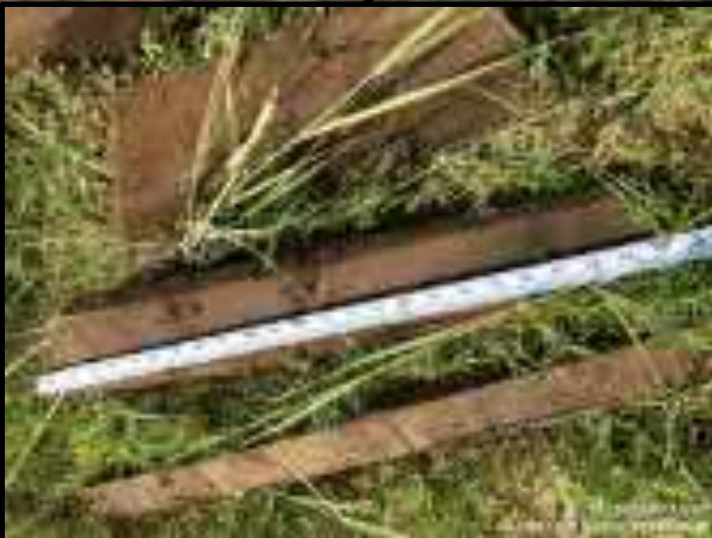
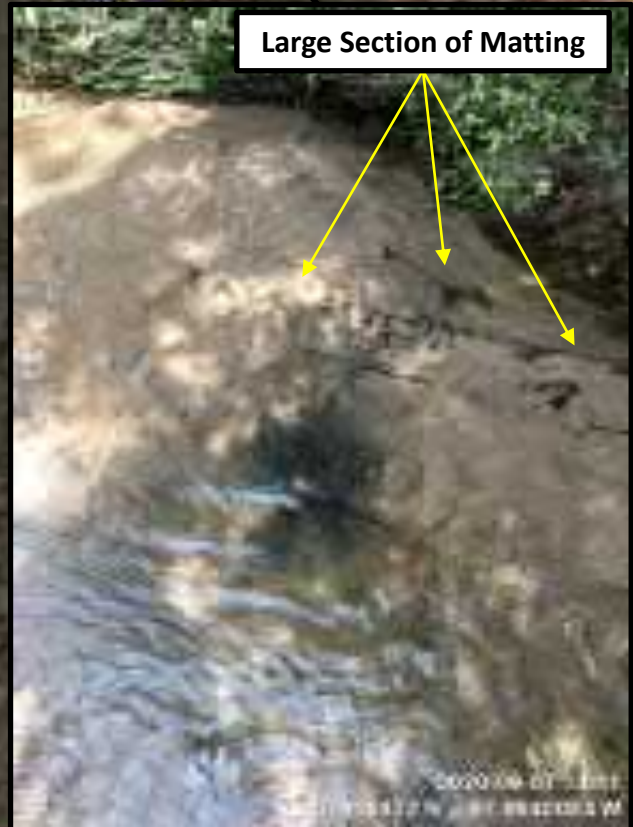
Mark Morris
GR-0353.000
0000-26-04N-05W-2-001-00

Large Section of Matting

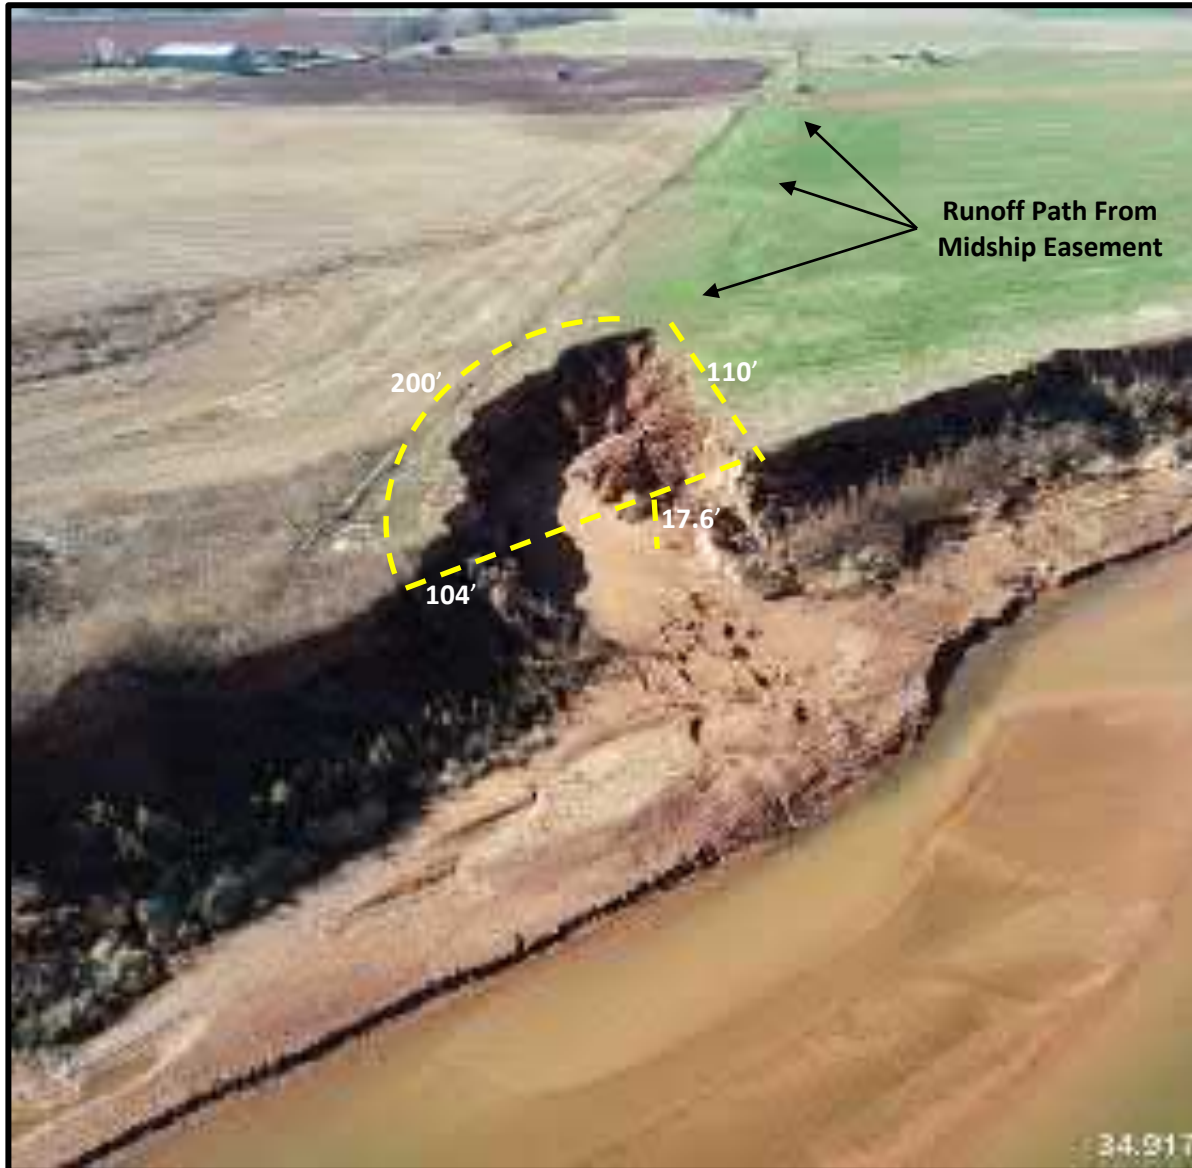
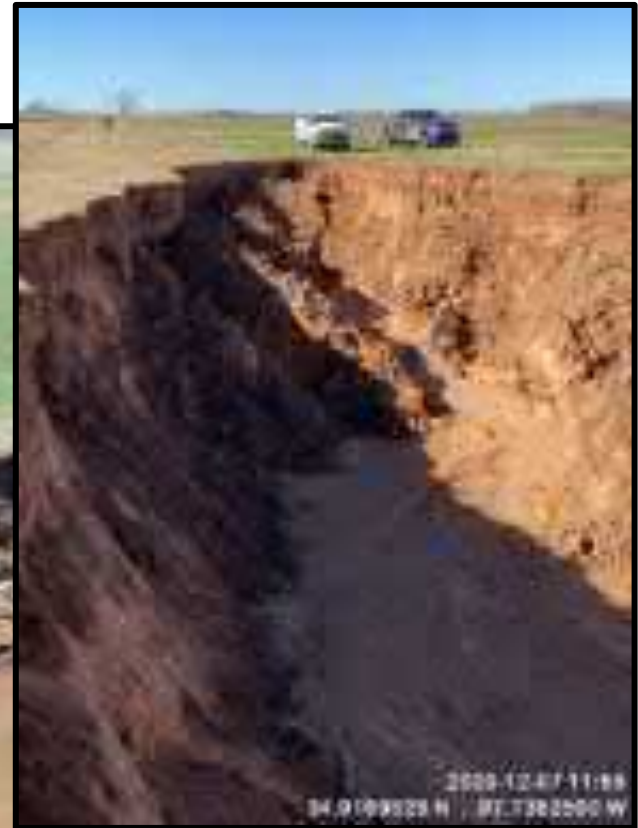
JAMES MCELVANY. TRACT GR-0310.000 (BANK EROSION ON ADJACENT OFF-LINE PROPERTY)

Approximately 3,000 Cubic Yards of Soil Will Be Needed to Fill Riverbank Erosion. Additional Stabilization and Drainage Measures May Be Needed to Avoid Erosion After Restoration.

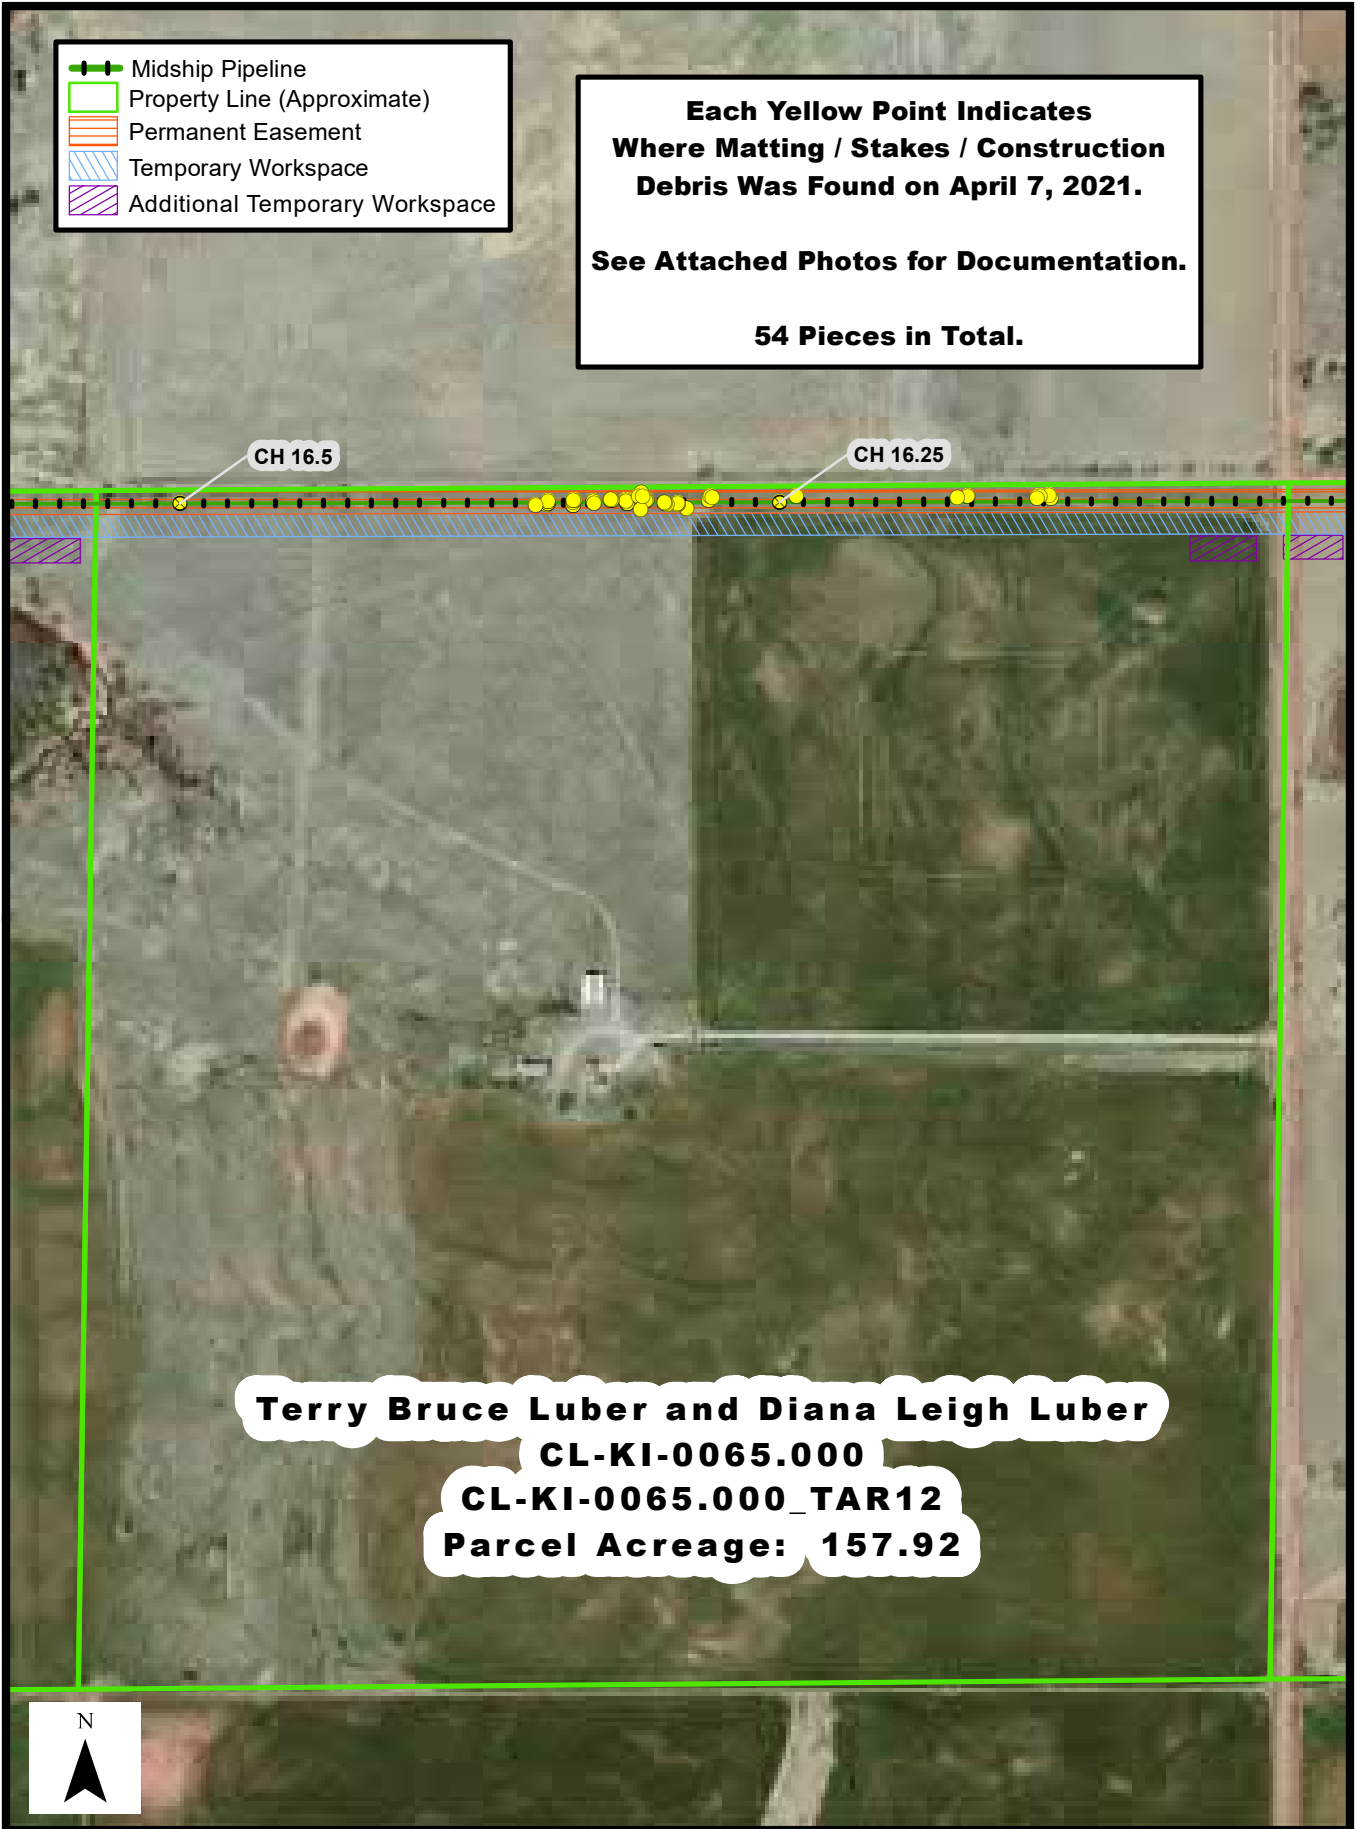
**Each Yellow Point Indicates
Where Matting / Stakes / Construction
Debris Was Found on April 7, 2021.**

54 Pieces in Total.
