Robert Squires - Squires Consulting LLC
Landowner Advocate

Opening Statement for May 5, 2021 Subcommittee on Civil Rights and Civil Liberties Hearing:
“Pipelines Over People (Part II): Midship Pipeline’s Disregard for Landowners in Its Pathway”

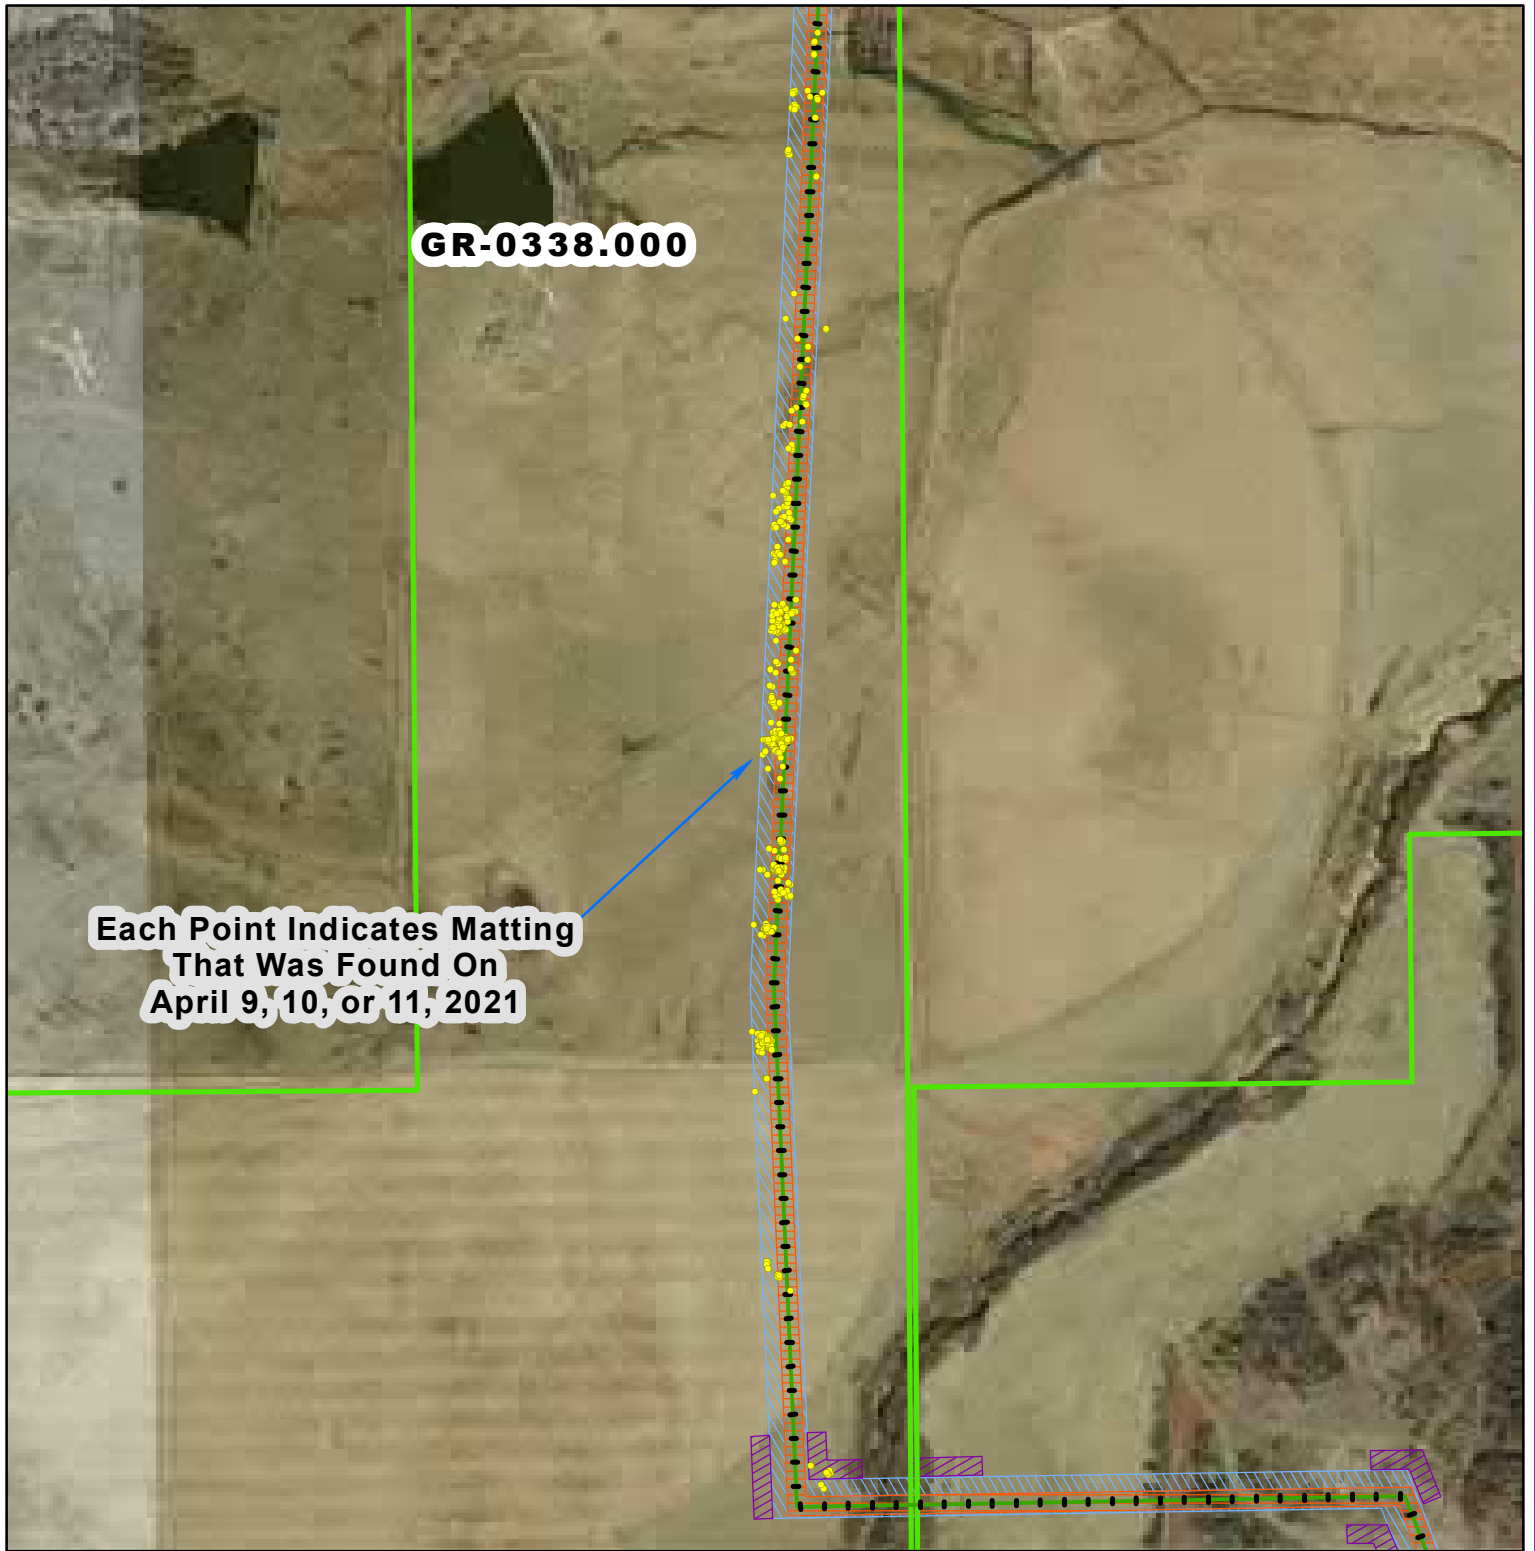
April 9 & 10 Matting Location Map Prepared For Sandy Creek Farms, Inc

7. By CLC's estimation, approximately 0.3% of the Midship easement on tract GR-0338.000 has been checked for matting to date.

**Each Point Indicates Matting
That Was Found On
April 9, 10, or 11, 2021**

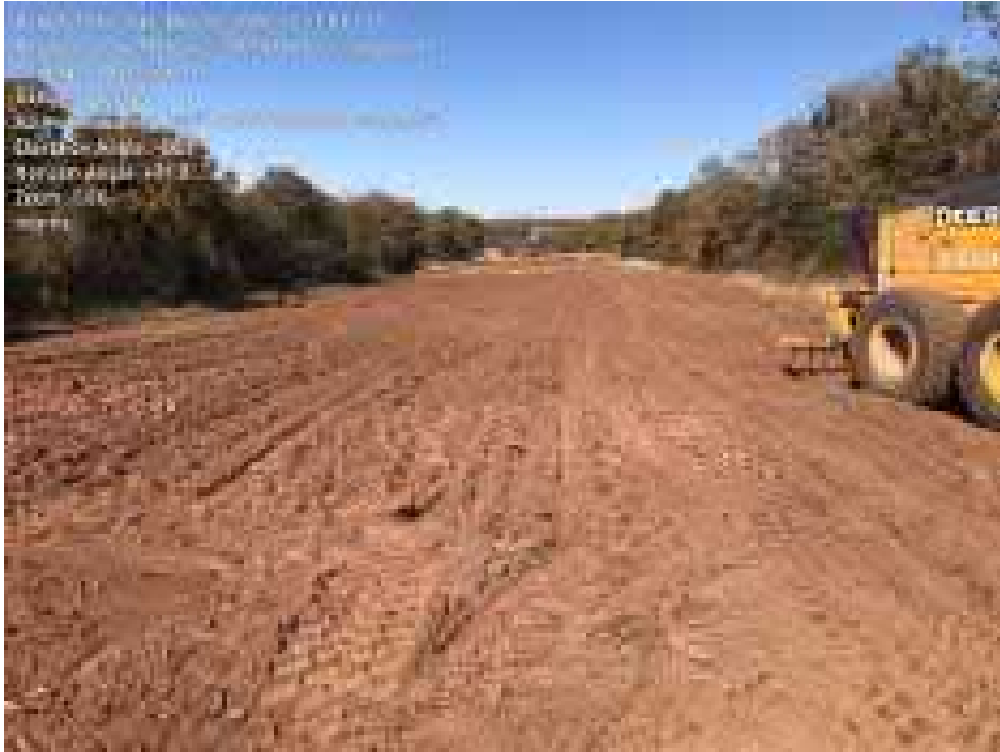
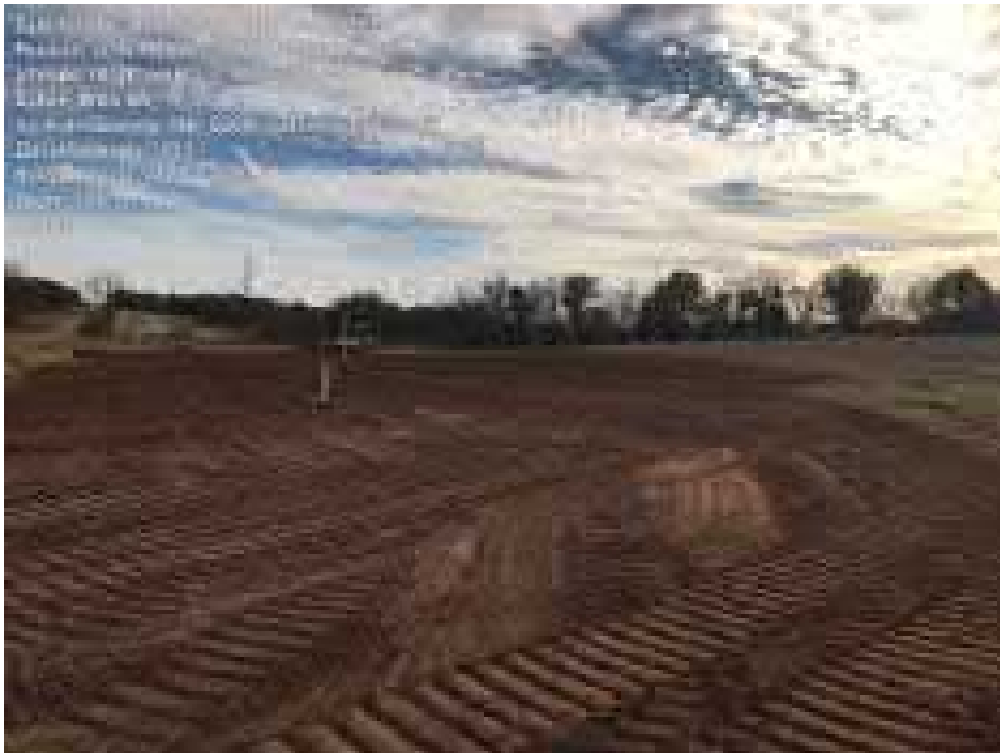
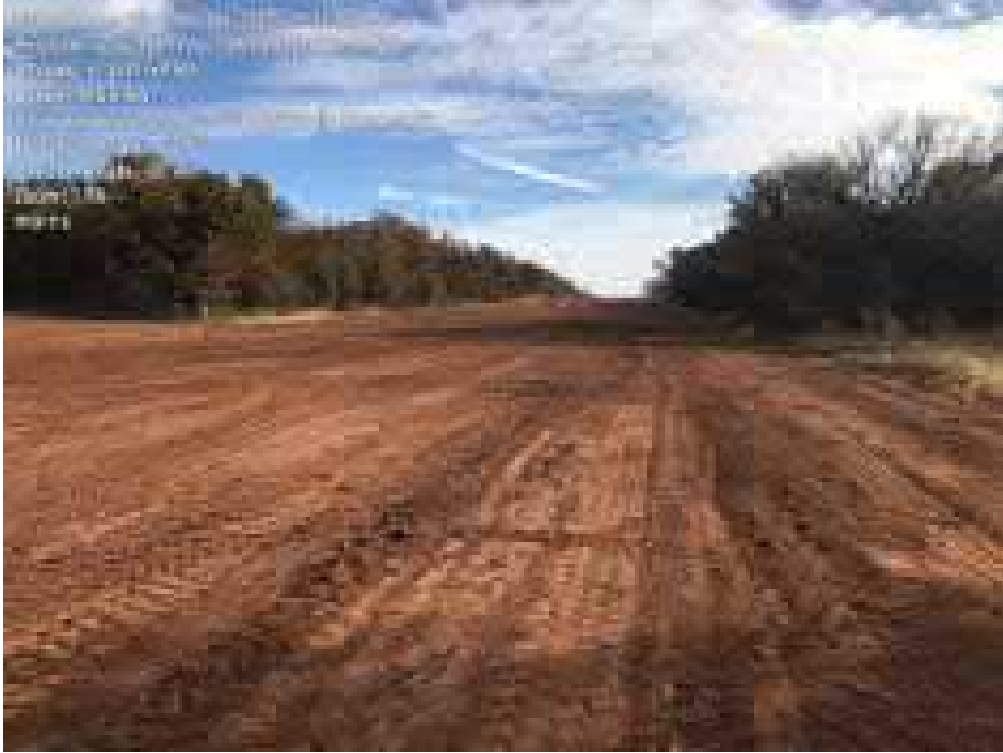
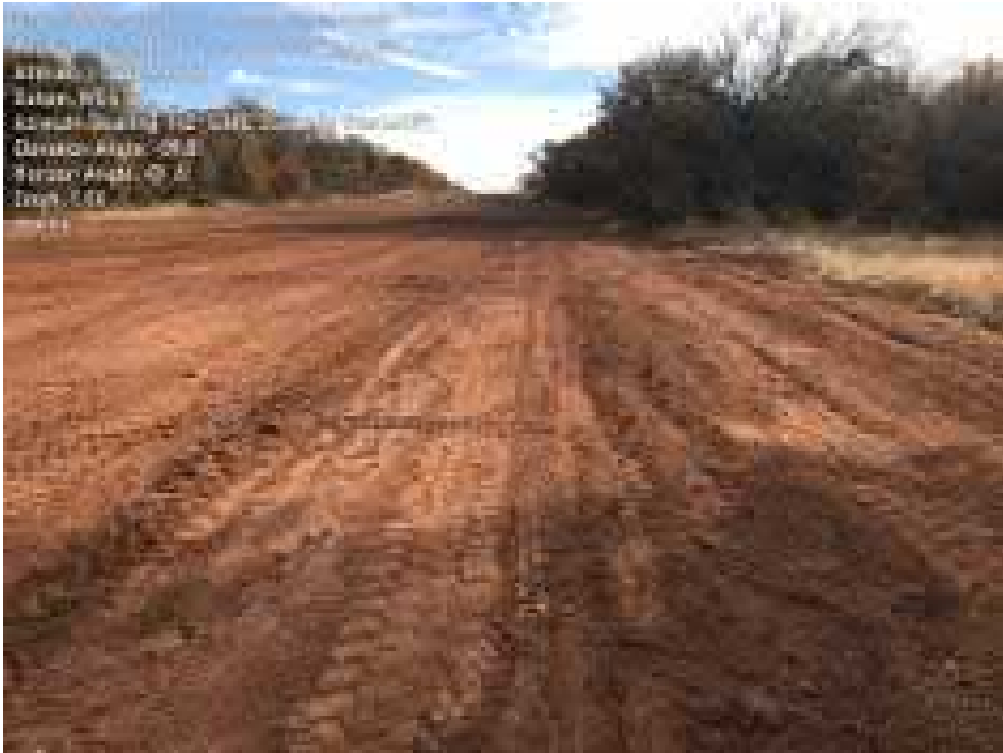
Tract Nos. GR-0353.000 and GR-0355.000

On November 2, 2020, Midship's contractor remobilized to the property and removed construction debris from the ROW. Accordingly, Midship believes the issue of construction debris on the ROW has been resolved, as all debris has been removed. This work was completed and was noted in Midship's weekly restoration report for this period. Please refer to the photographs of the Landowner's property included in **Attachment A**.

Photos of Restoration Activities on Morris Property

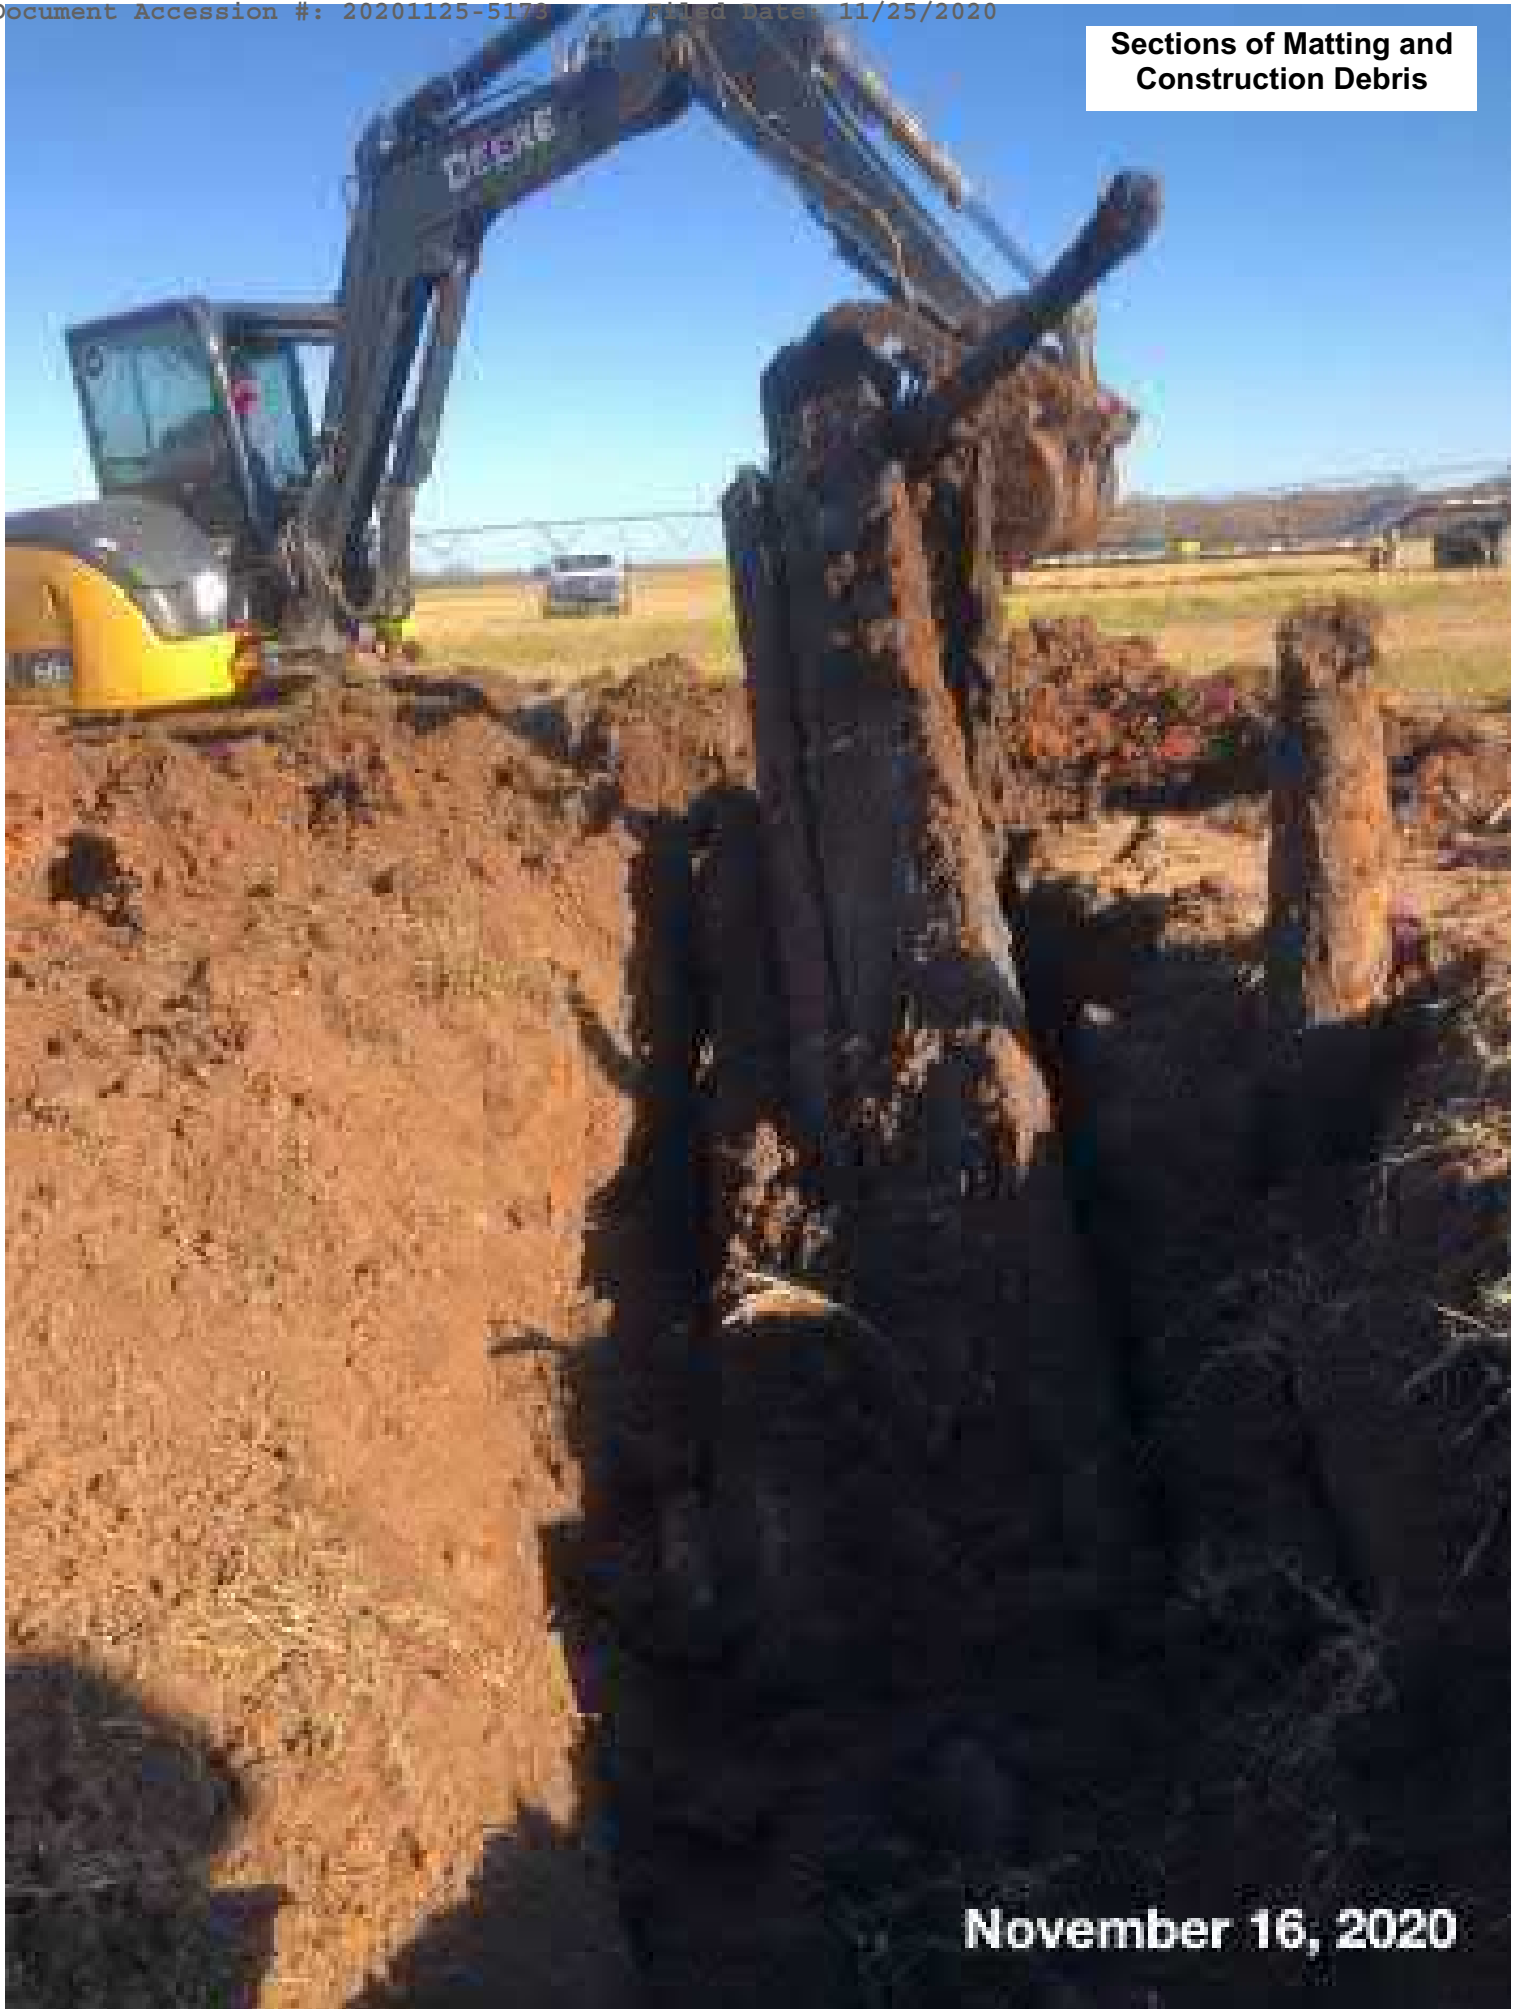
**Sections of Matting and
Construction Debris**

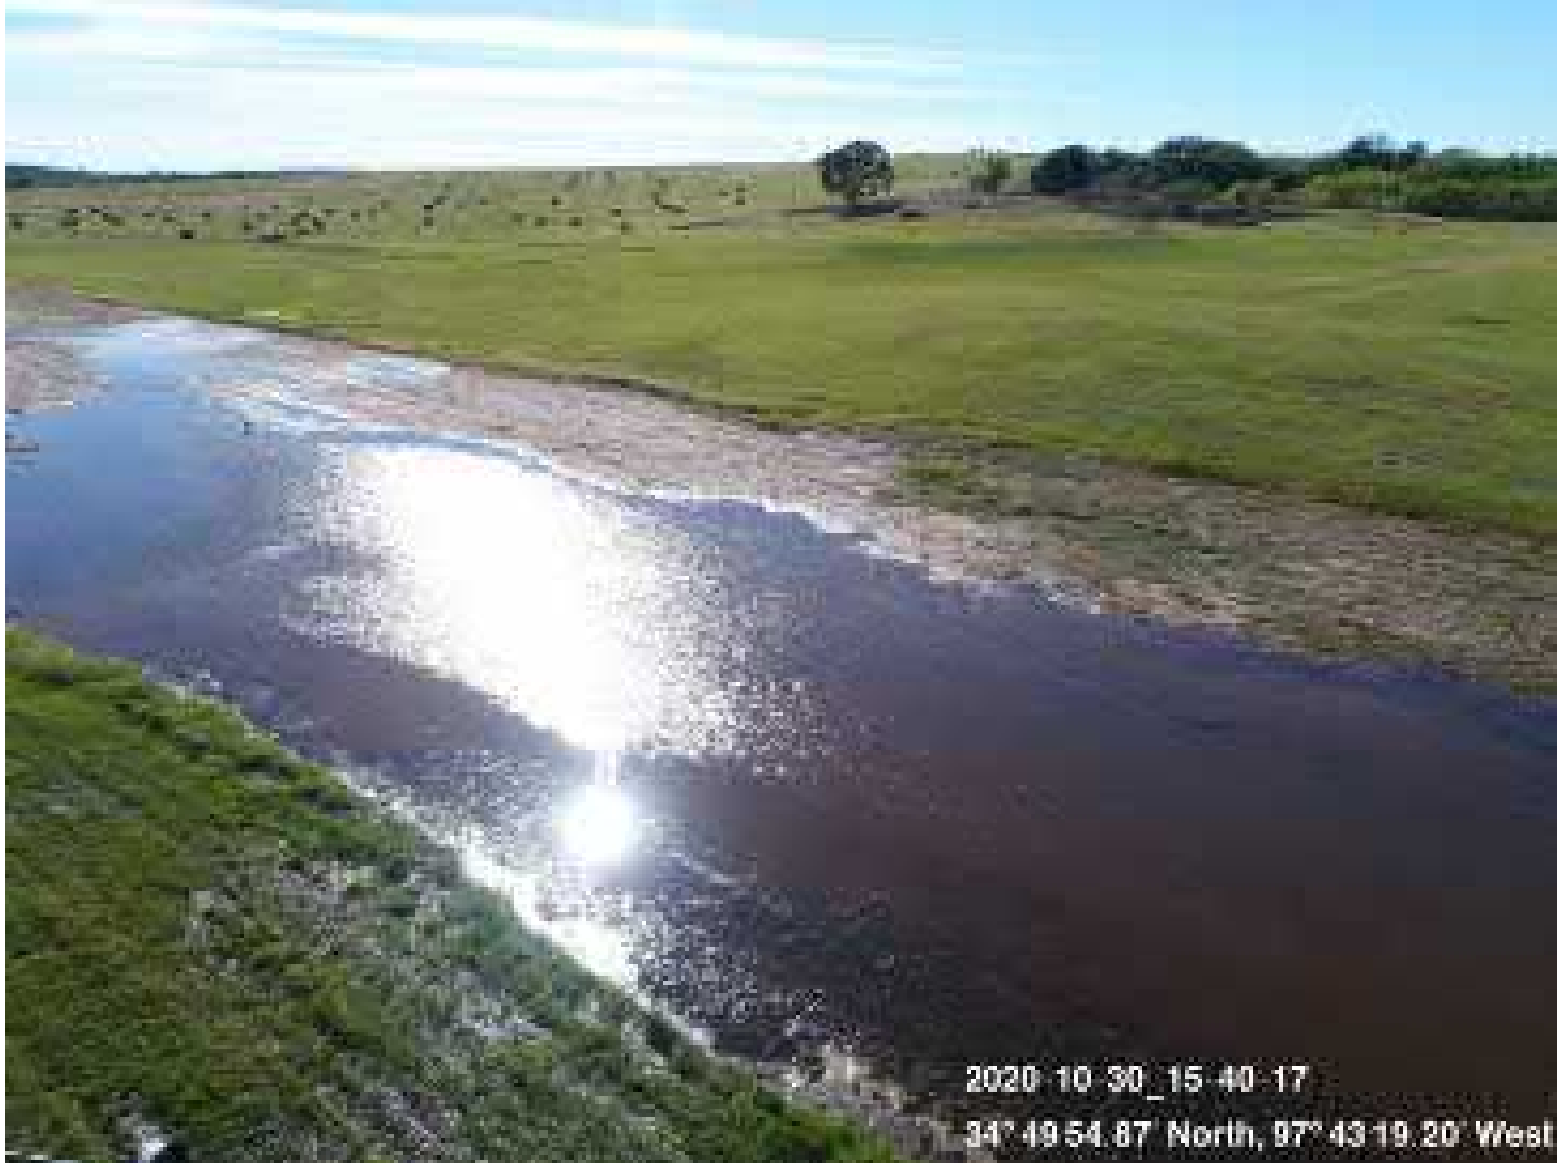
**Flooded Easement Due to the Altered Grade and Drainage
Issues the Will Need Remediated On and Off ROW**

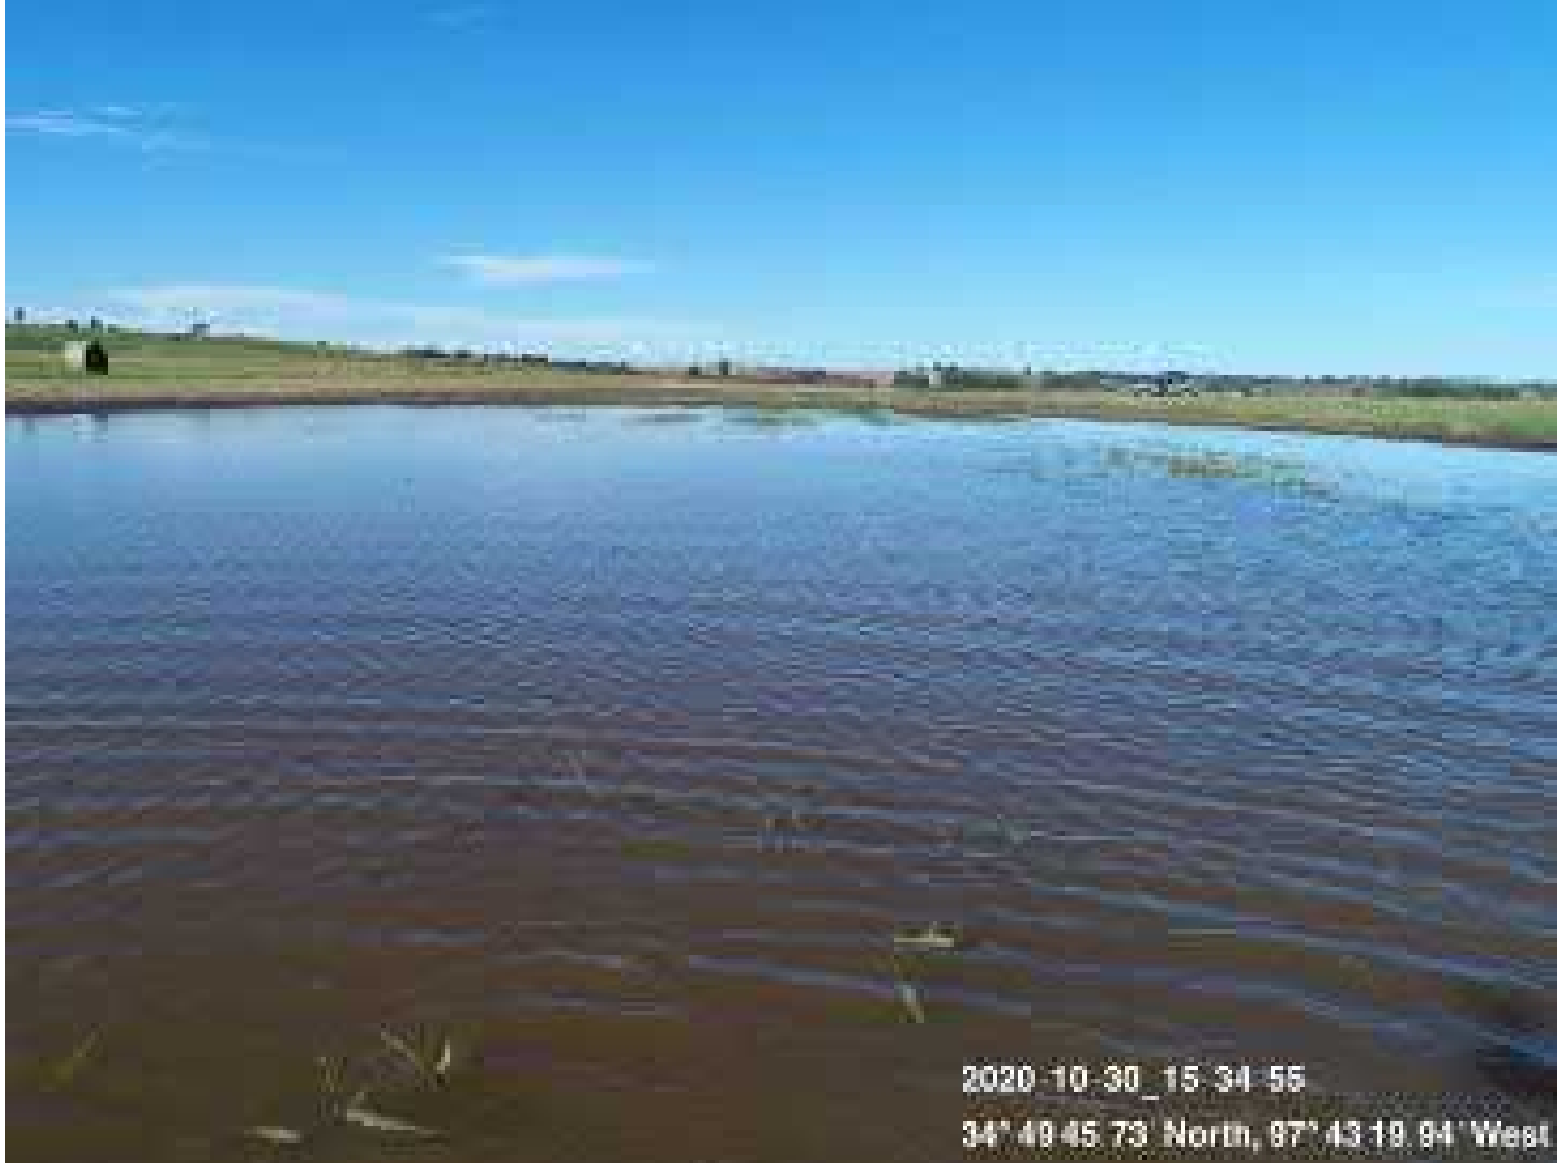
**Flooded Easement Due to the Altered Grade and Drainage Issues
the Will Need Remediated On and Off ROW**

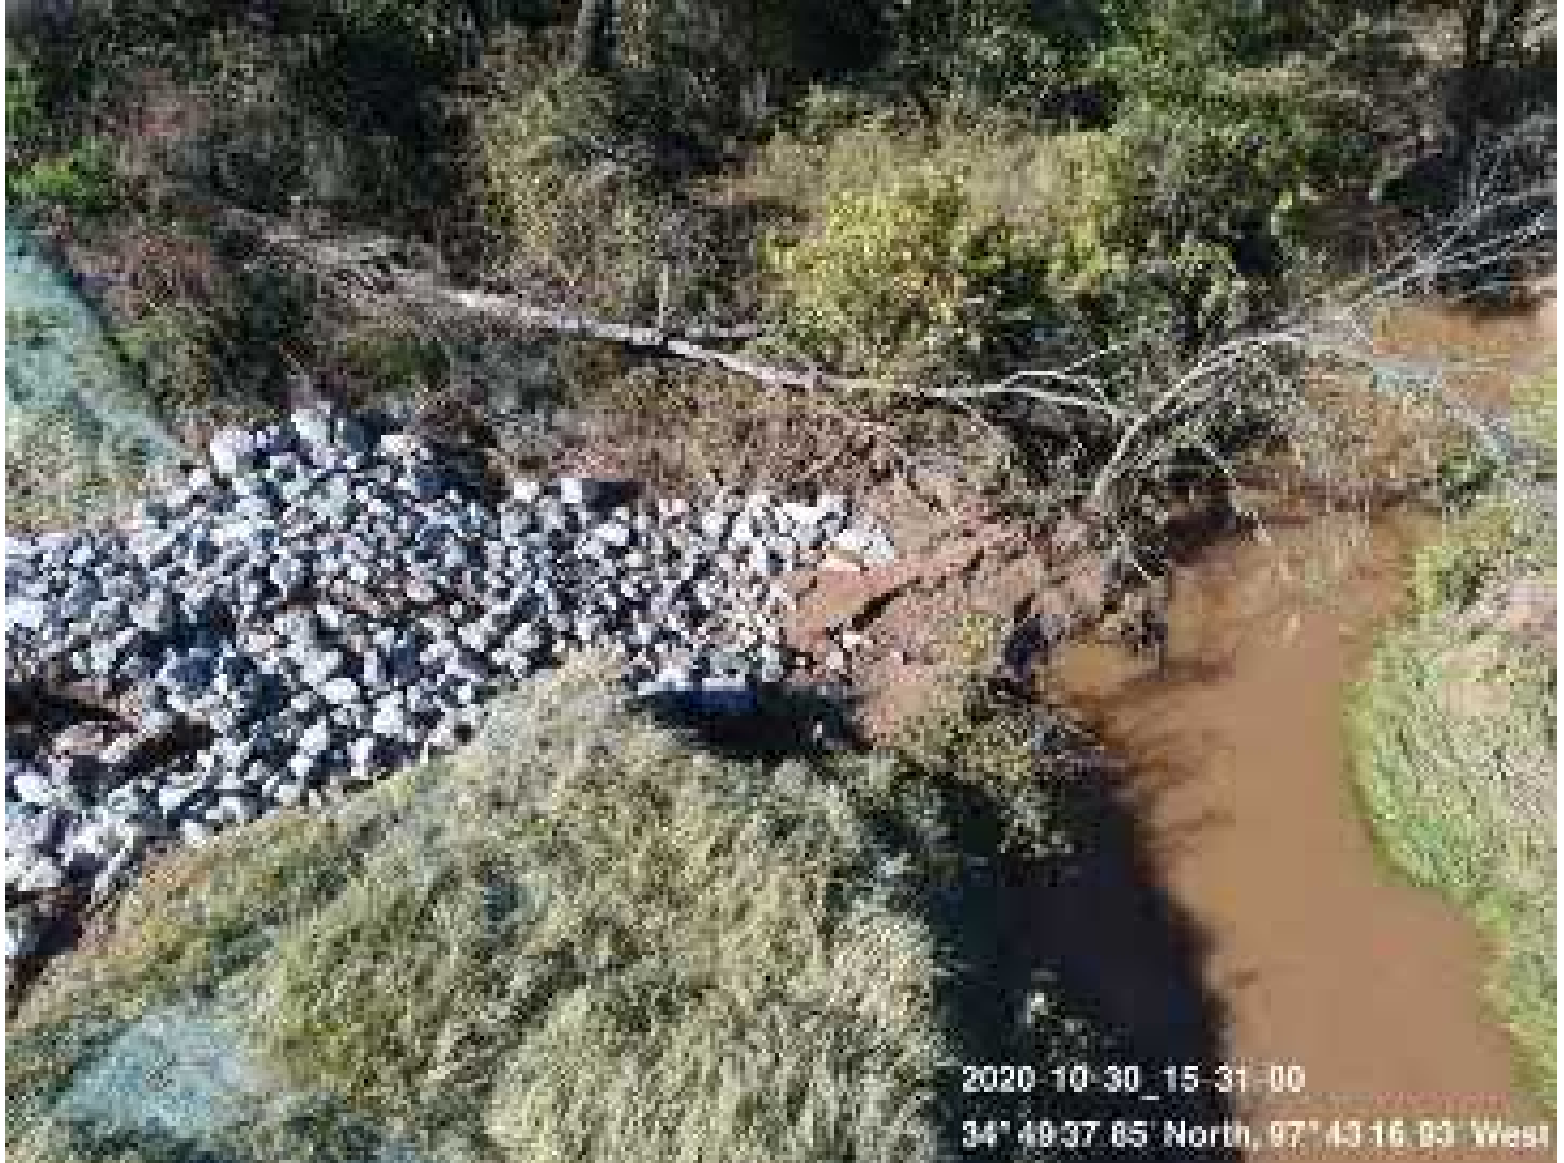
**Sections of the Sandy Creek Bank Have Slipped Causing Erosion
and Timber is Falling into the Creek. The Drainage has Been Altered
Causing Consistent Runoff**

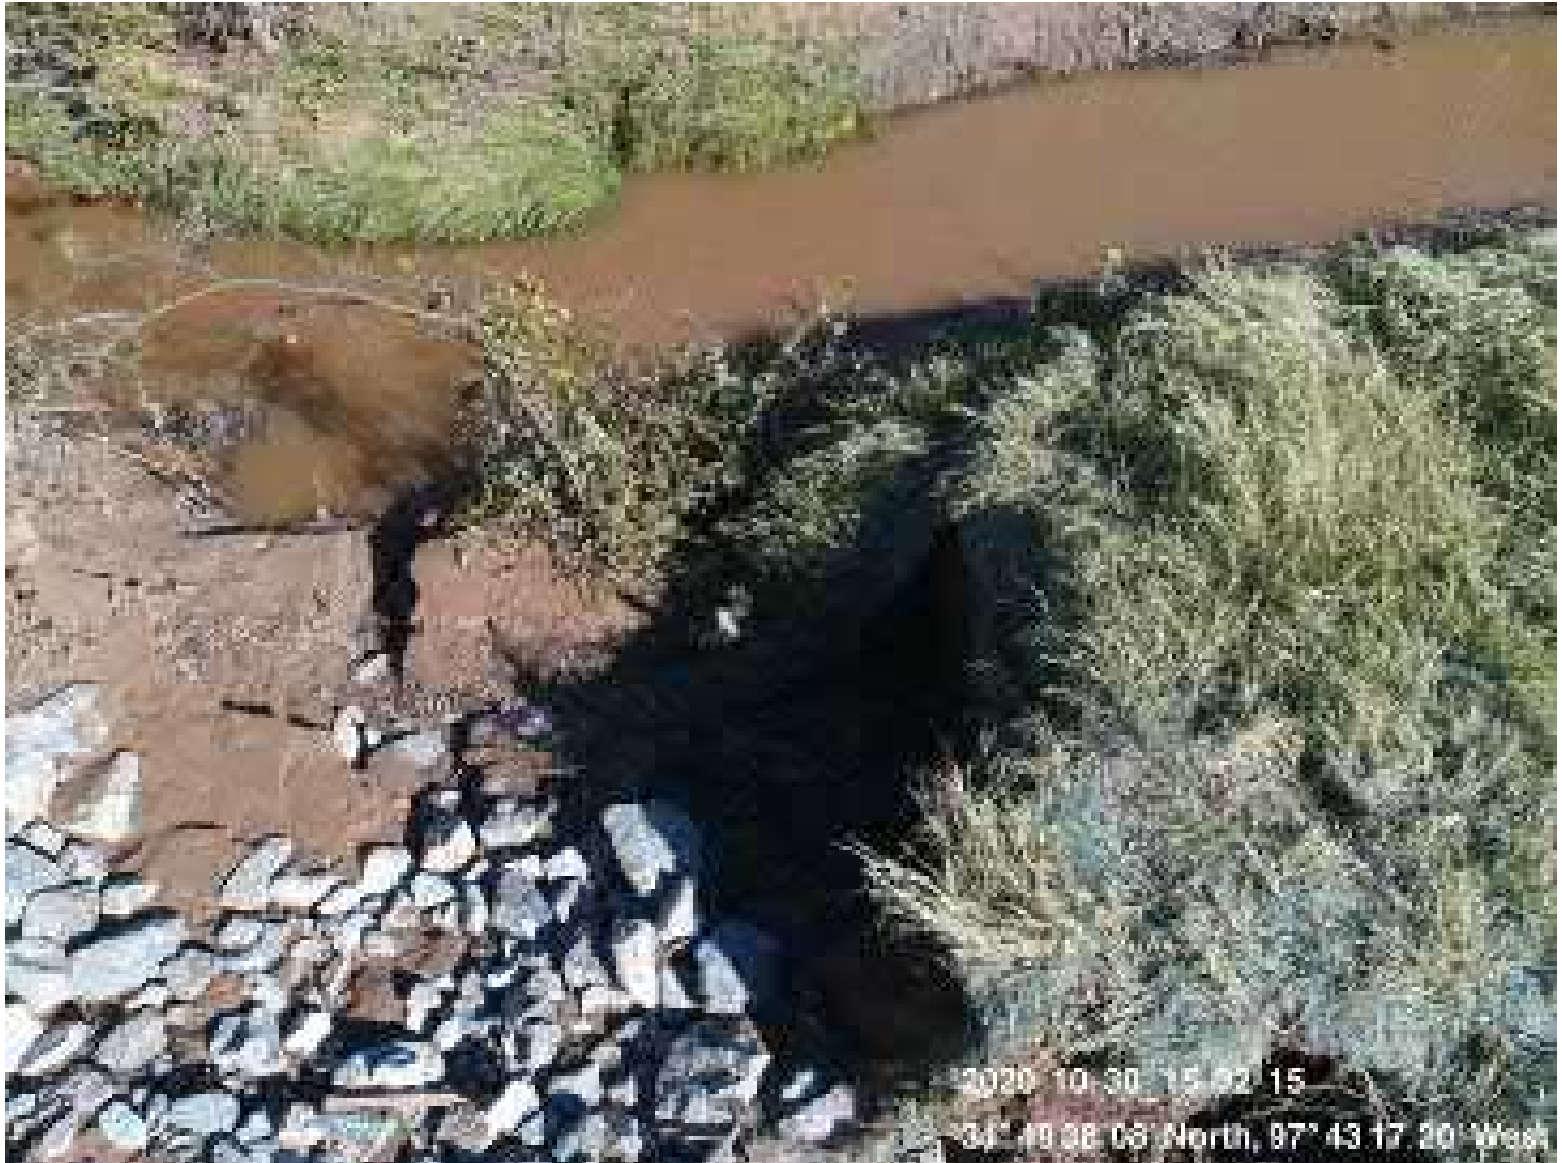
**Excessive Erosion Patterns Have Been Created Causing Stormwater
Runoff and Drainage Issues**

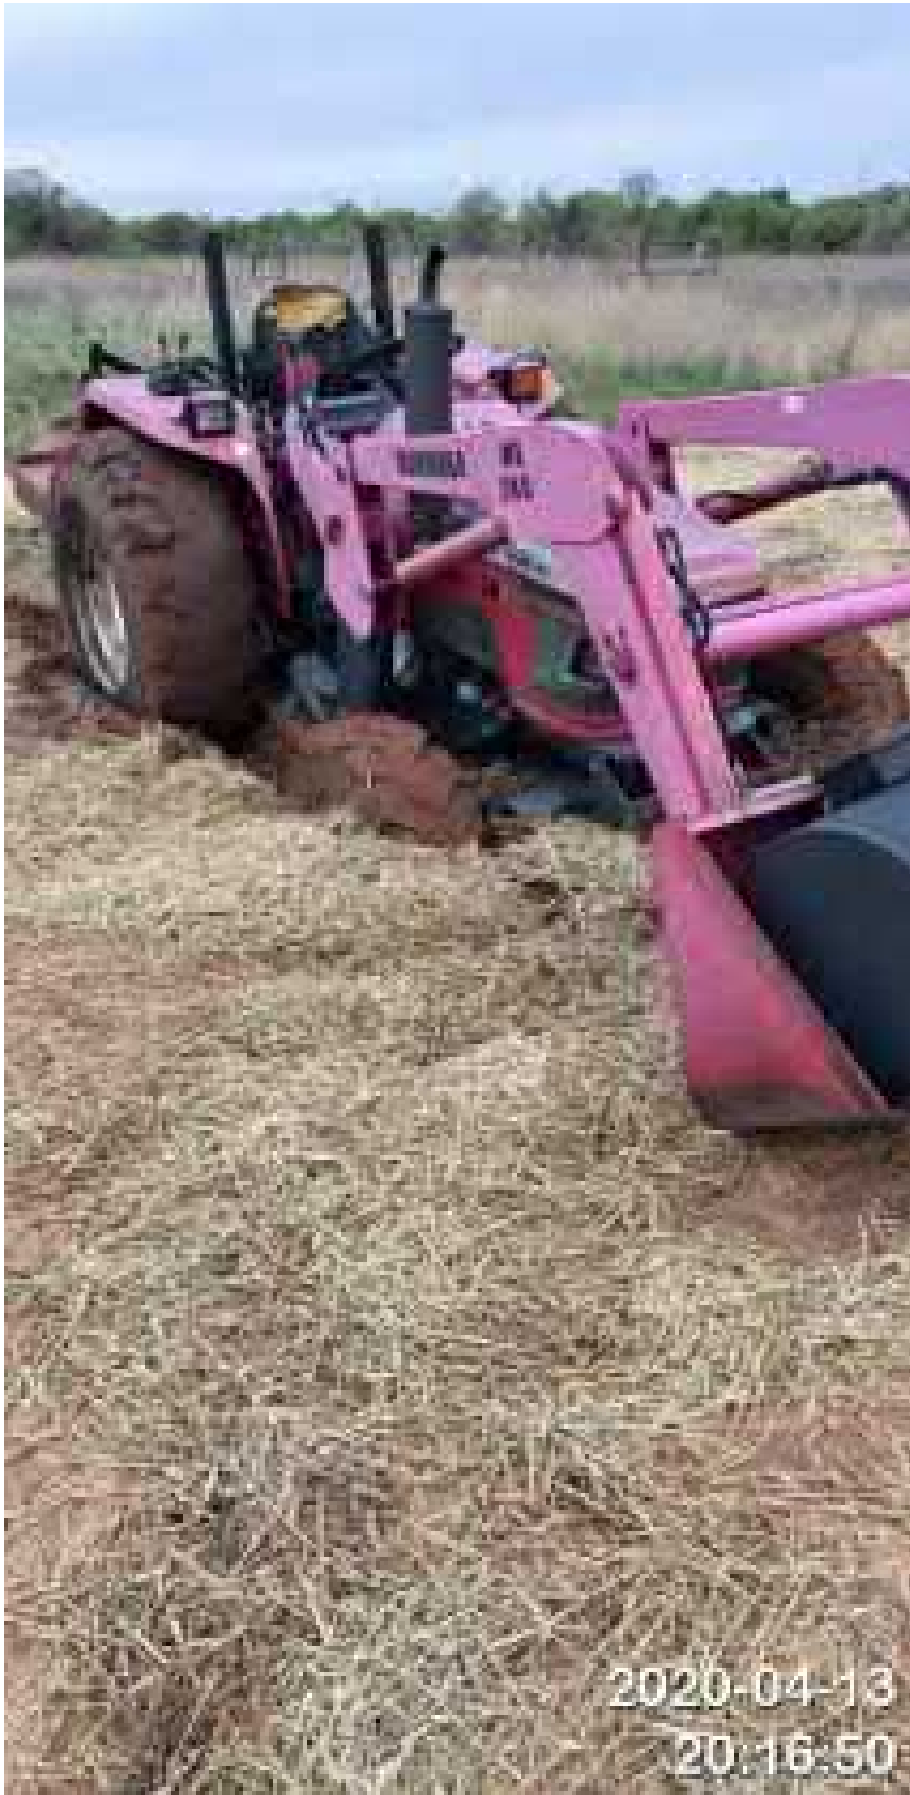
Section 1

Tractor Unable to Cross Easement
