Robert Squires - Squires Consulting LLC
Landowner Advocate

Opening Statement for May 5, 2021 Subcommittee on Civil Rights and Civil Liberties Hearing:
“Pipelines Over People (Part II): Midship Pipeline’s Disregard for Landowners in Its Pathway”

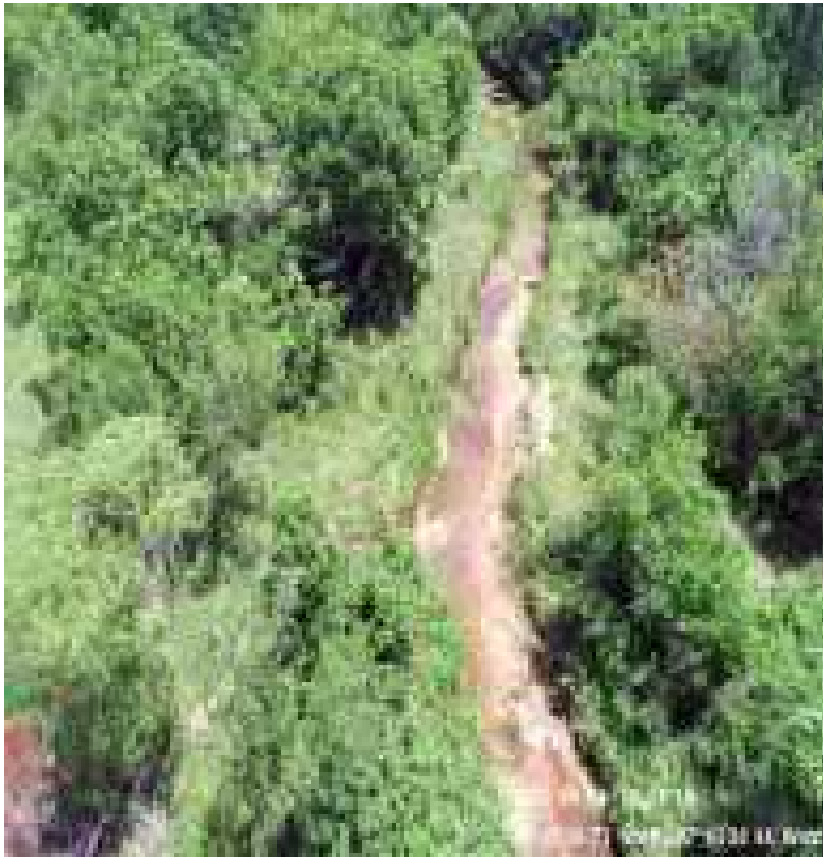
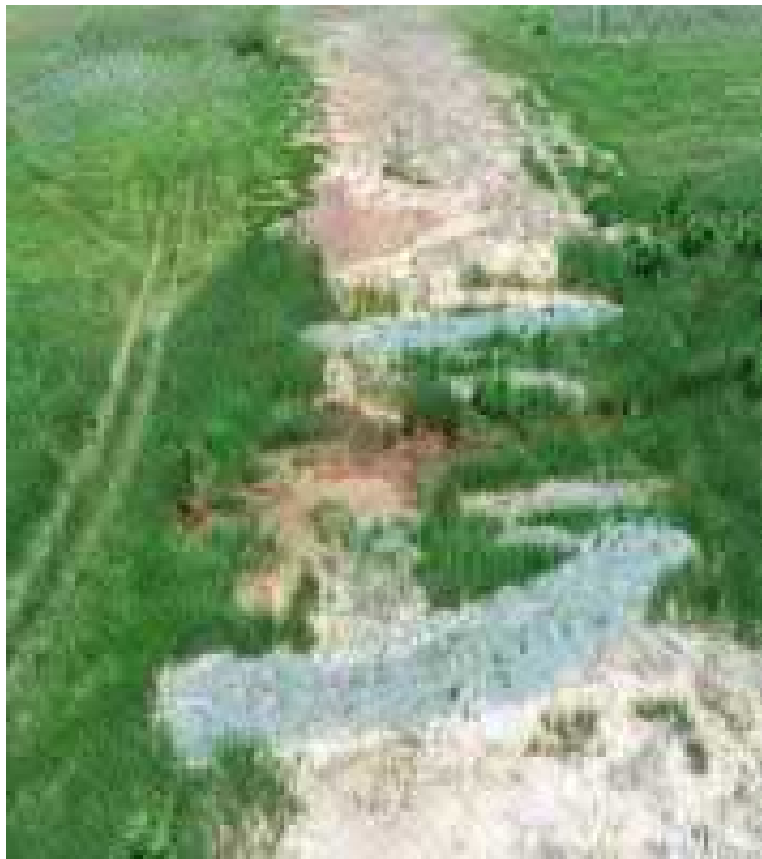
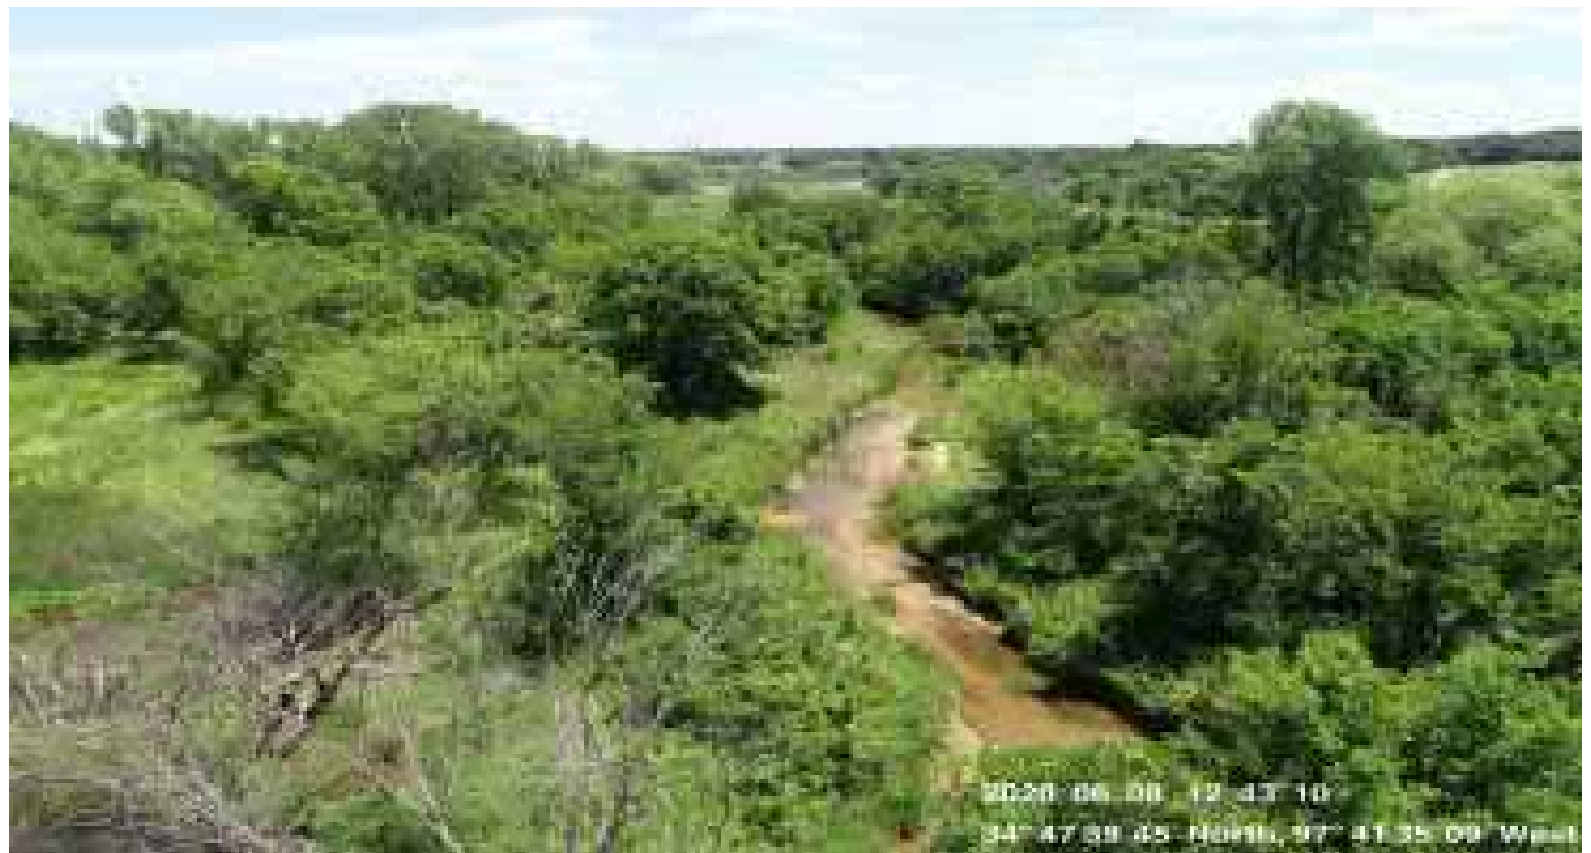
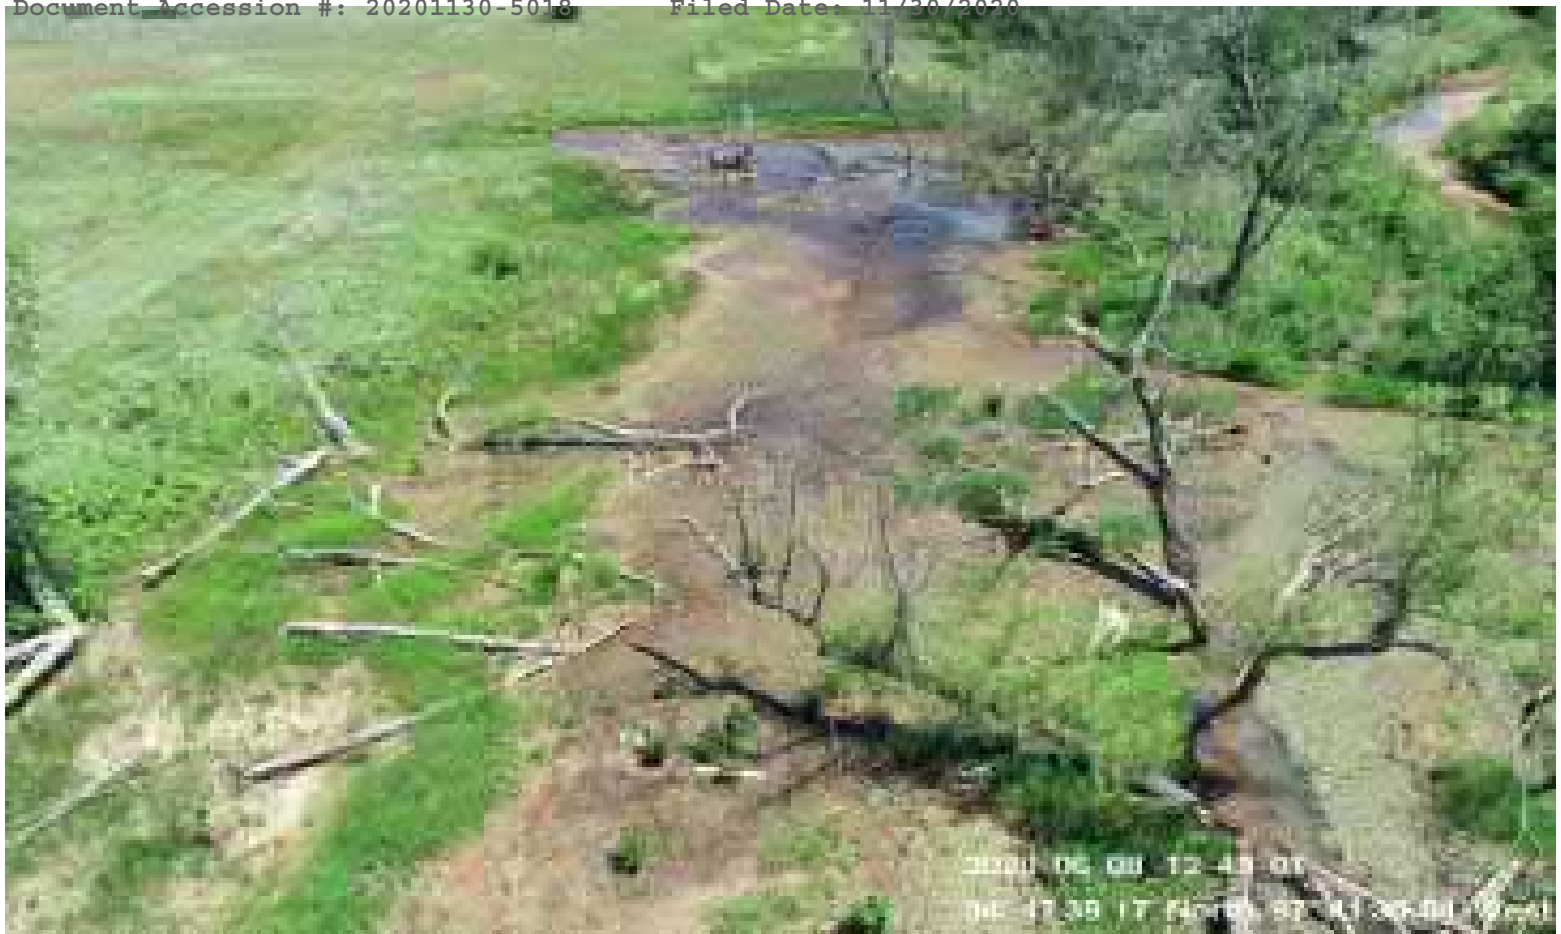
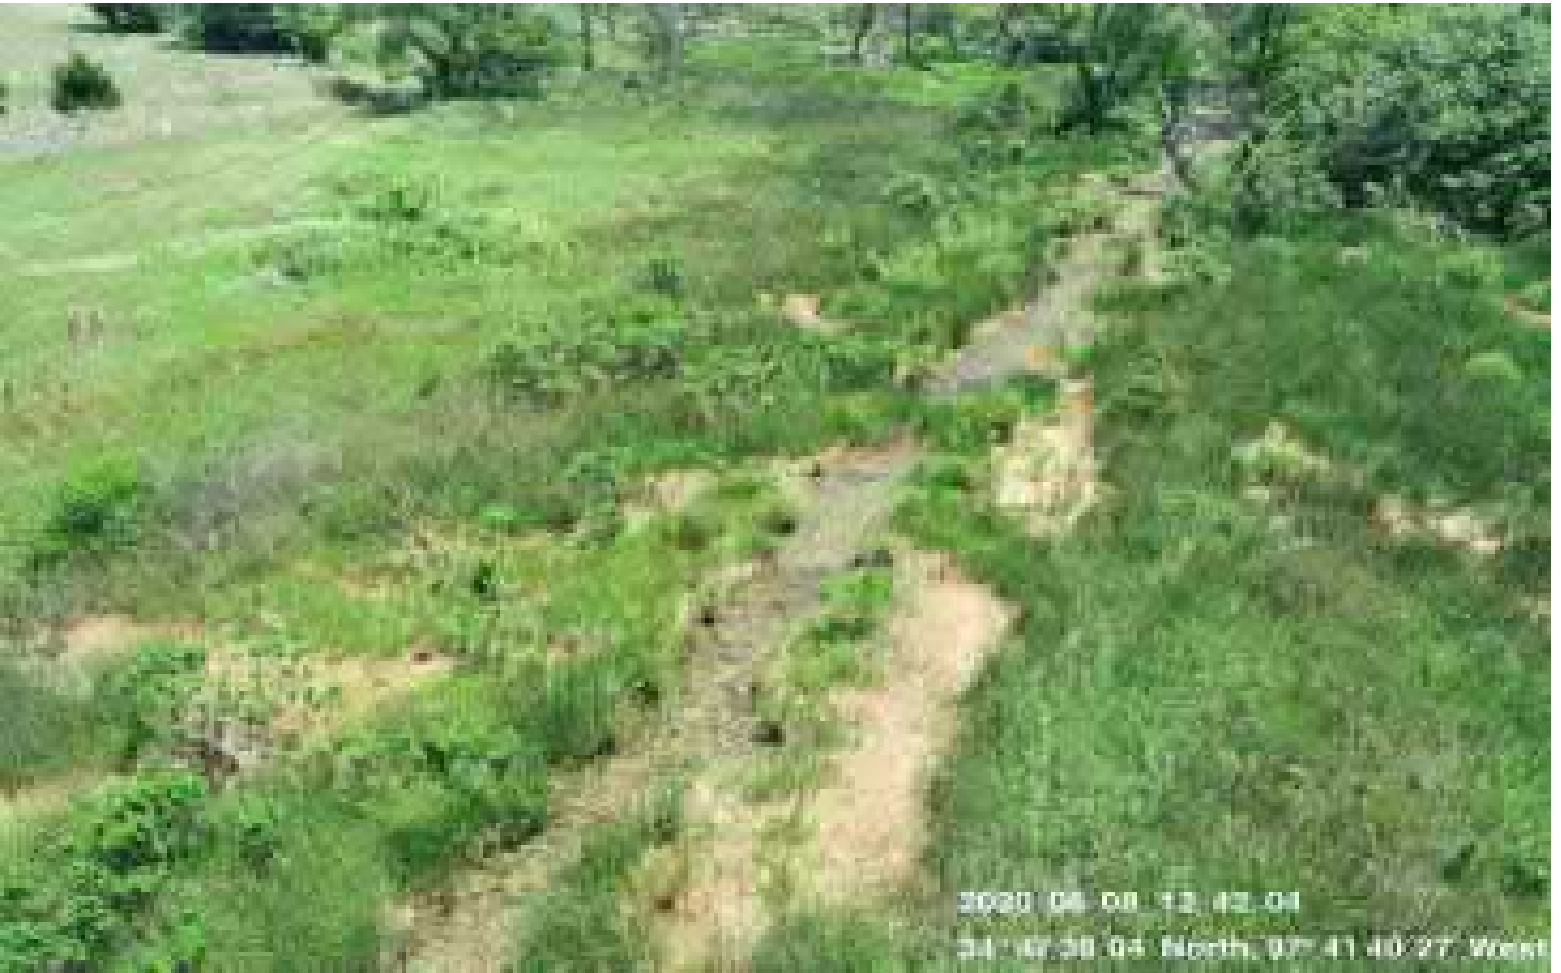
Damages

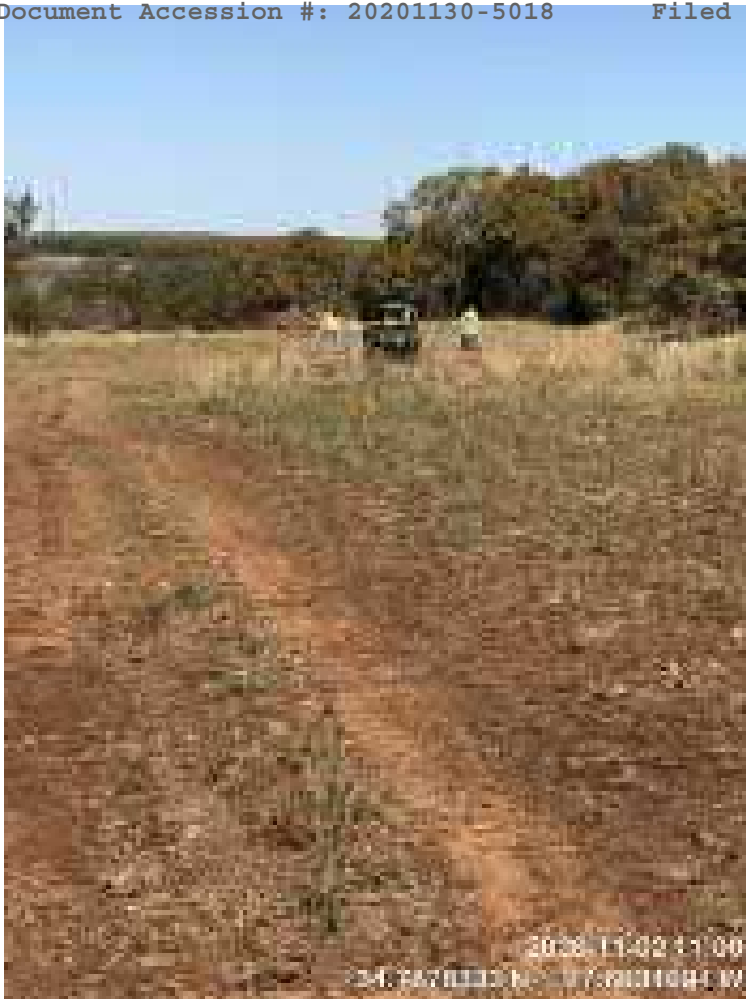
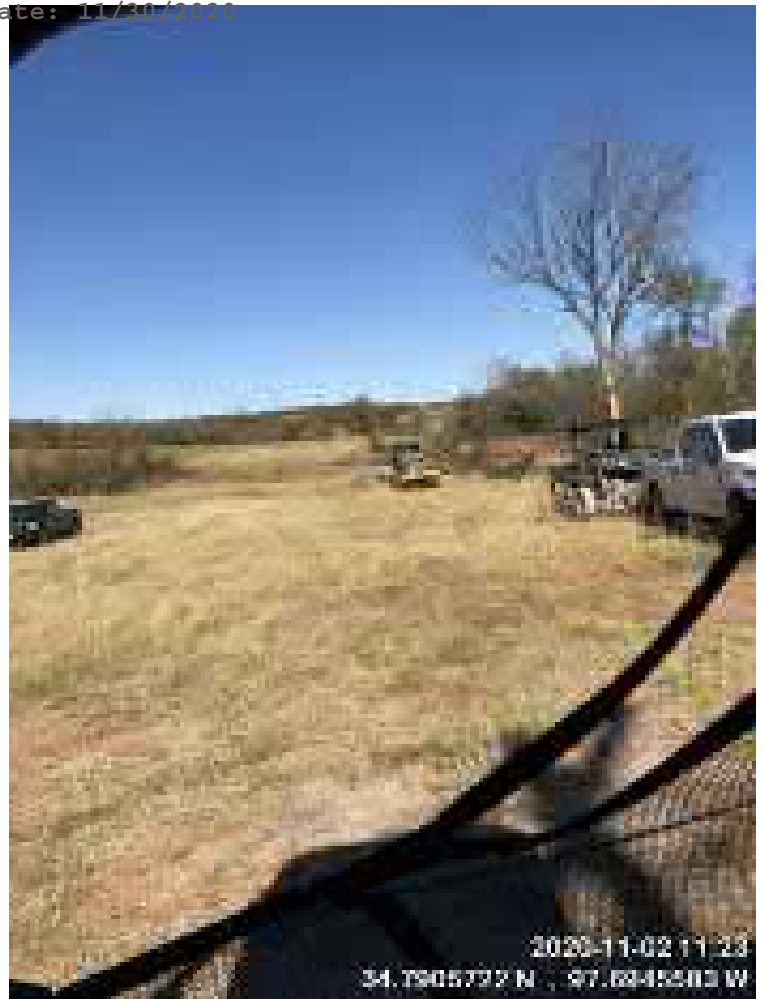
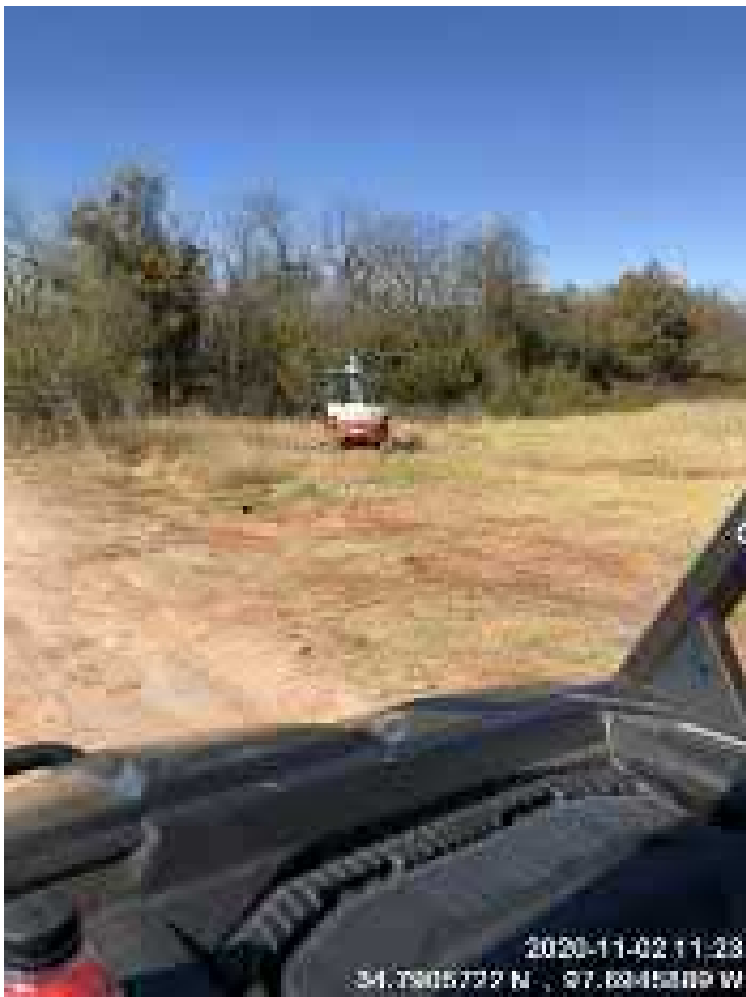
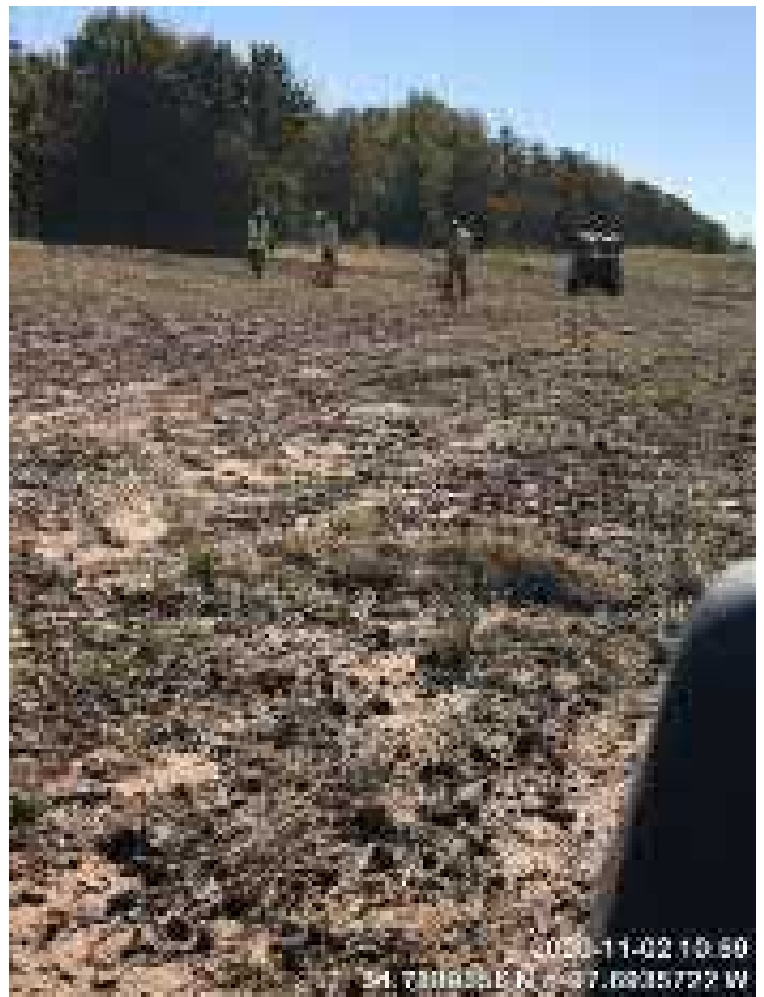
Minimal Surface Clean Up on November 2, 2020

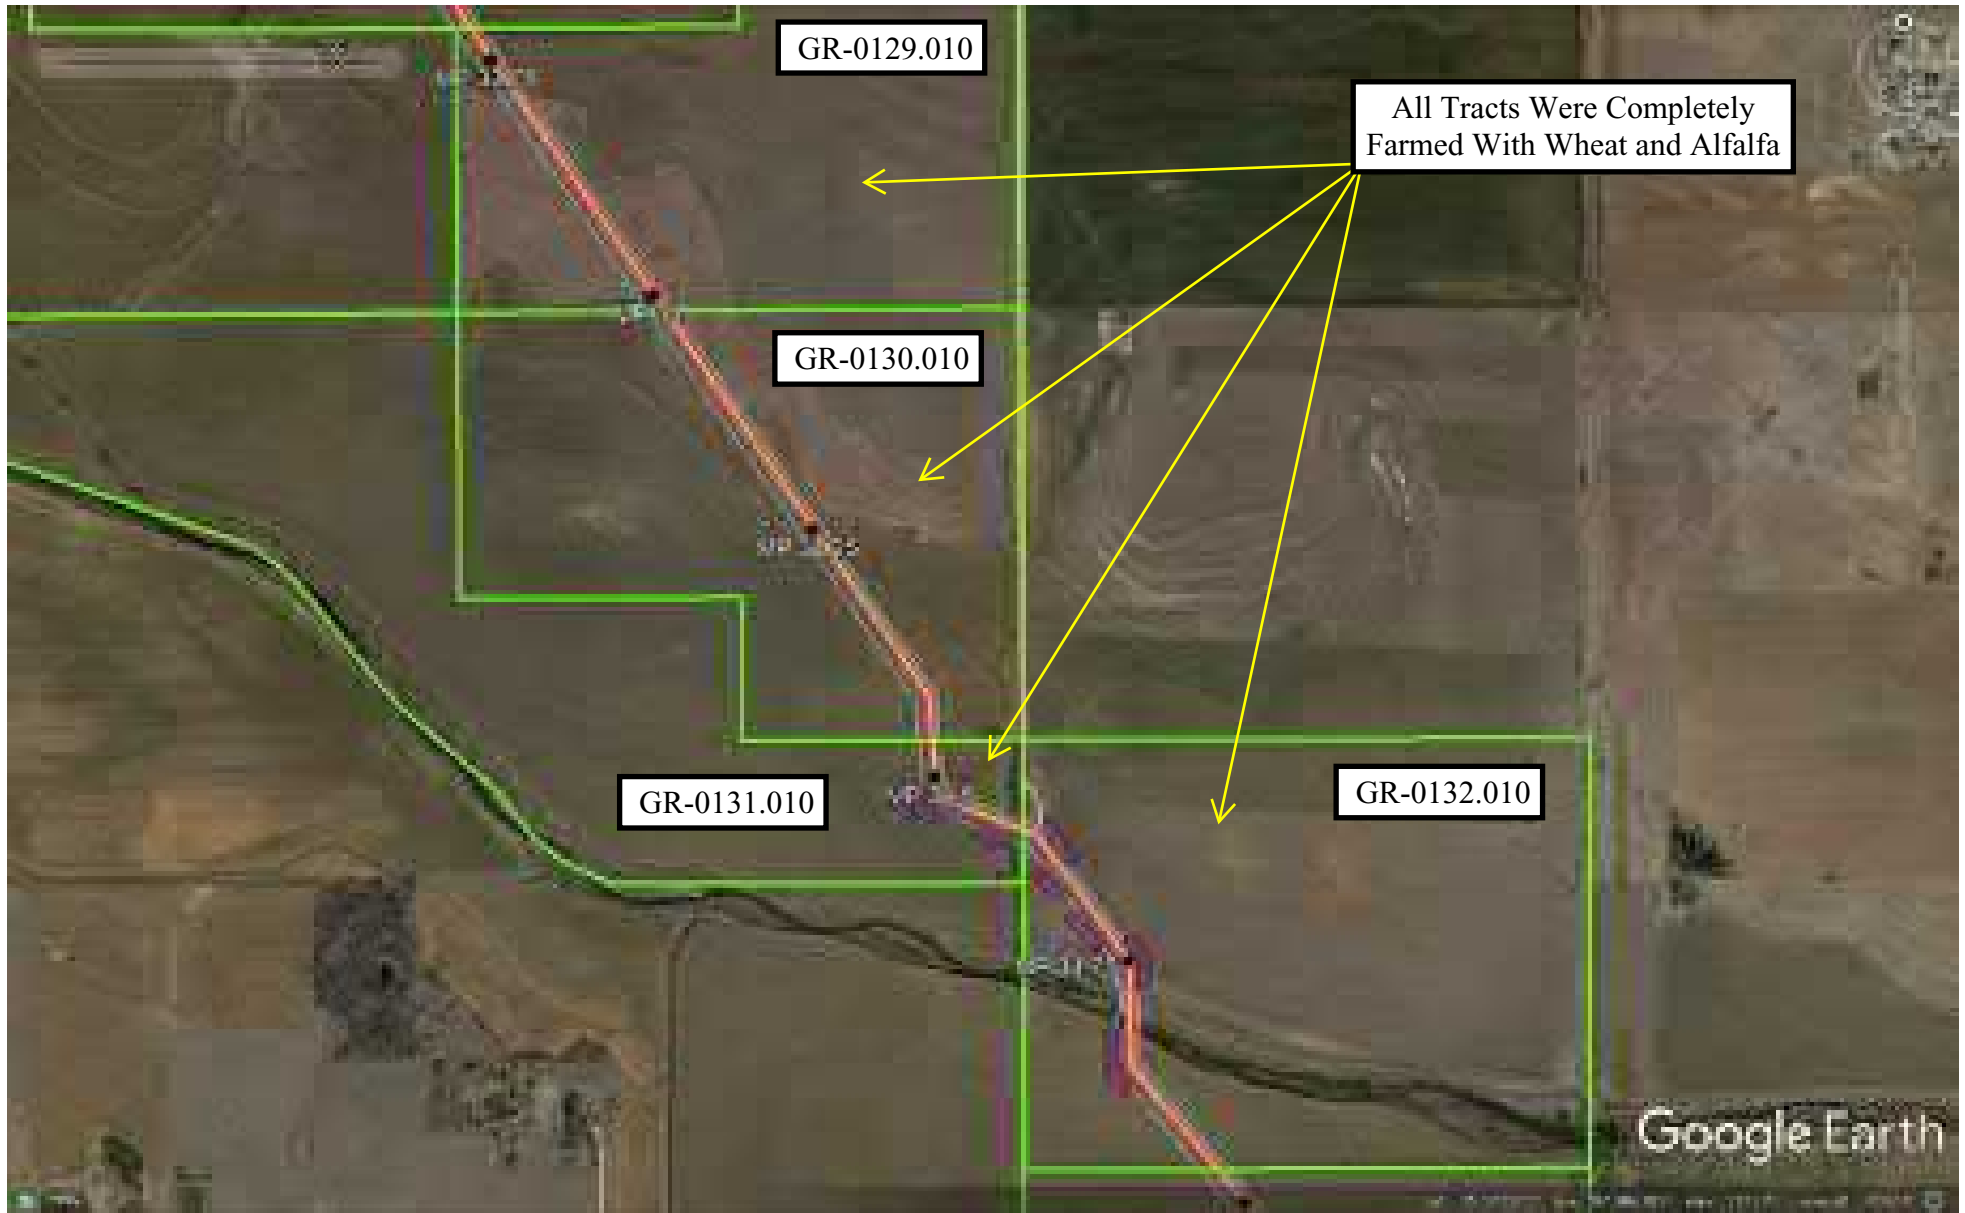
**GR-0129.010, GR-0130.010, GR-0131.010, &
GR-0132.010**

McComas Tracts GR-0129.010, GR-0130.010, GR-0131.010, & GR-0132.010 Indicating No Ponding or Deficiencies Near the Easement. Compared to Current Condition, This Shows That the Tract Has Not Been Restored Near It's Pre-Construction Condition.

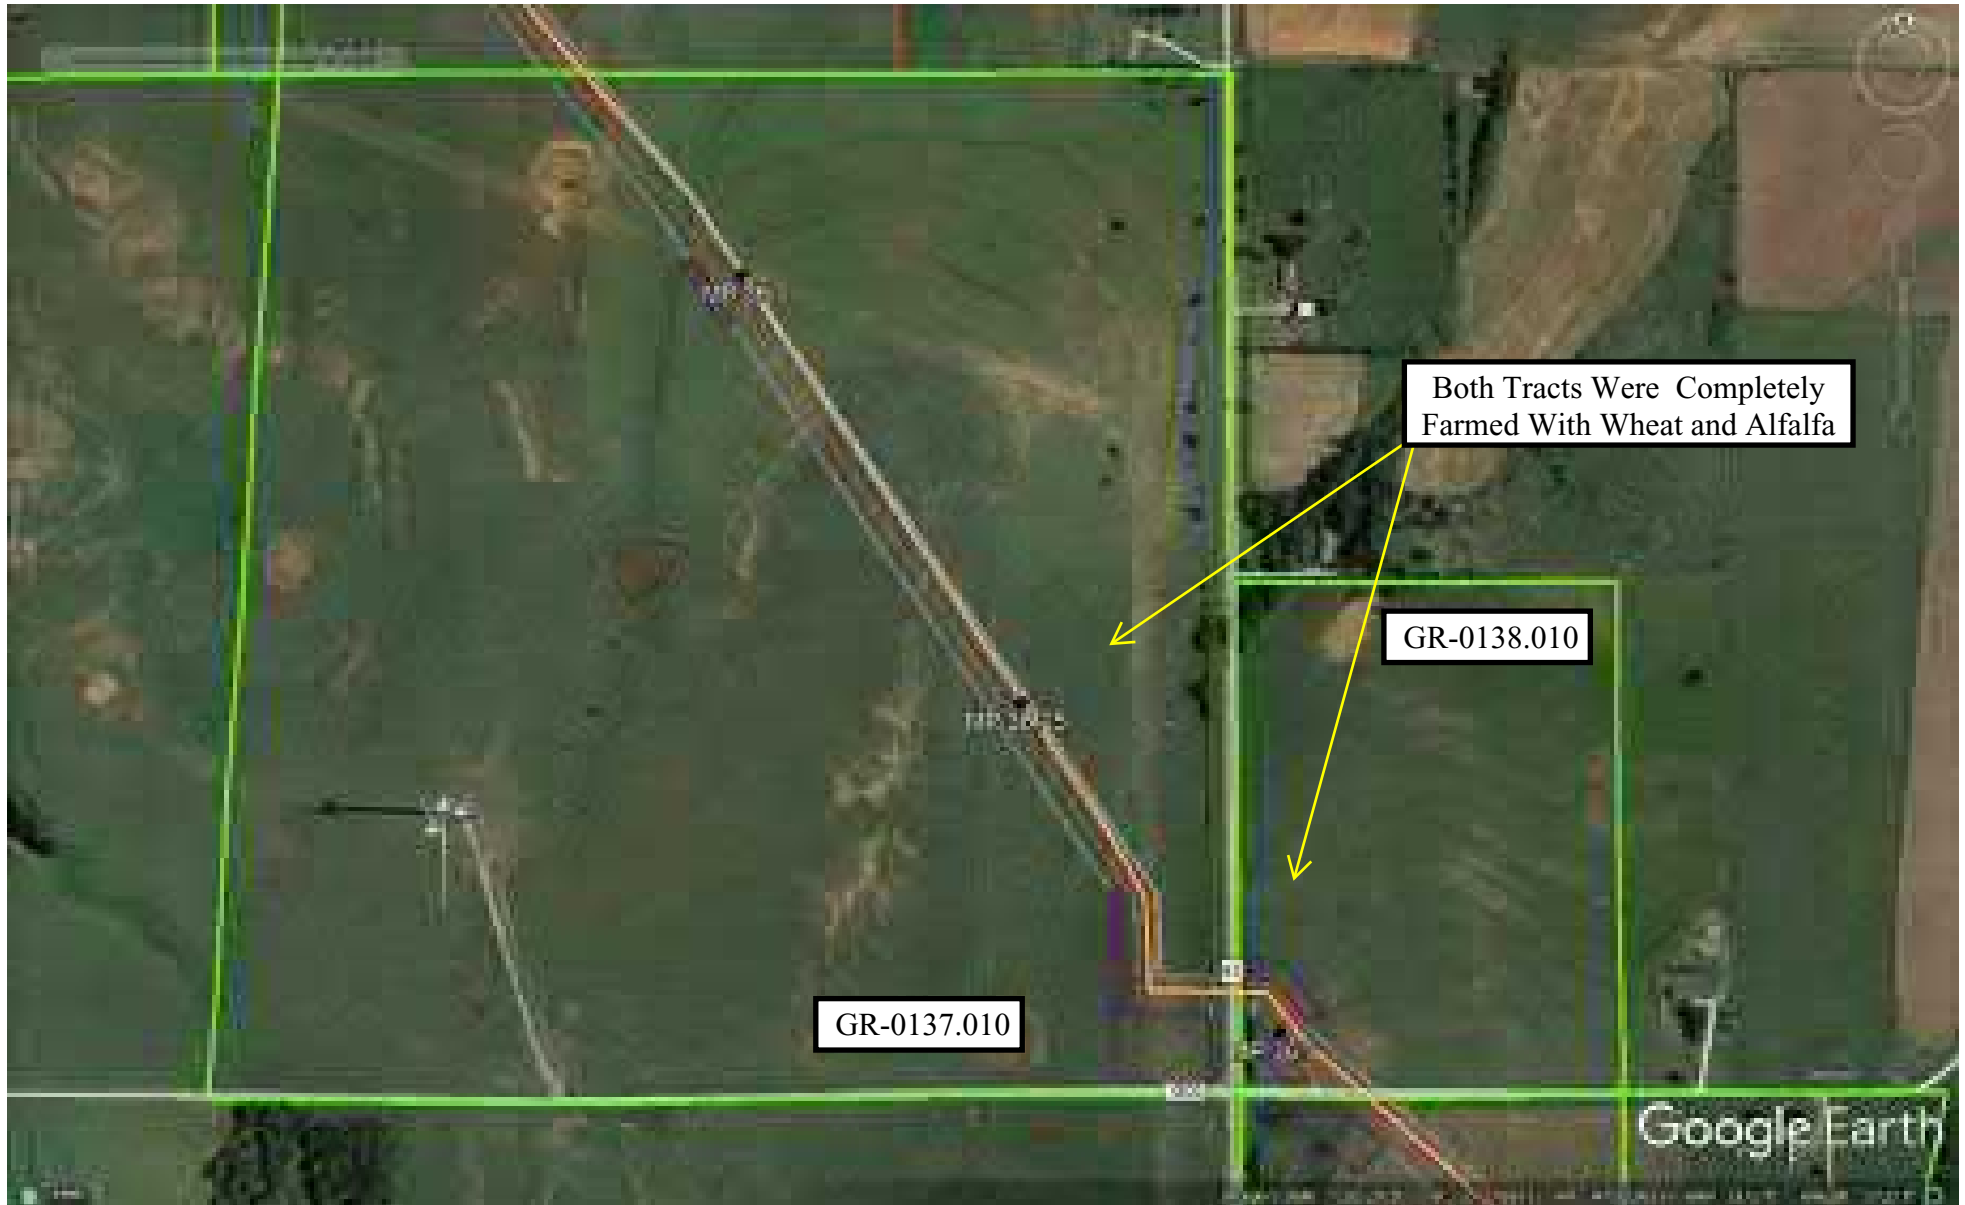
McComas Tracts GR-0137.010 & GR-0138.010 Indicating No Ponding or Deficiencies Near the Easement.
Compared to Current Condition, This Shows That the Tract Has Not Been Restored Near It's Pre-Construction Condition.

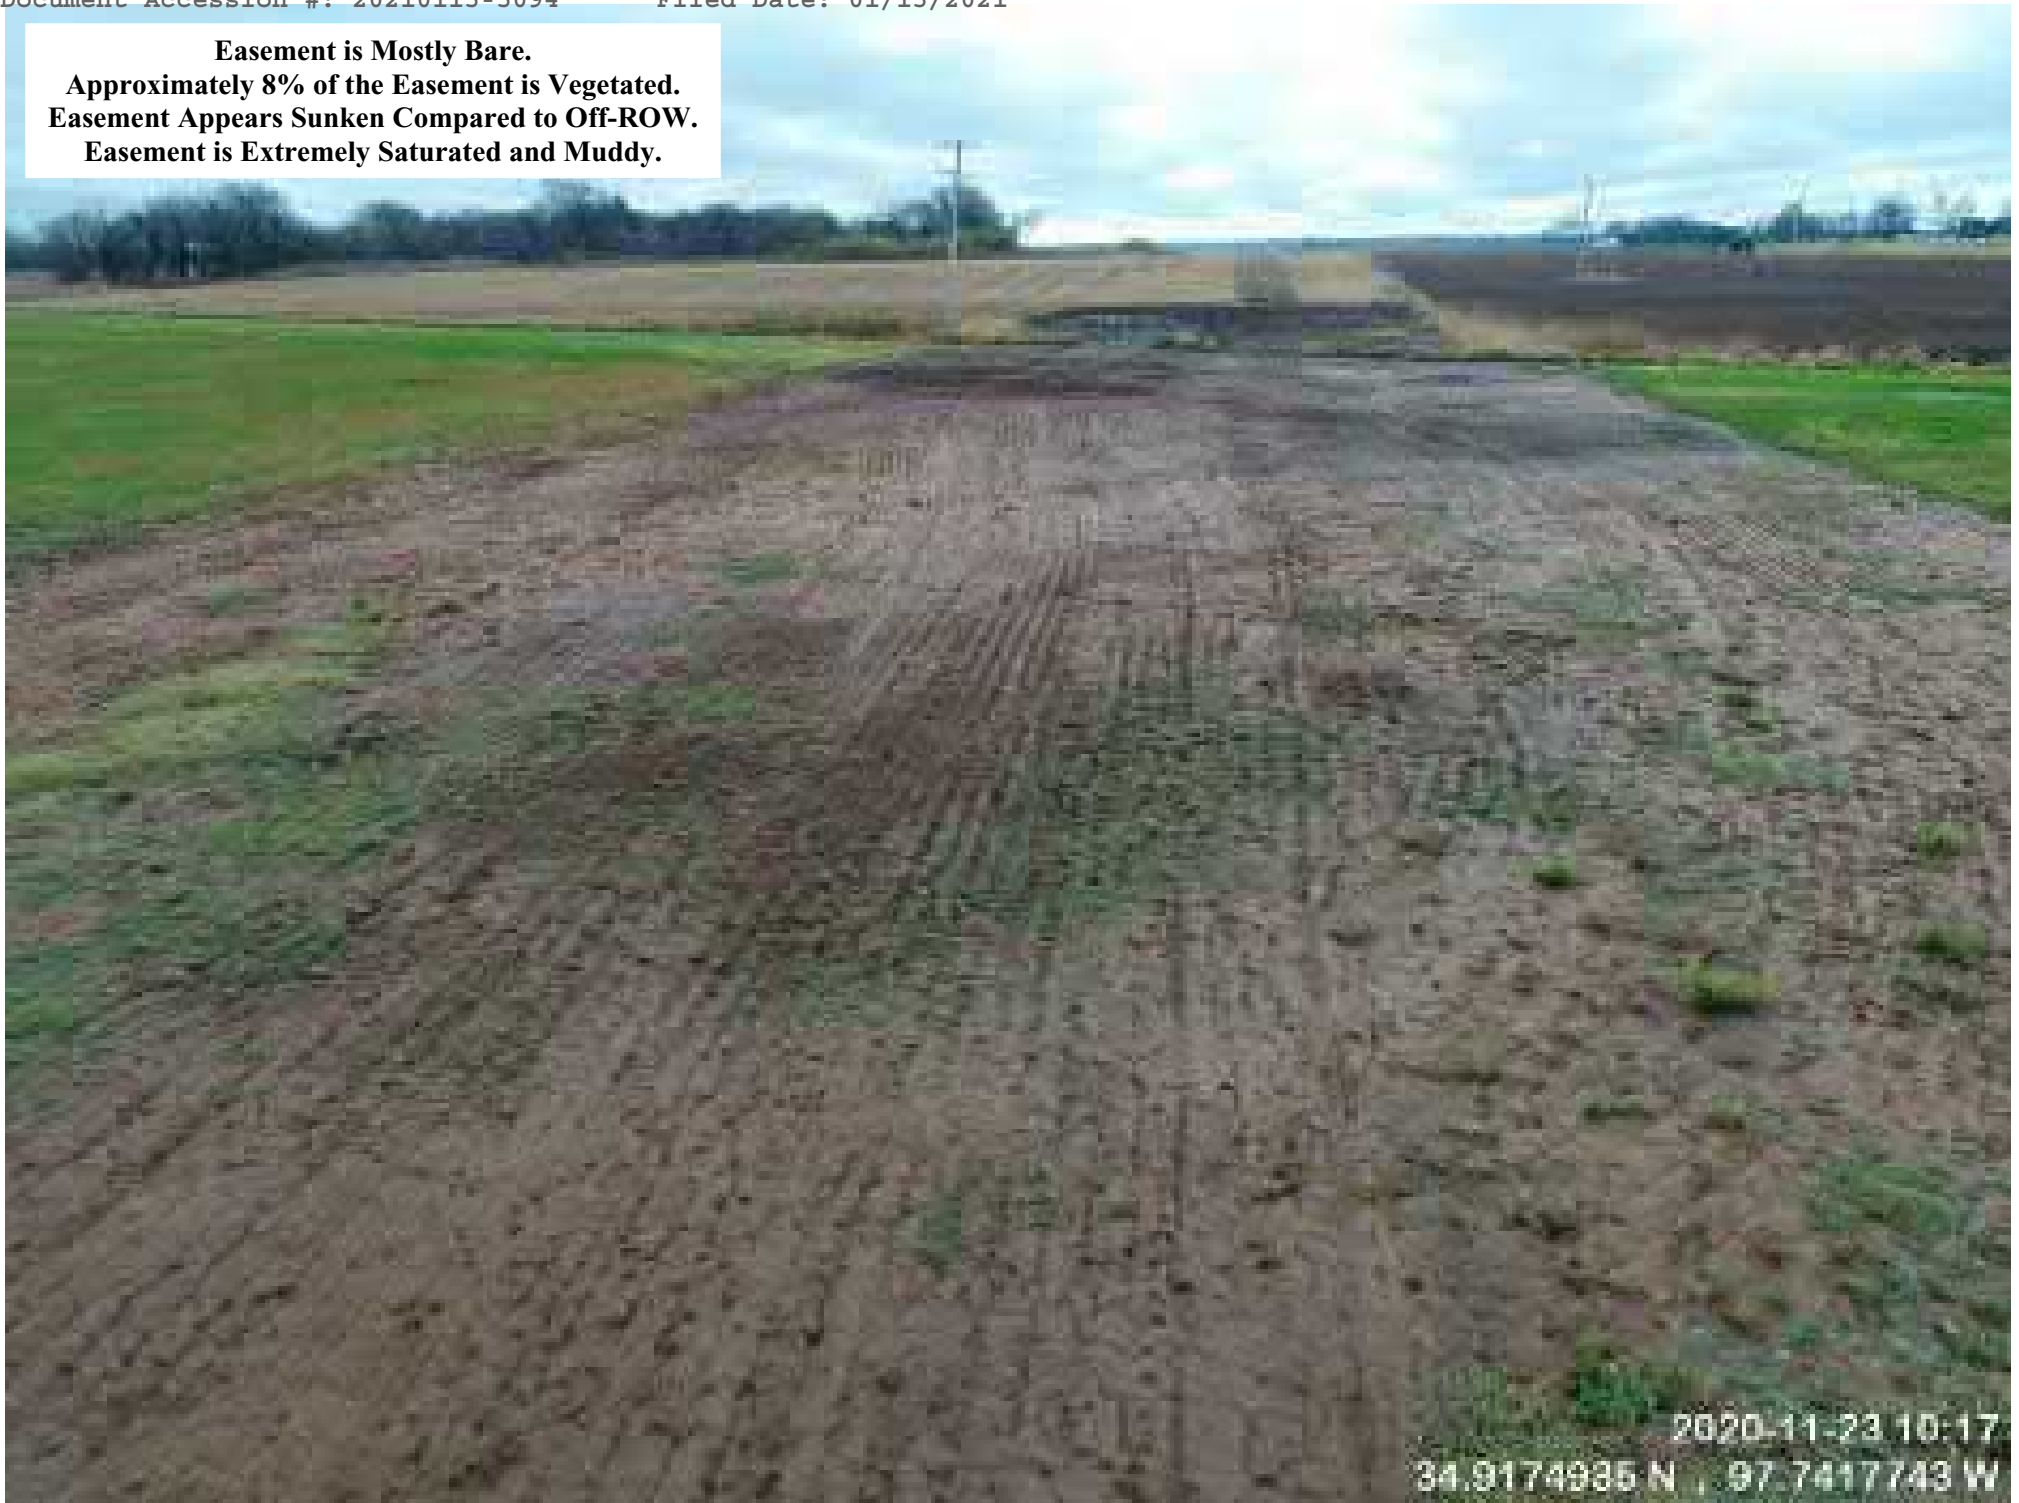
**Easement is Mostly Bare.
Approximately 8% of the Easement is Vegetated.
Easement Appears Sunken Compared to Off-ROW.
Easement is Extremely Saturated and Muddy.**

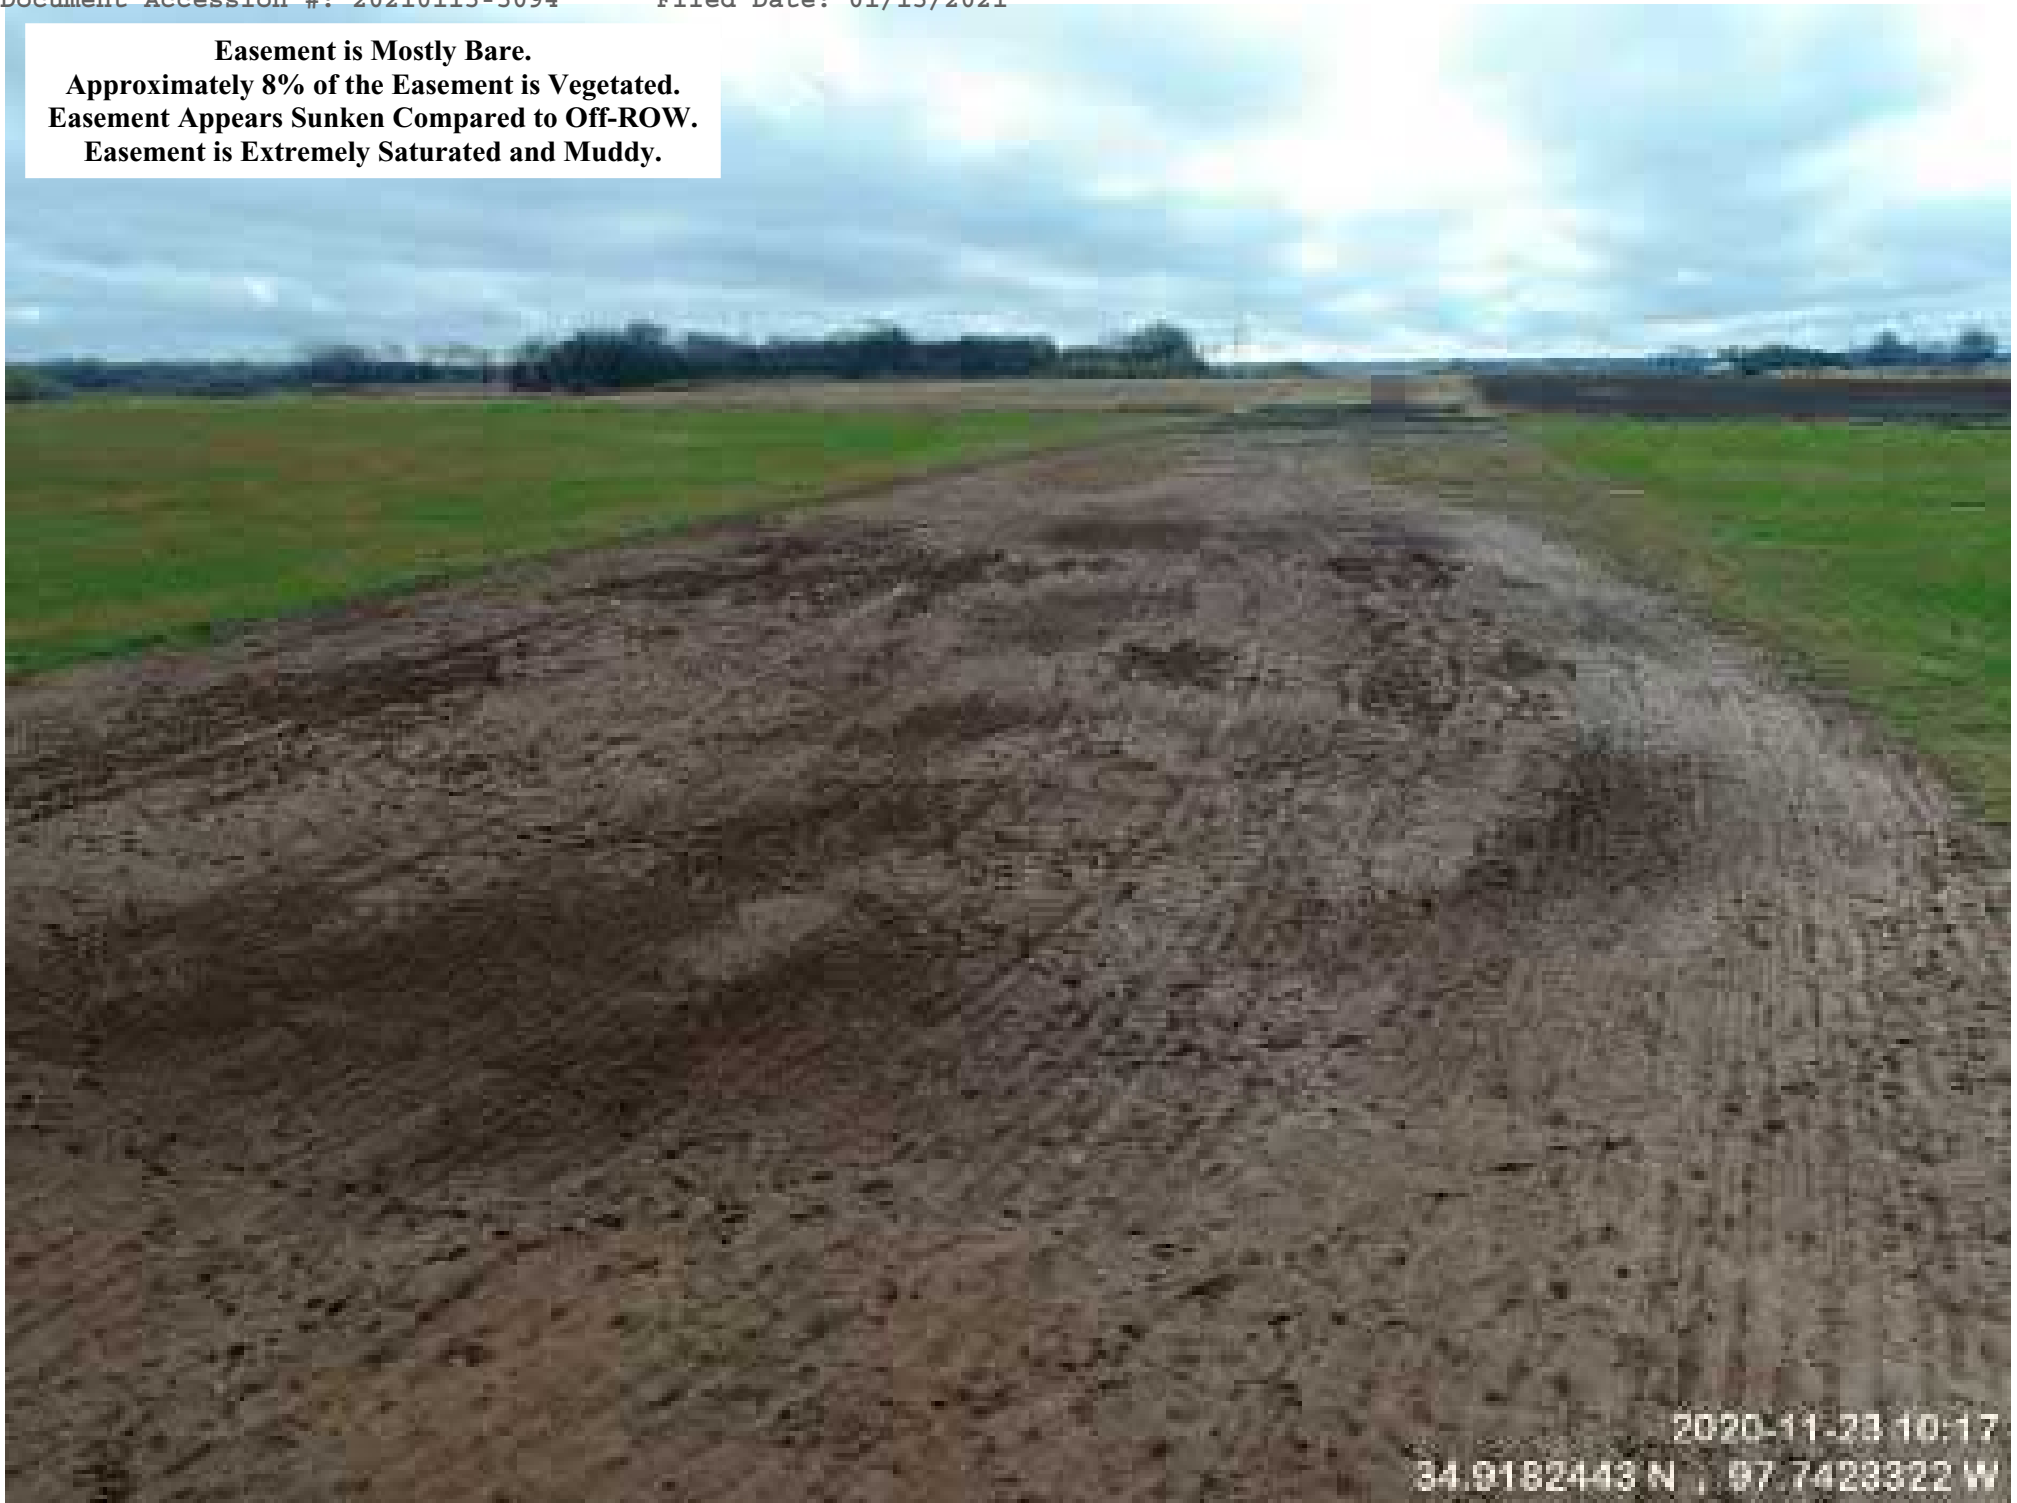
**Easement is Mostly Bare.
Approximately 8% of the Easement is Vegetated.
Easement Appears Sunken Compared to Off-ROW.
Easement is Extremely Saturated and Muddy.**

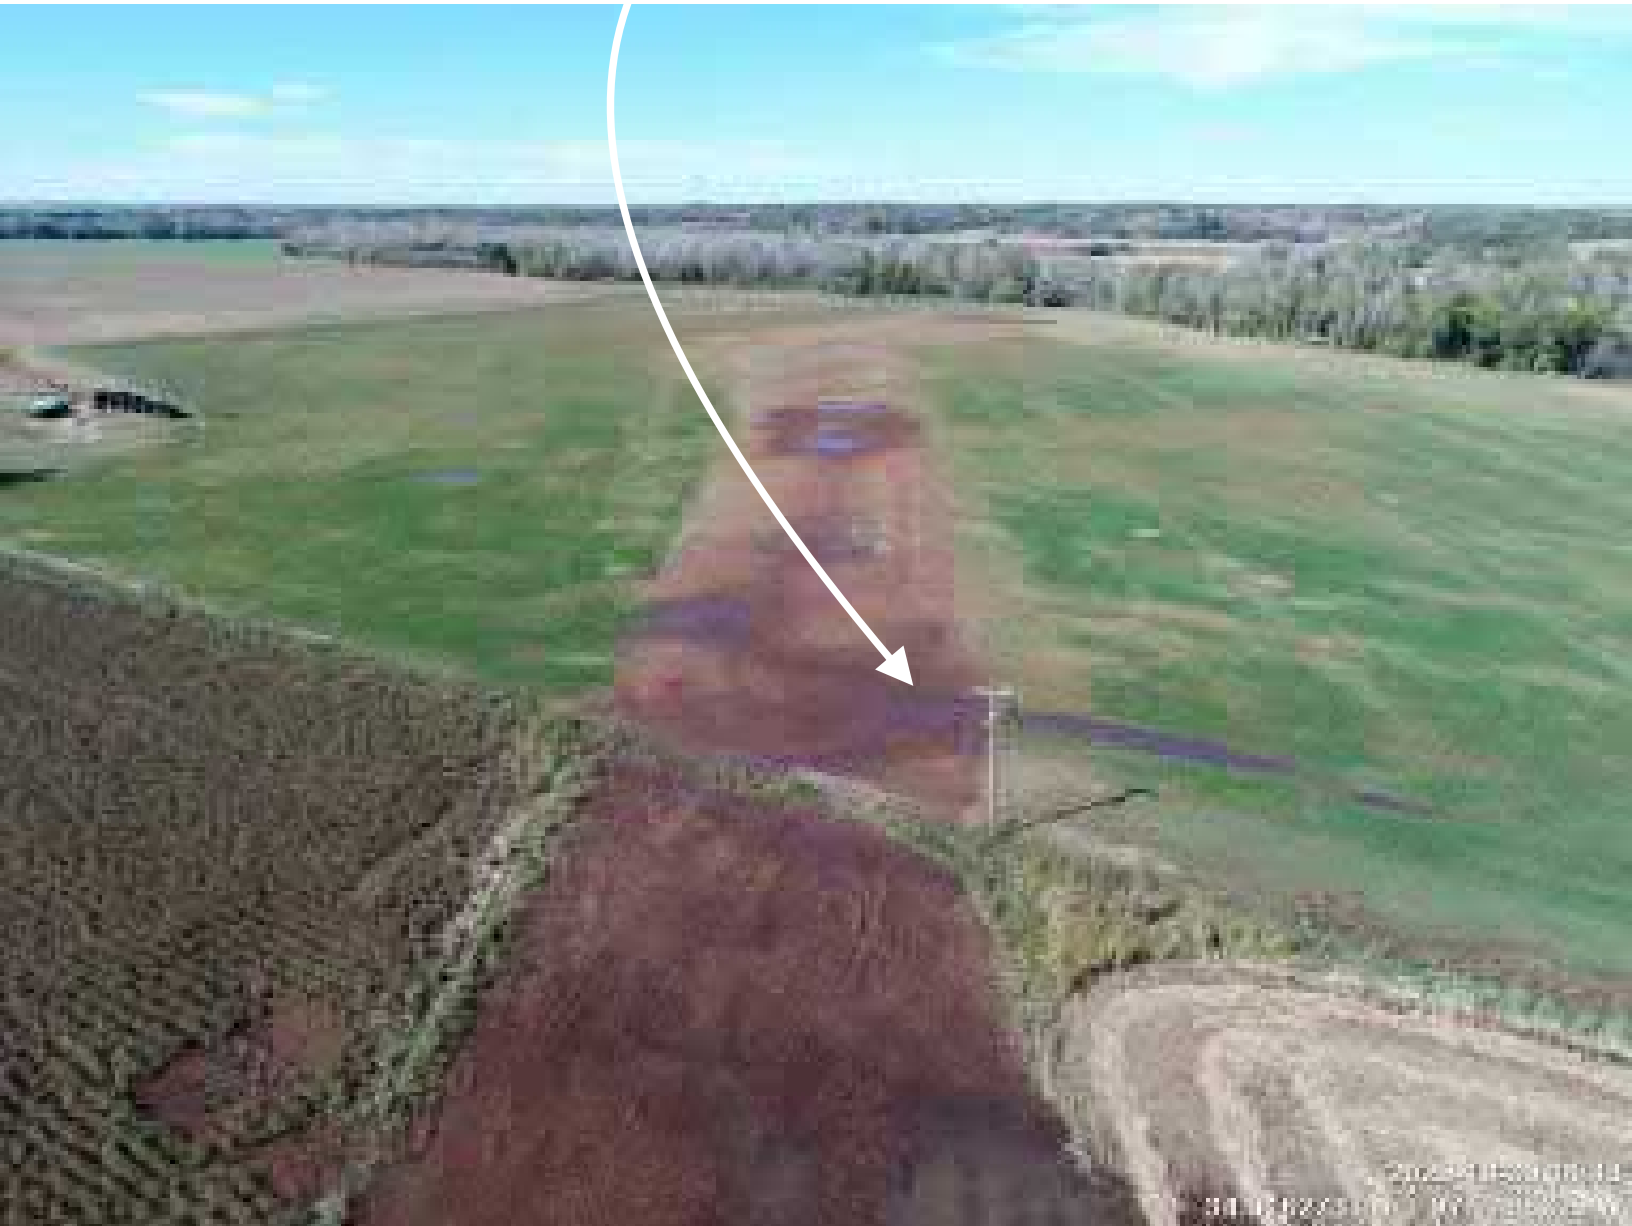
**Lack of Vegetation, Drainage Issues Causing Erosion and
Runoff Patterns Towards Washita River**
