Robert Squires - Squires Consulting LLC
Landowner Advocate

Opening Statement for May 5, 2021 Subcommittee on Civil Rights and Civil Liberties Hearing:
“Pipelines Over People (Part II): Midship Pipeline’s Disregard for Landowners in Its Pathway”

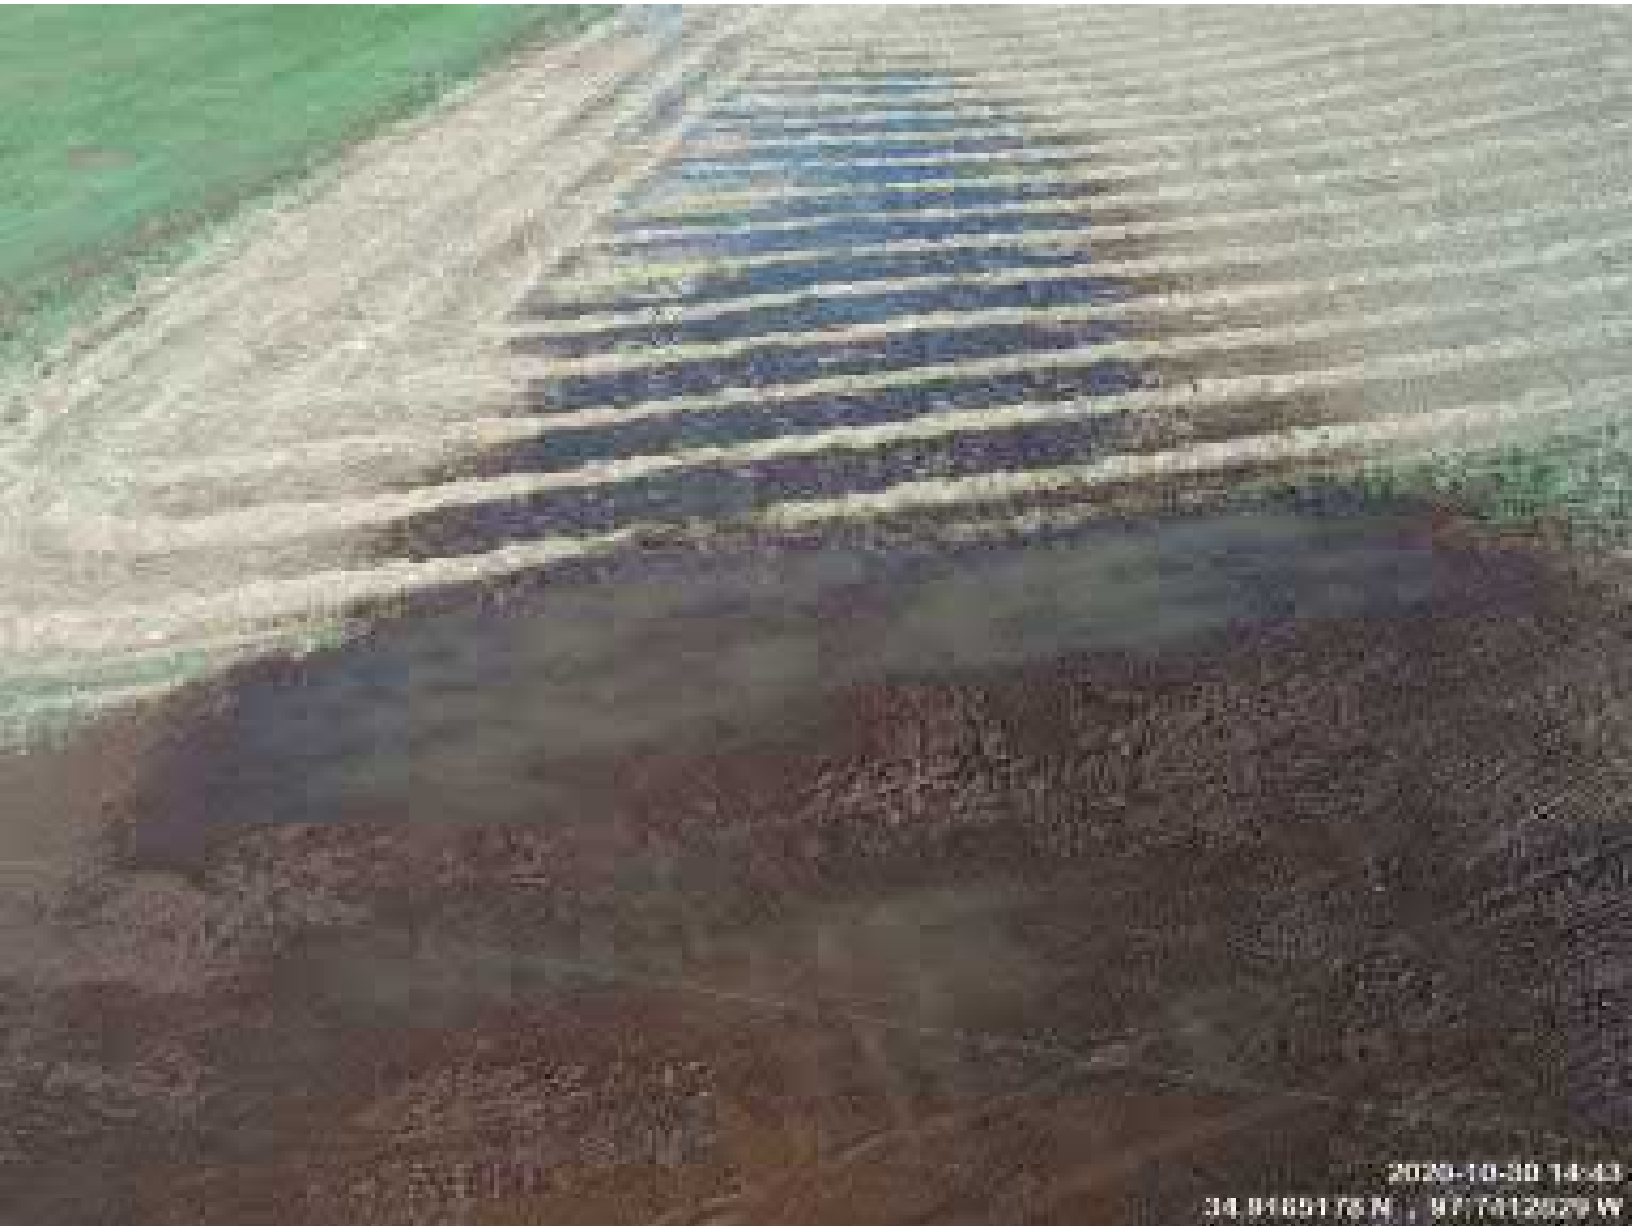
Off-Row Ponding , Grade and Drainage Issues

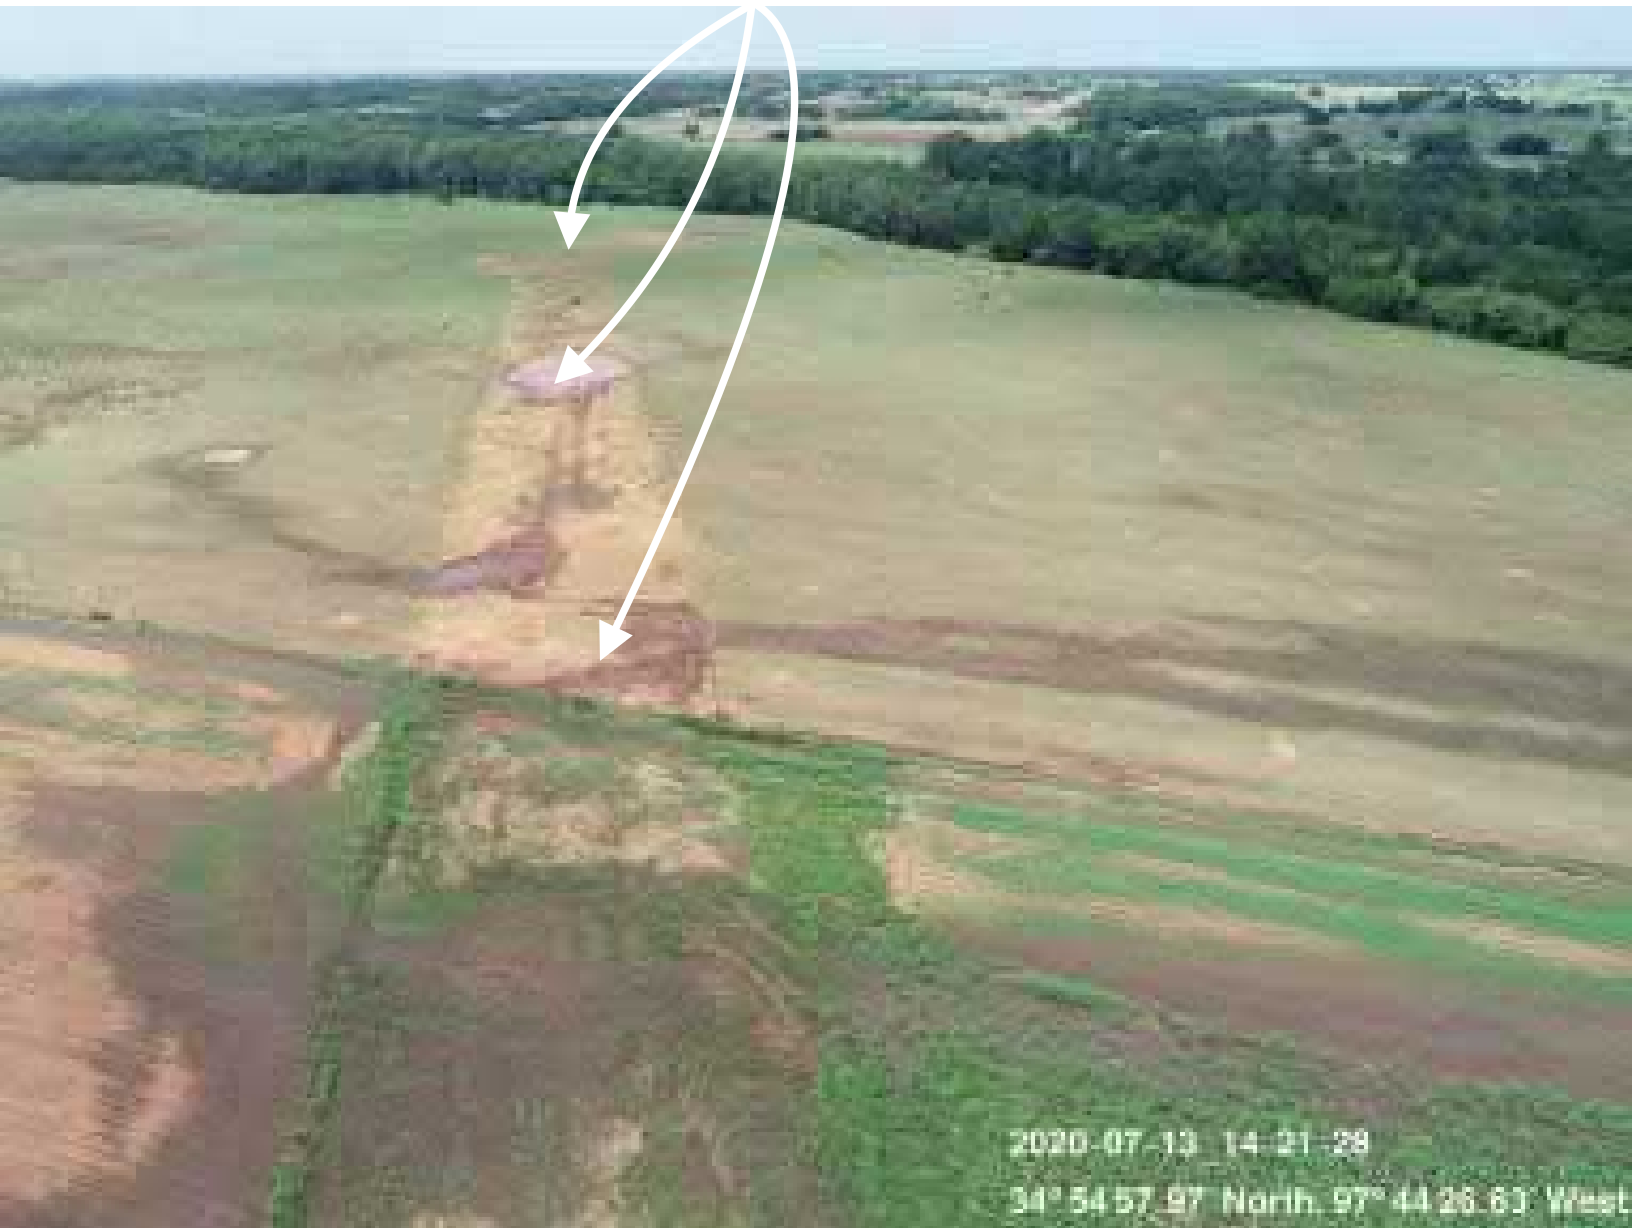
**Lack of Vegetation, Drainage Issues Causing Erosion and Runoff
Patterns, Grade has been Altered, Topsoil Importation and Grading
Work Will Be Required**

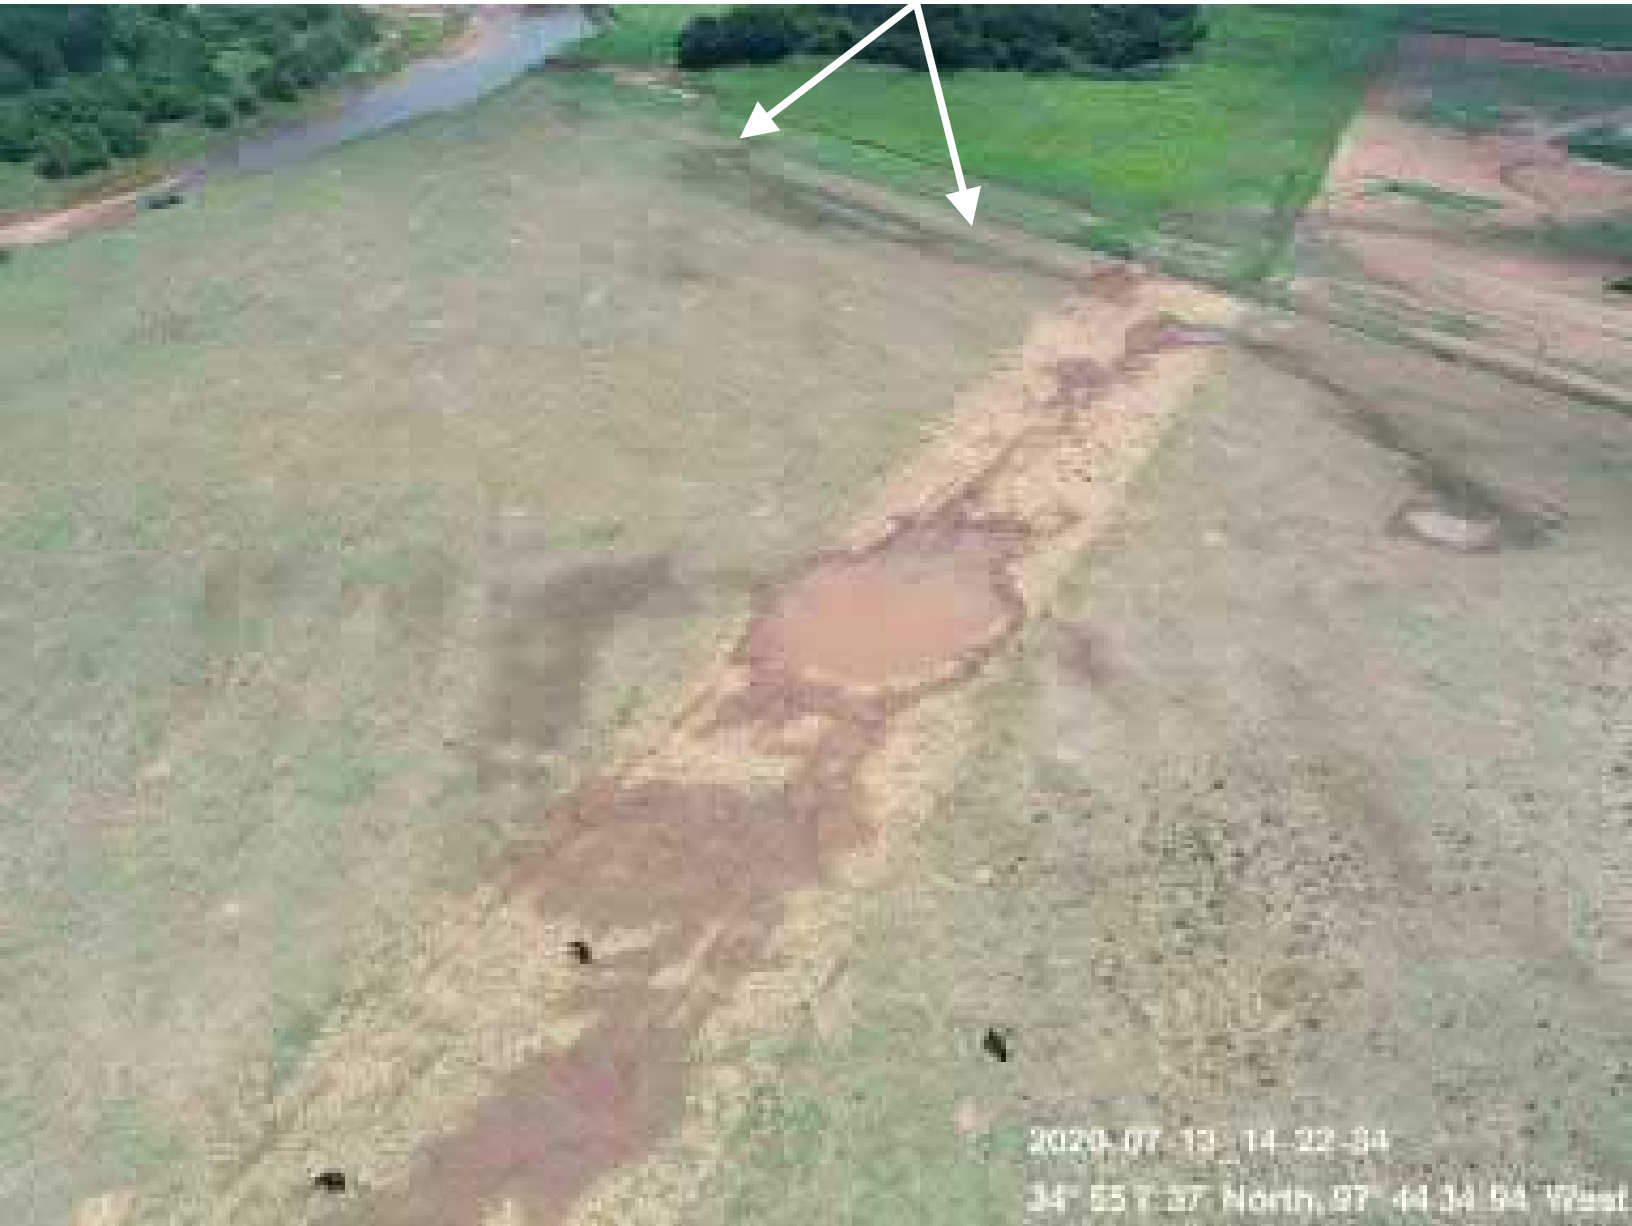
**Lack of Vegetation, Drainage Issues Causing Erosion and Runoff
Patterns Towards Washita River**

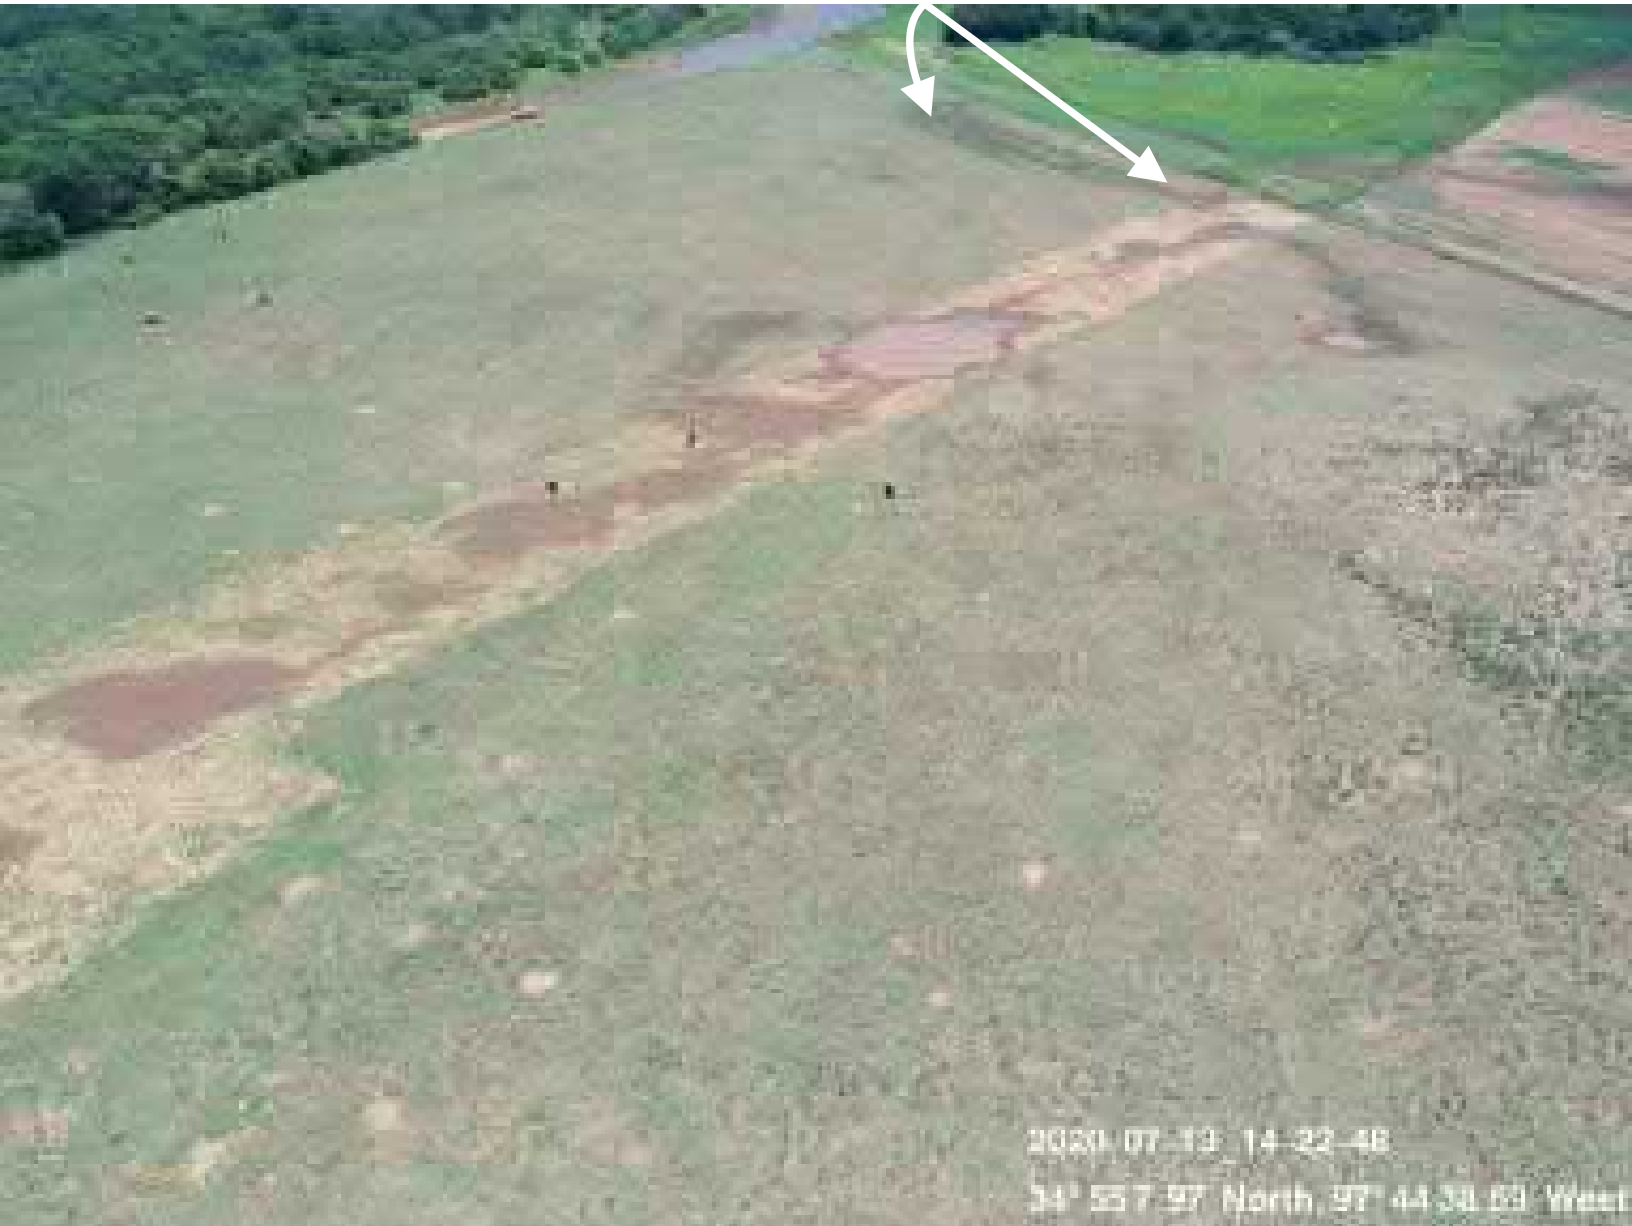
**Lack of Vegetation, Drainage Issues Causing Erosion and
Runoff Patterns Towards Washita River**

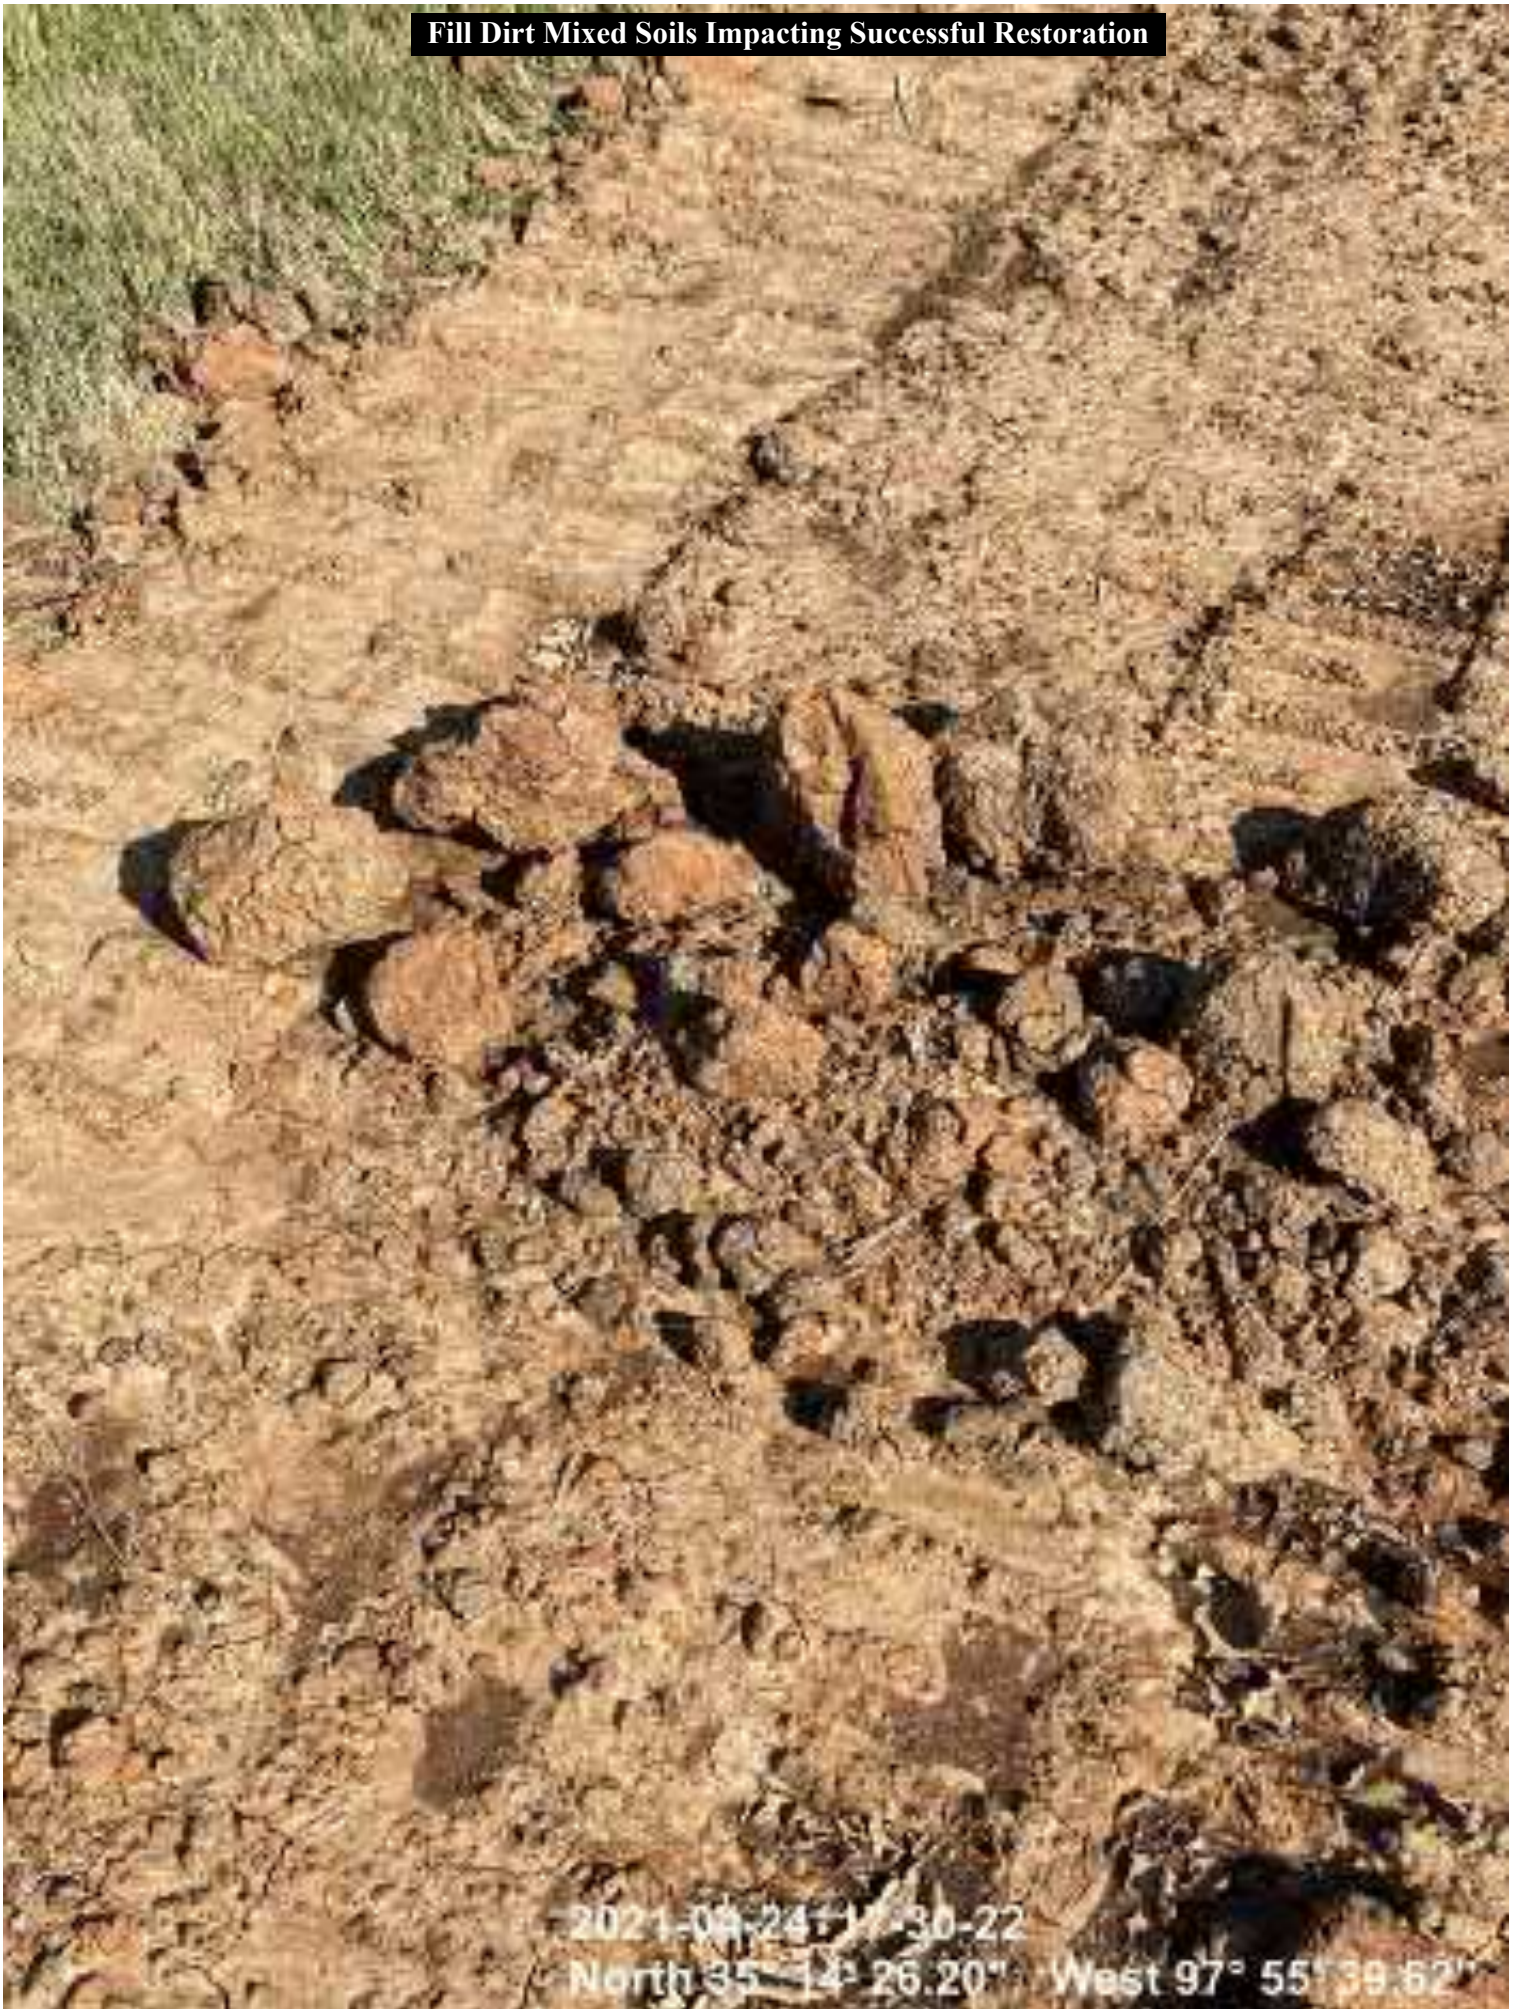
Fill Dirt Mixed Soils Impacting Successful Restoration

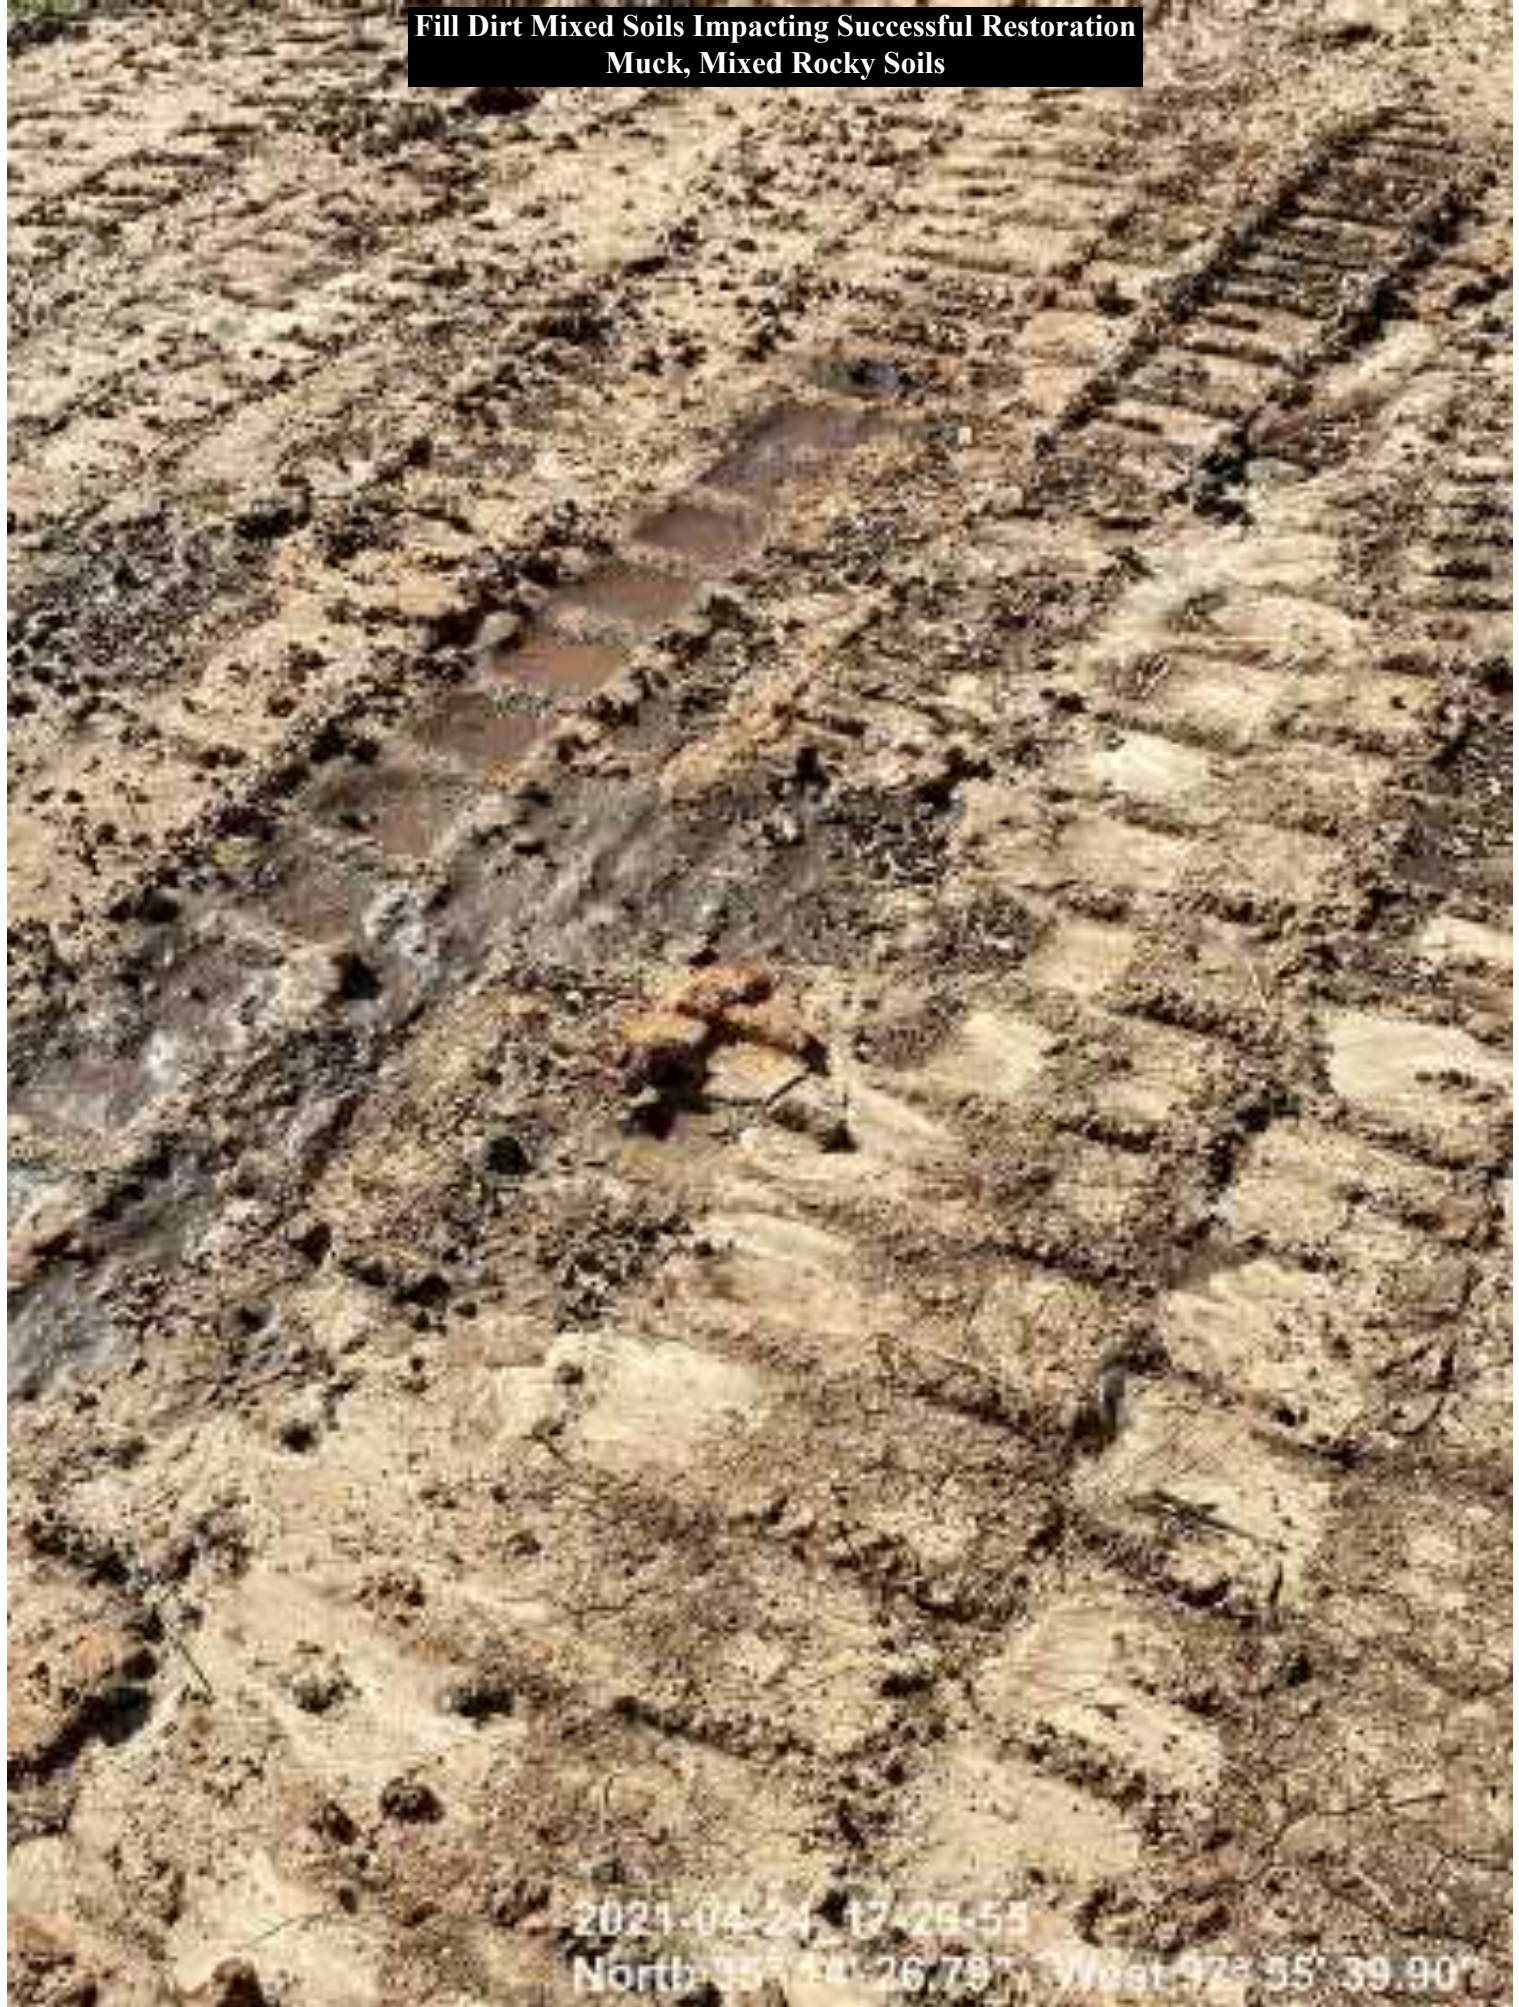
**Fill Dirt Mixed Soils Impacting Successful Restoration
Muck, Mixed Rocky Soils**

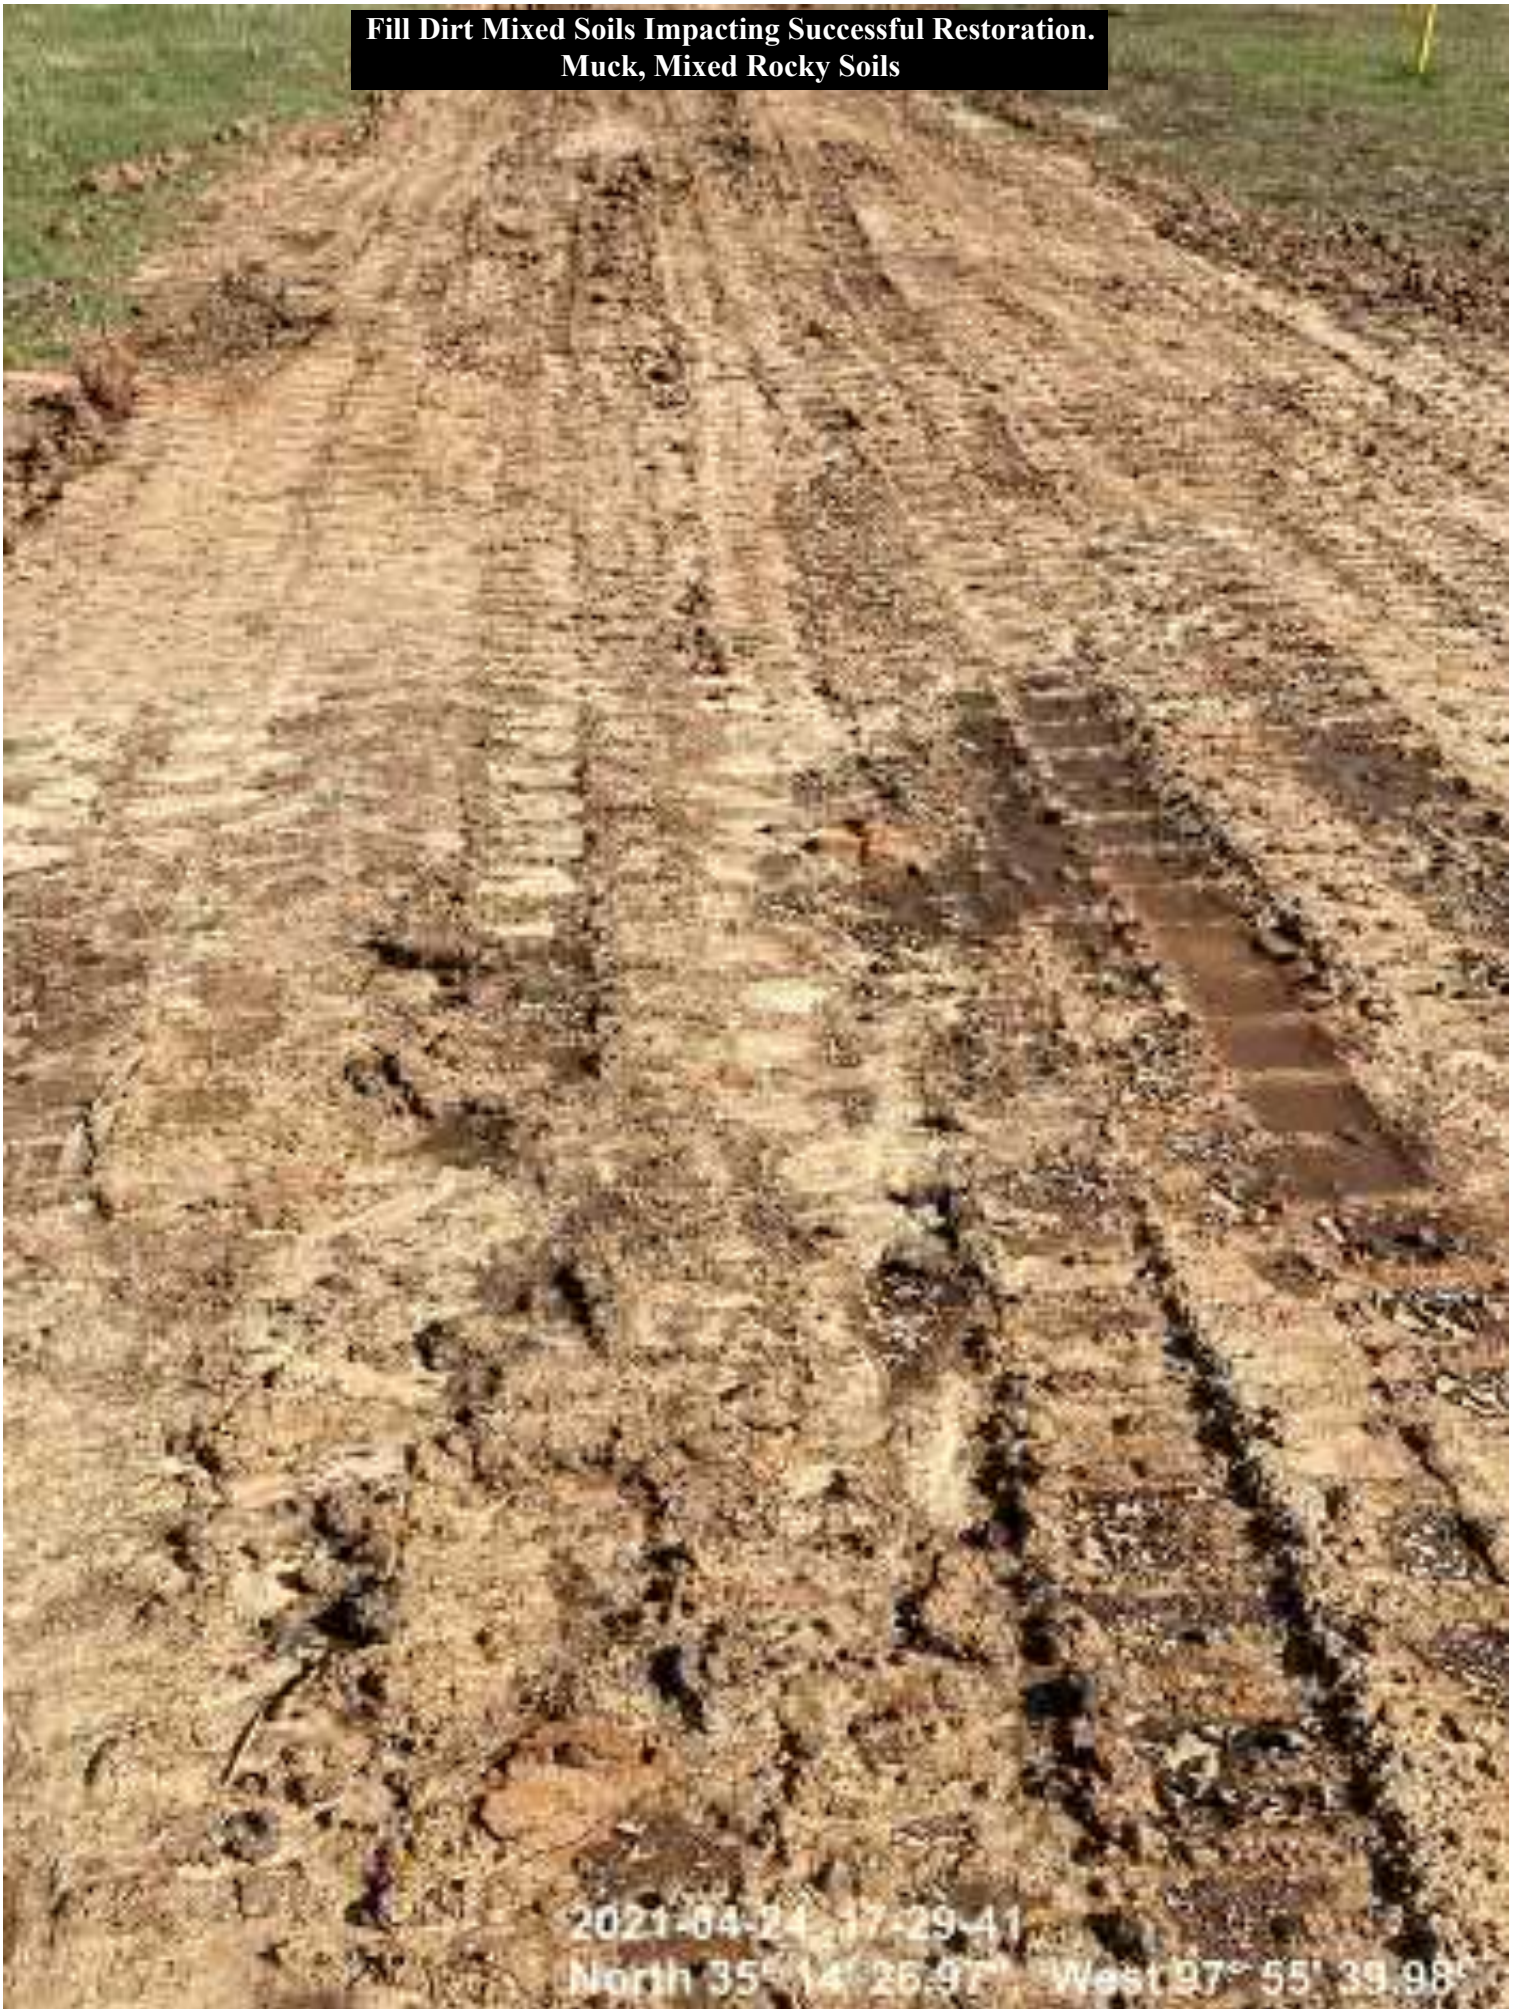
**Fill Dirt Mixed Soils Impacting Successful Restoration.
Muck, Mixed Rocky Soils**

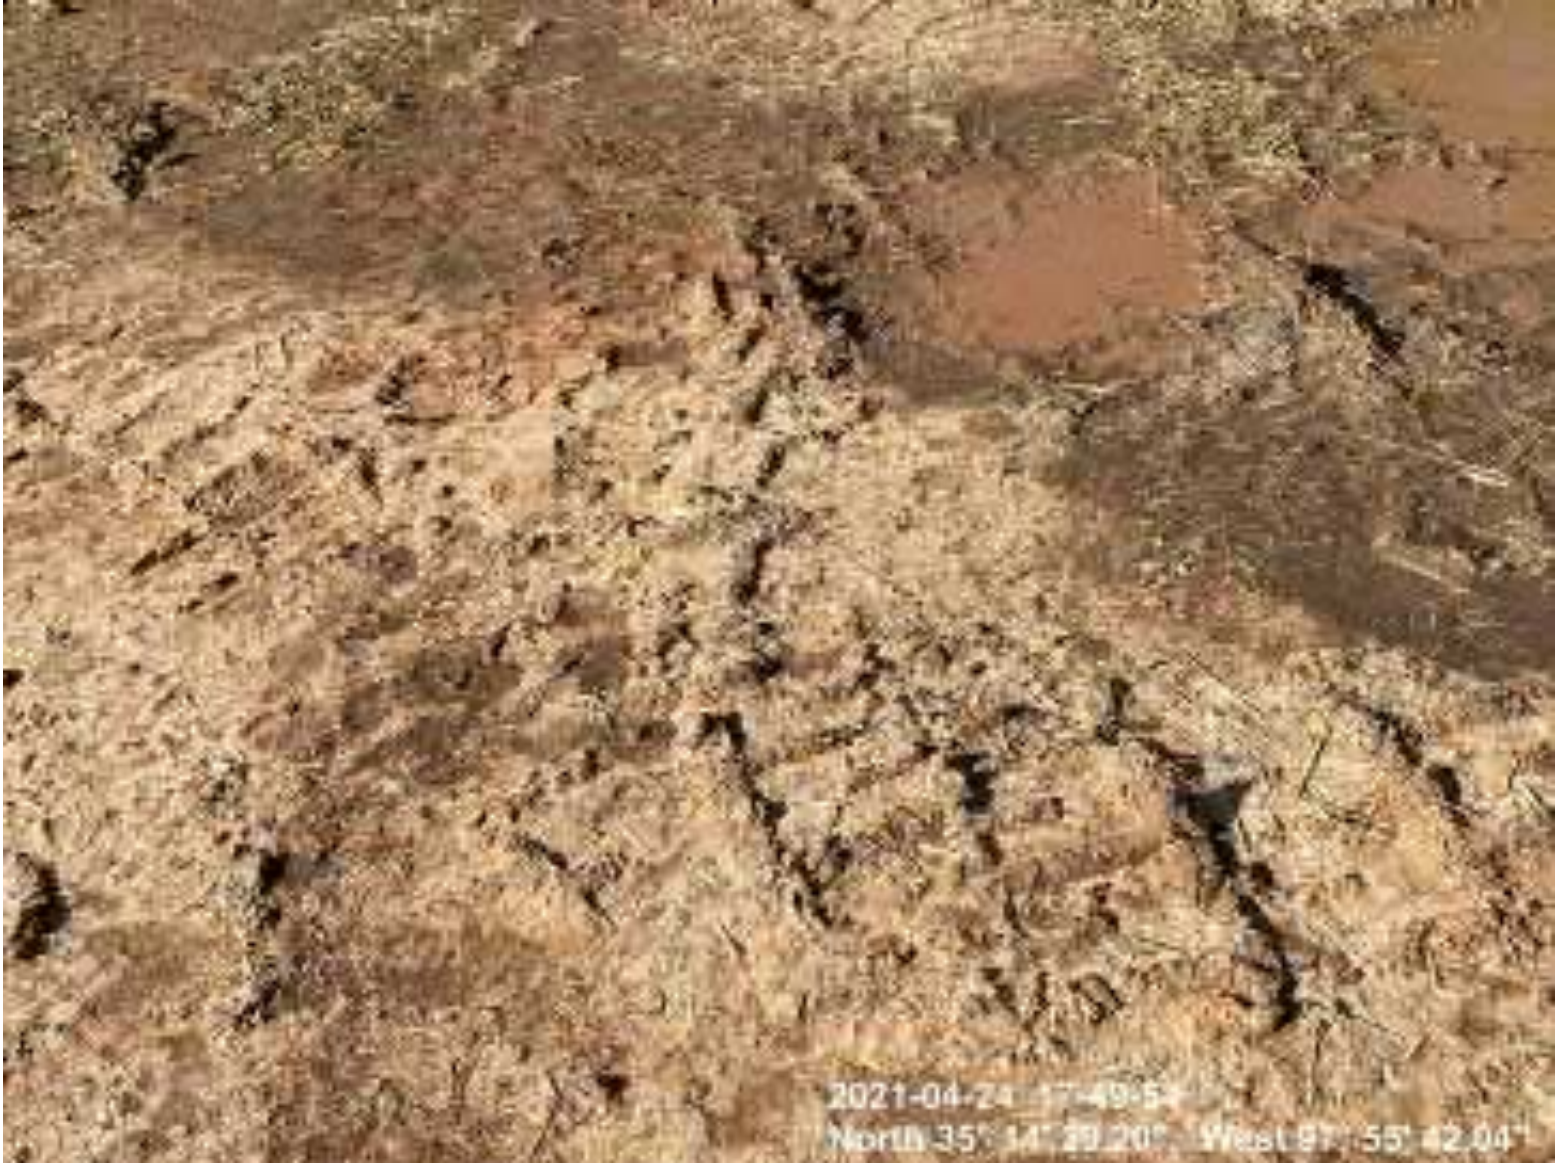
Fill Dirt Mixed Soils With Additional Erosion

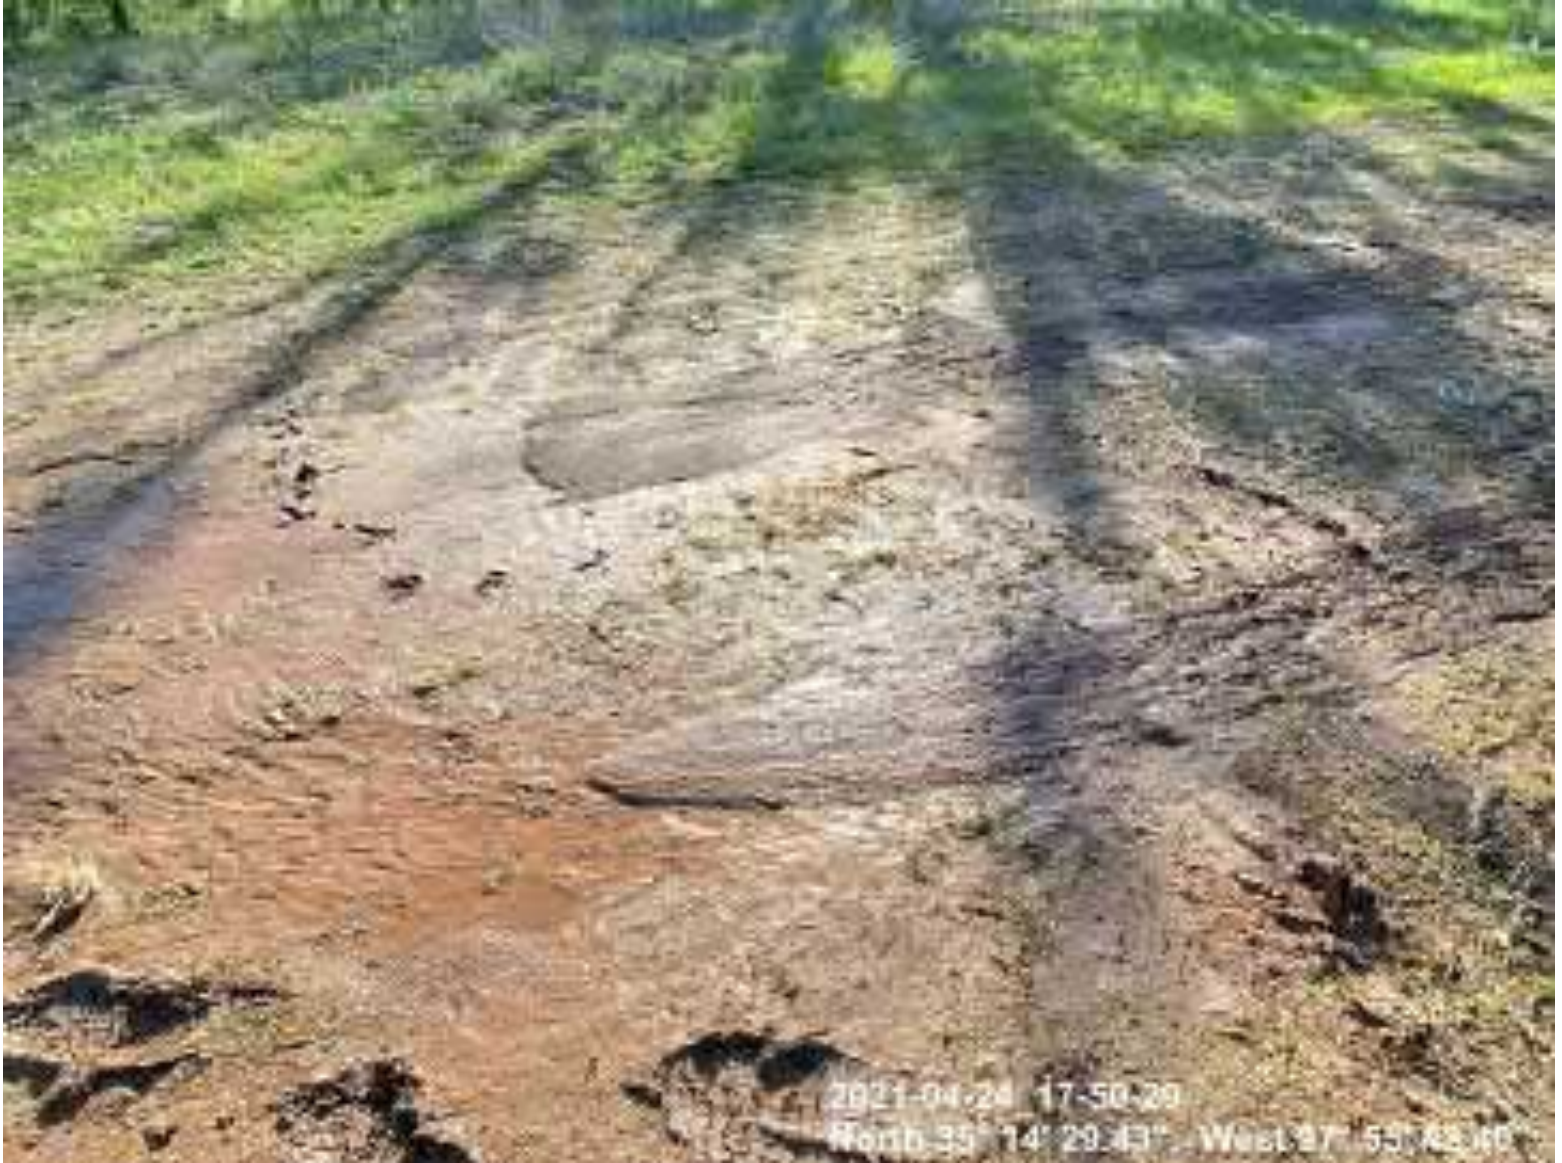
Fill Dirt Mixed Soils Overtop Matting
