Robert Squires - Squires Consulting LLC
Landowner Advocate

Opening Statement for May 5, 2021 Subcommittee on Civil Rights and Civil Liberties Hearing:
“Pipelines Over People (Part II): Midship Pipeline’s Disregard for Landowners in Its Pathway”

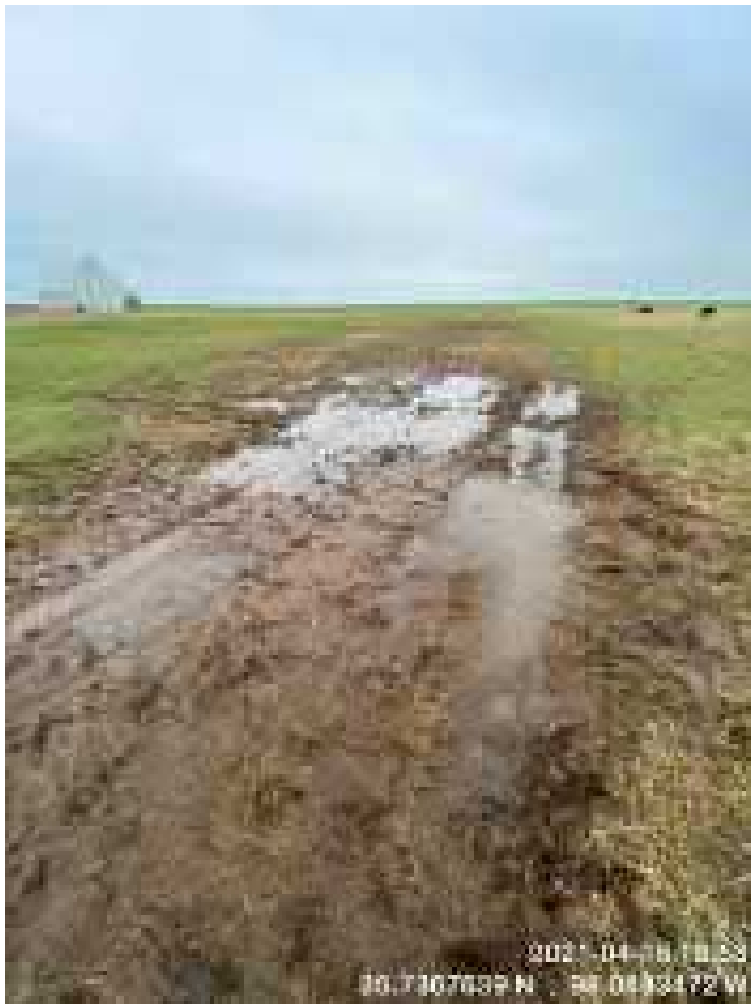
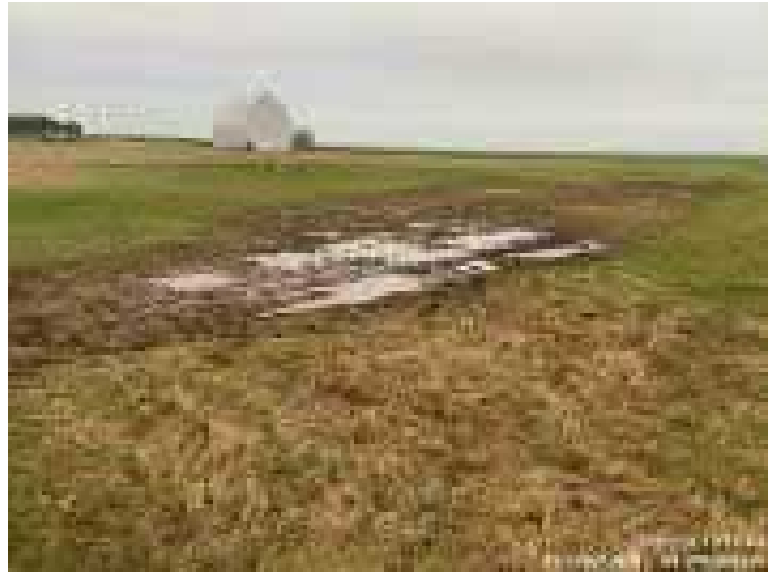
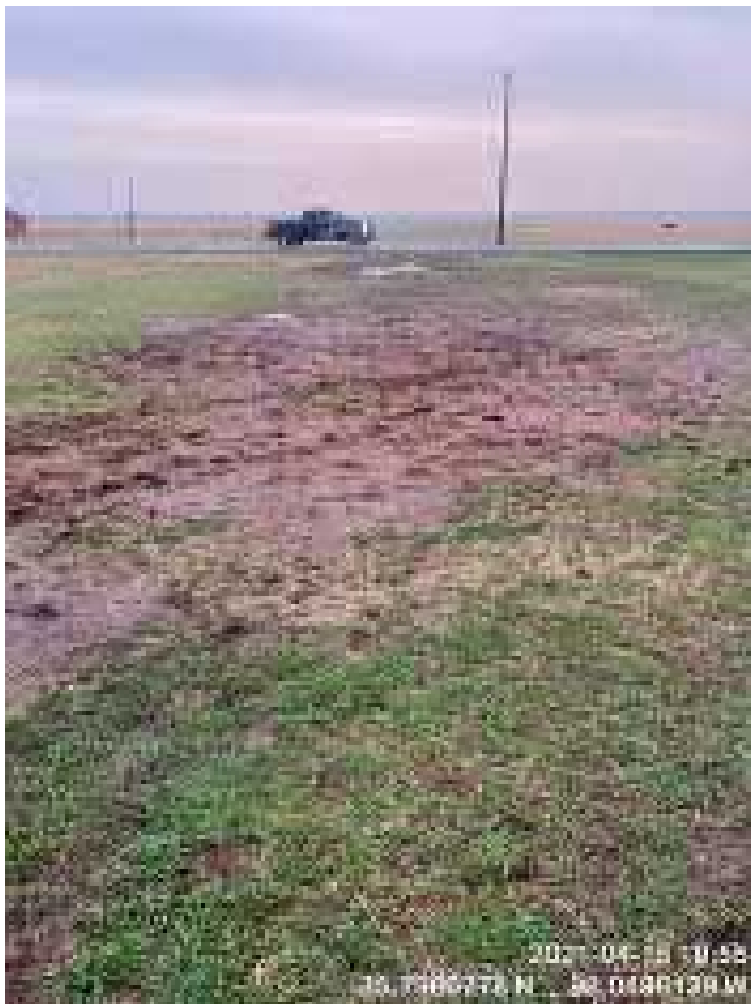
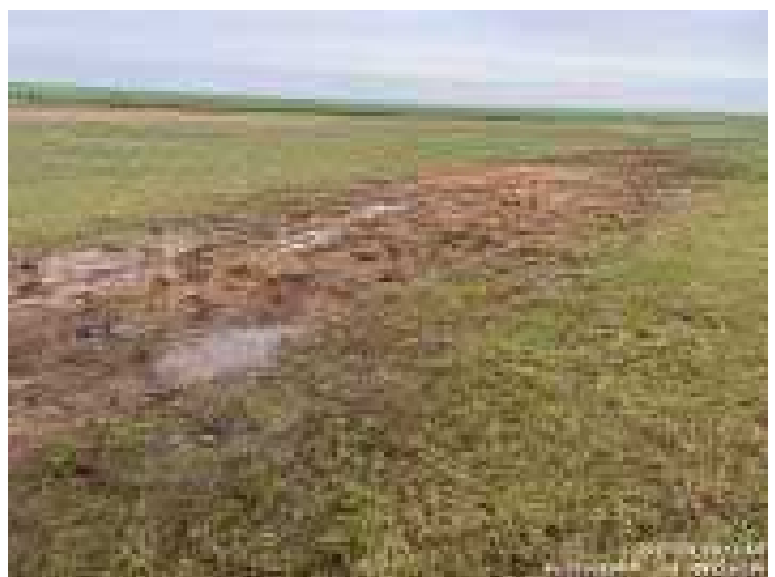
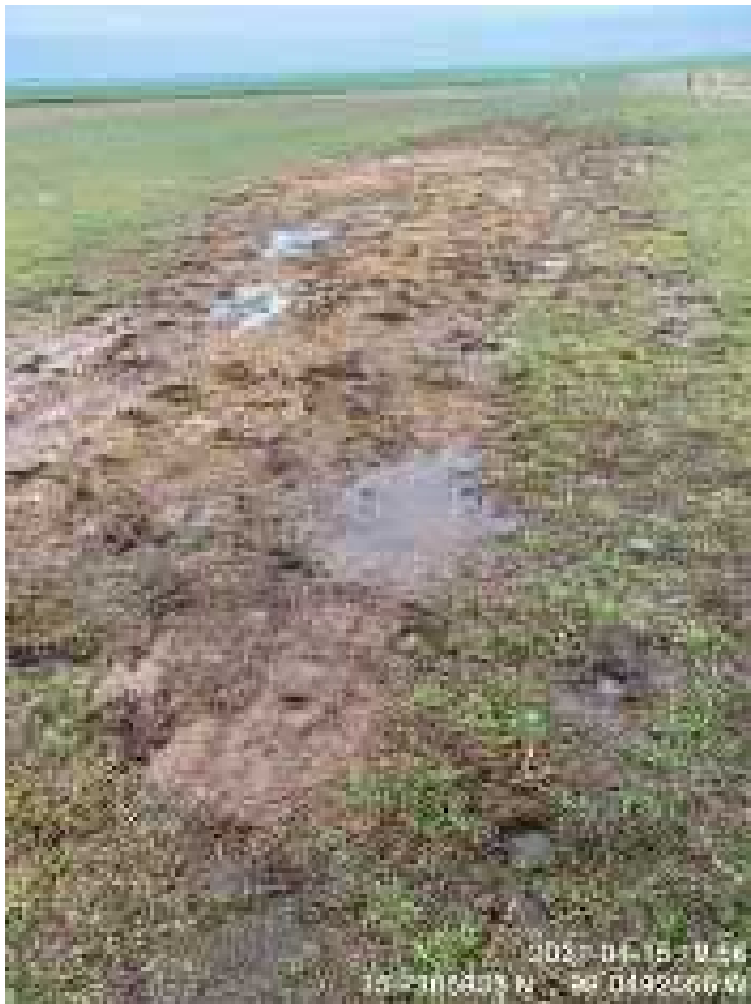
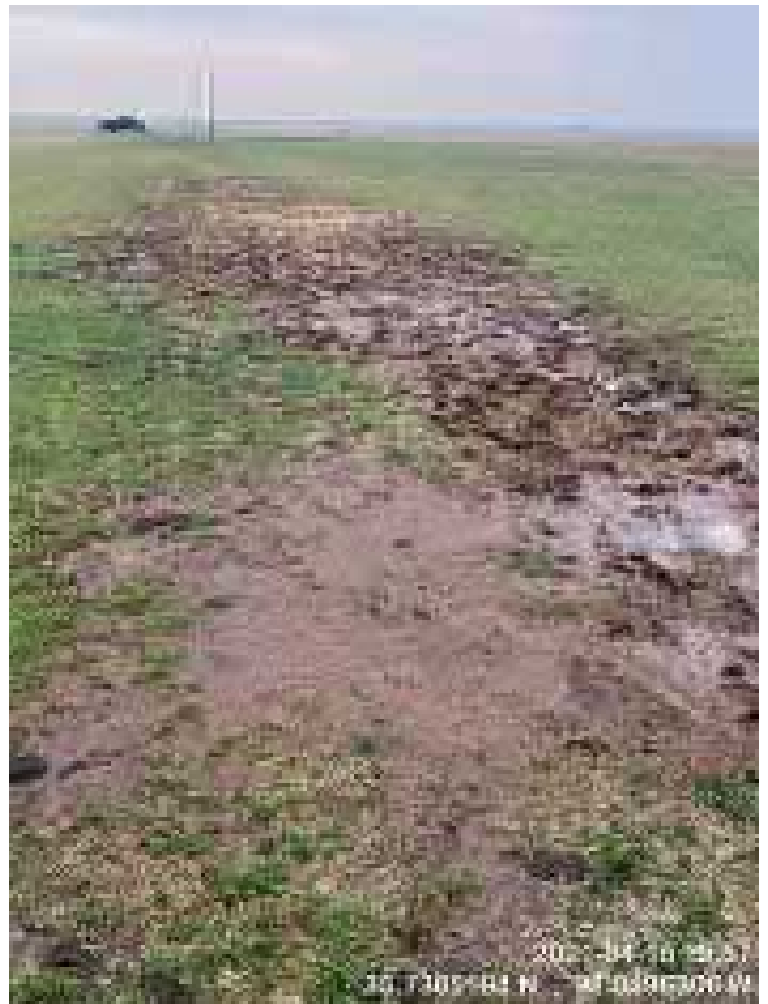
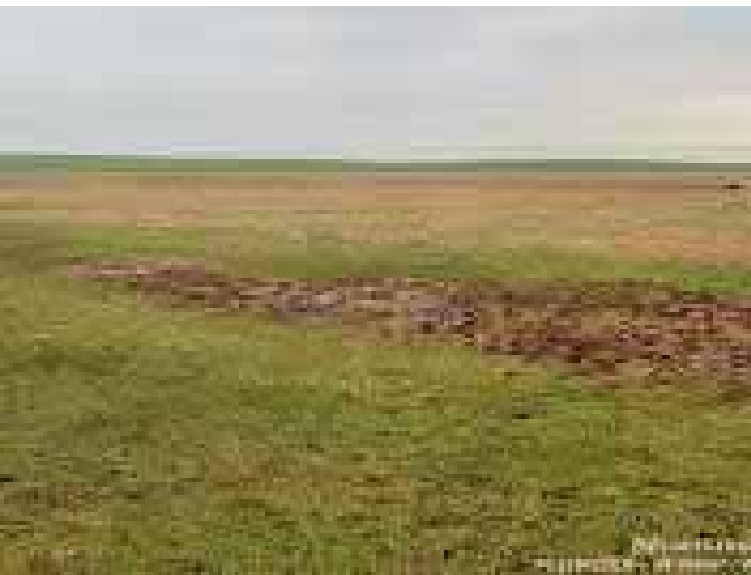
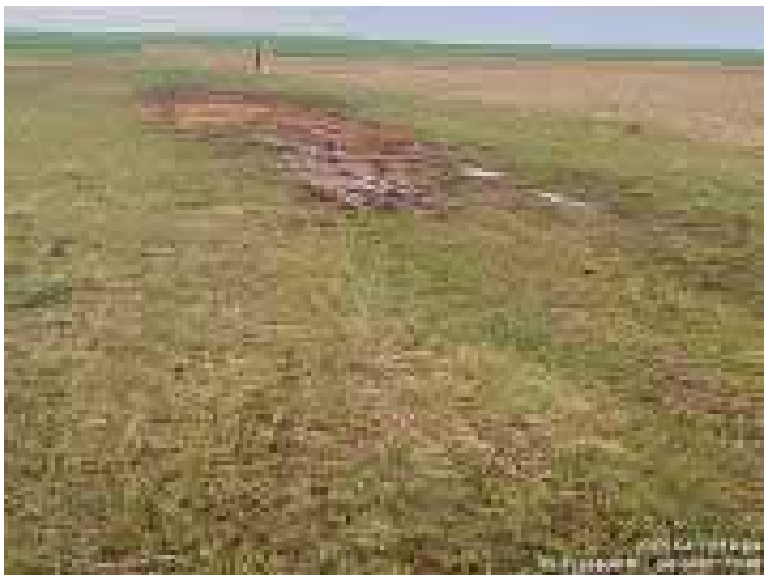
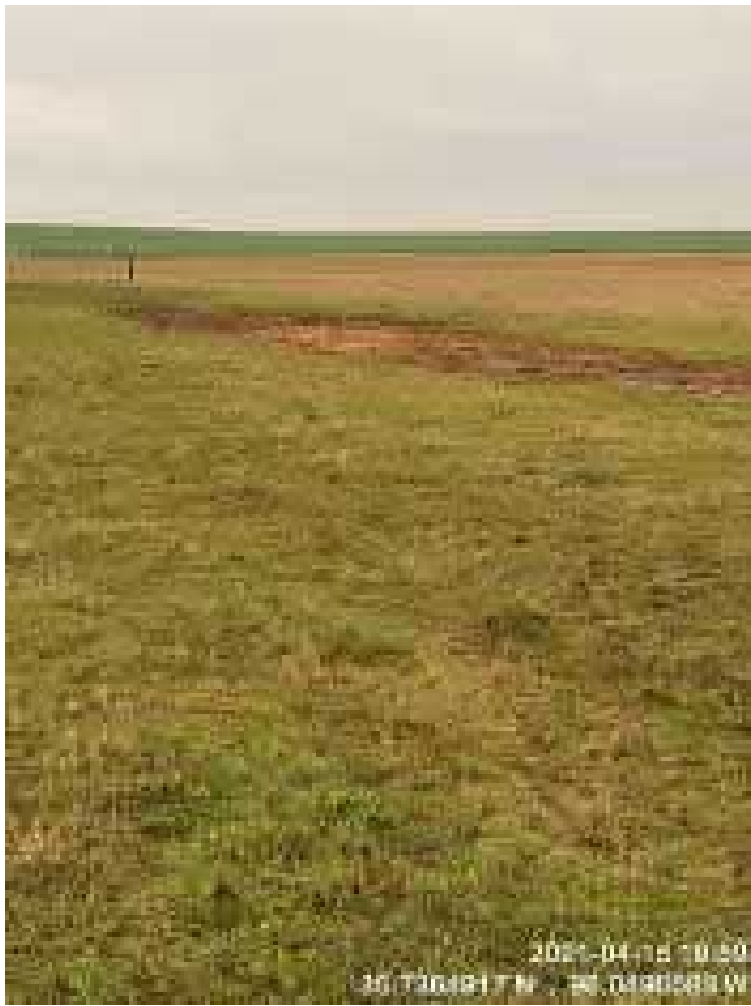
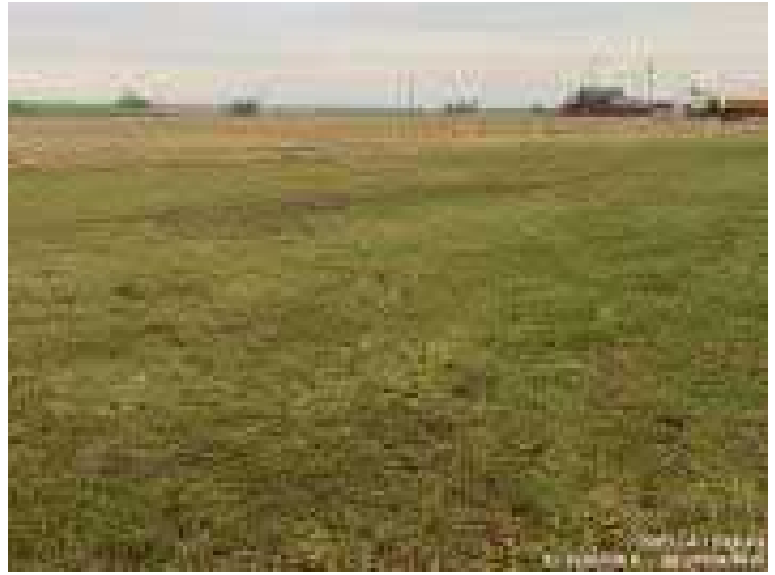
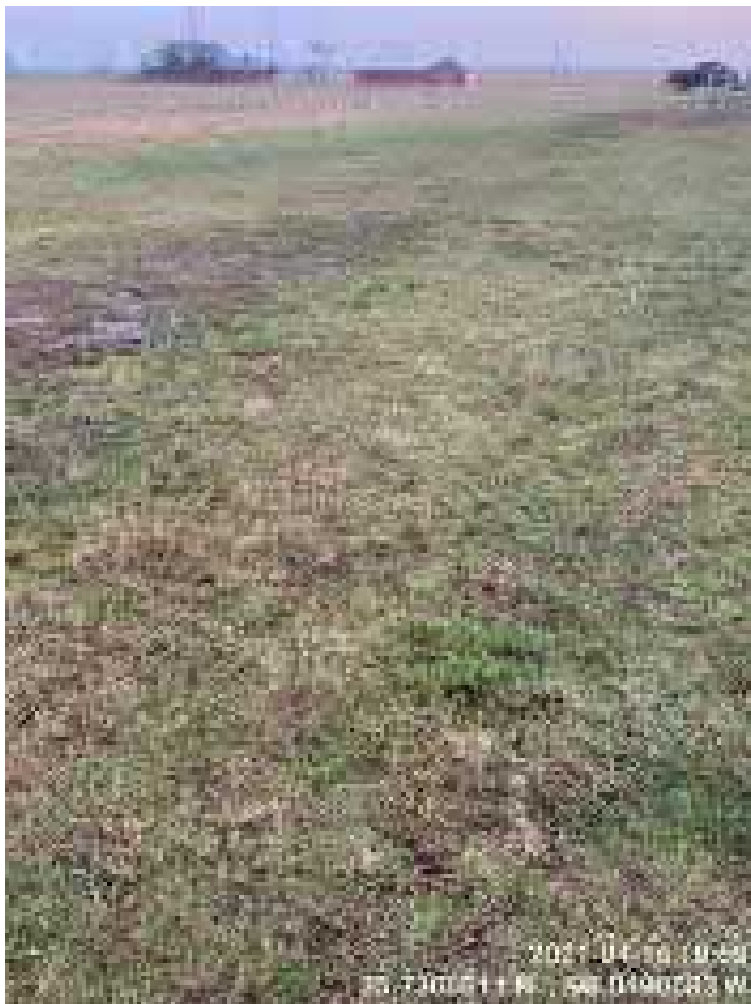
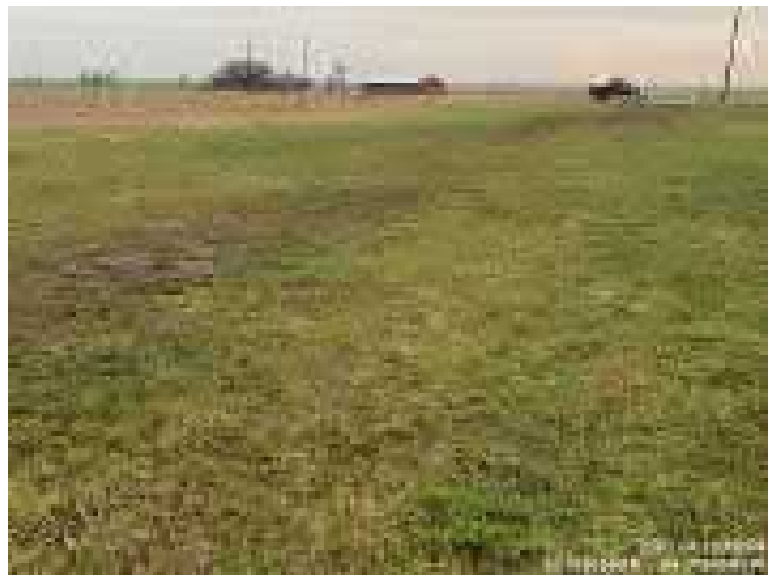
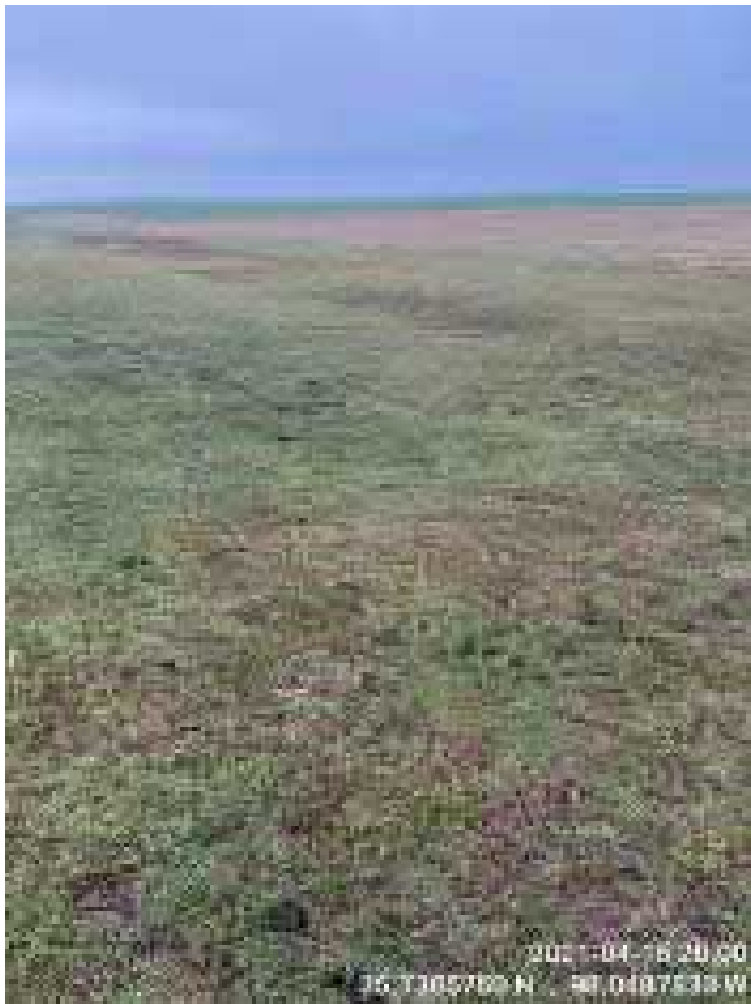
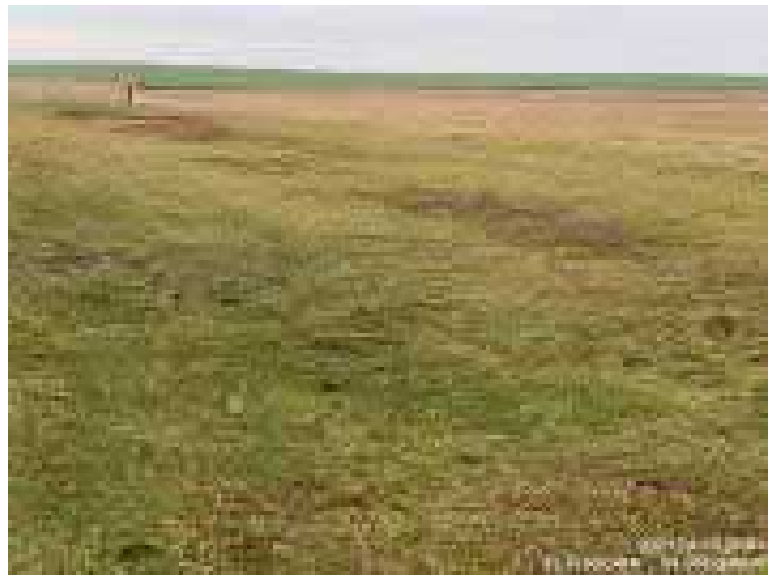
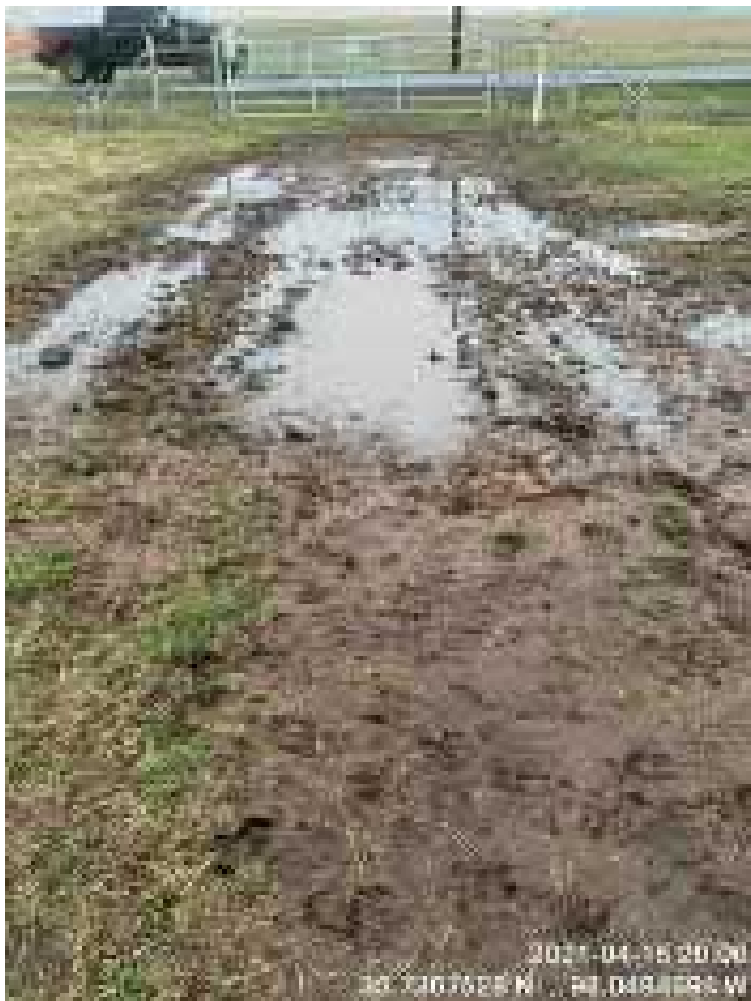
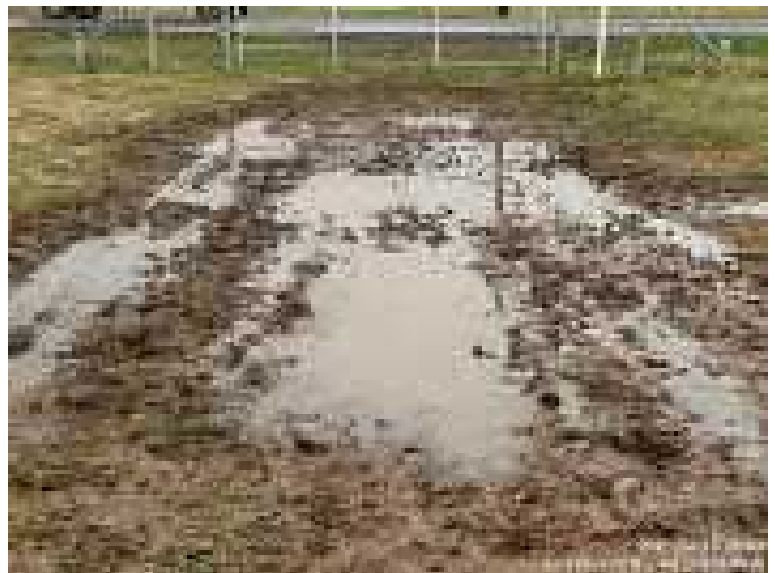
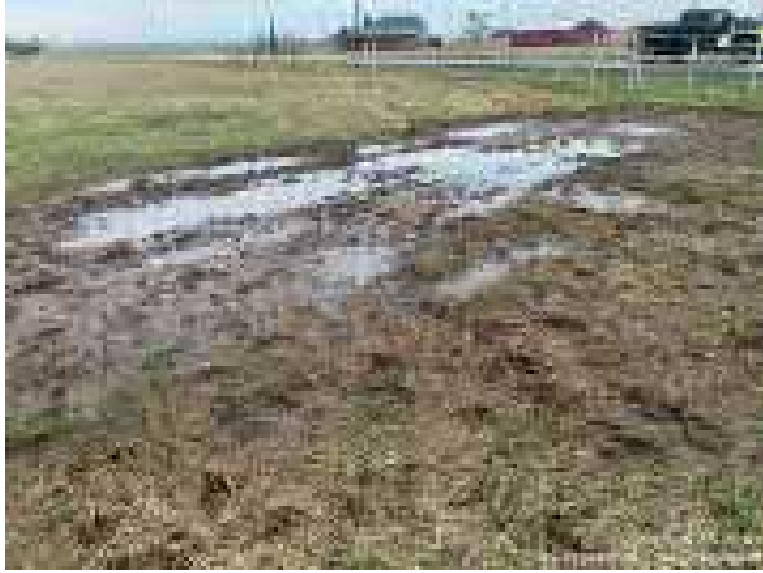
2024-04-18 10:52
35.7167944 N - 98.0493167 W

The landowners request Midship to coordinate and consult with themselves and CLC on all issues and efforts to successfully restore the properties including those included in the FERC order dated March 18, 2021 as well as others not explicitly listed in the Order. Attached are photos depicting the current condition throughout the Midship right-of-way.

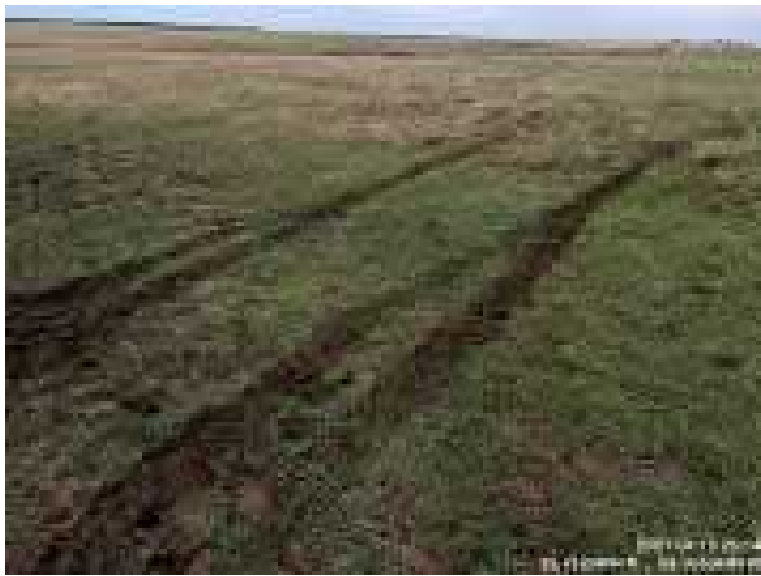
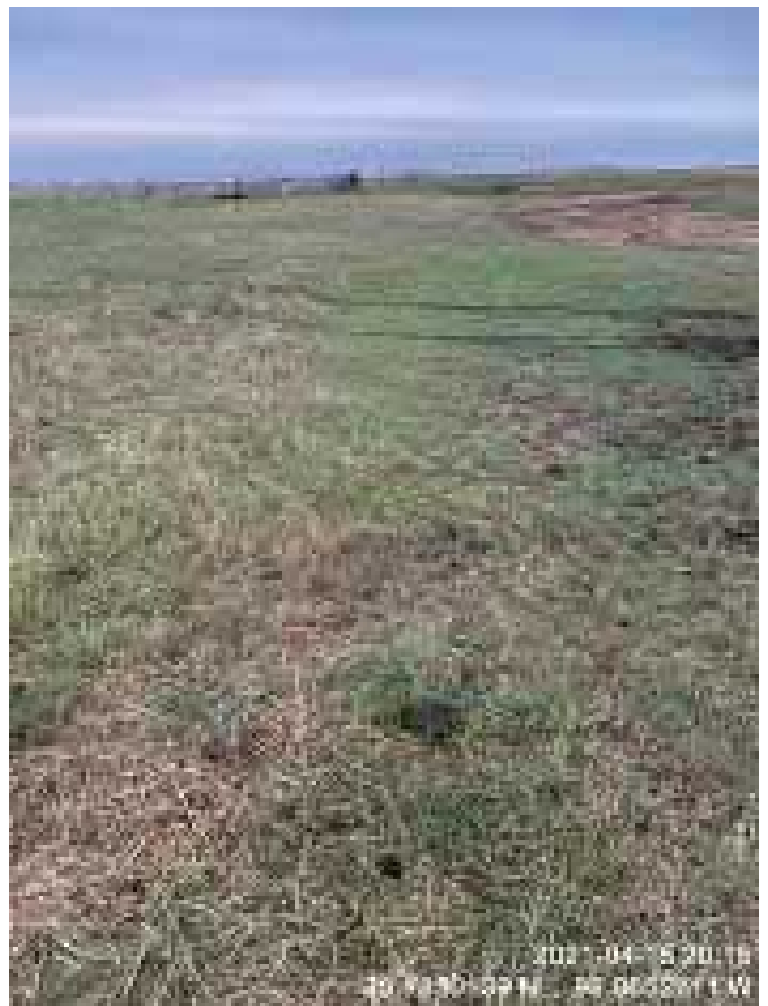
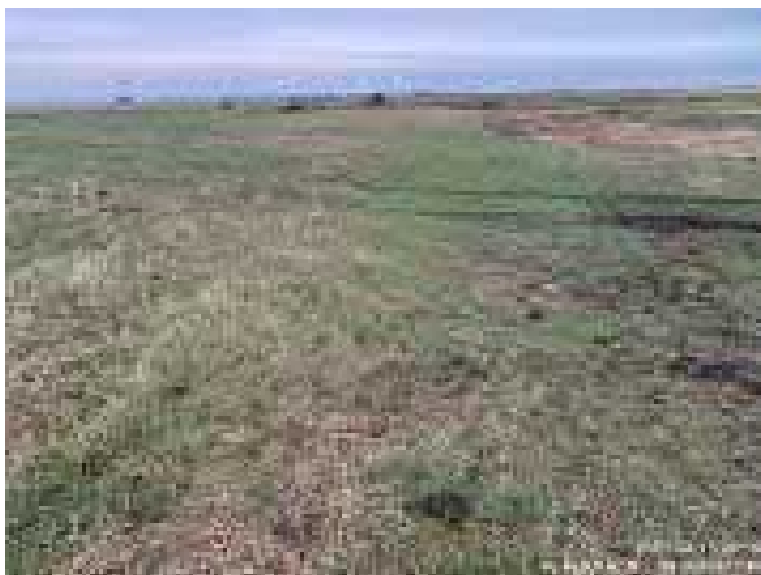
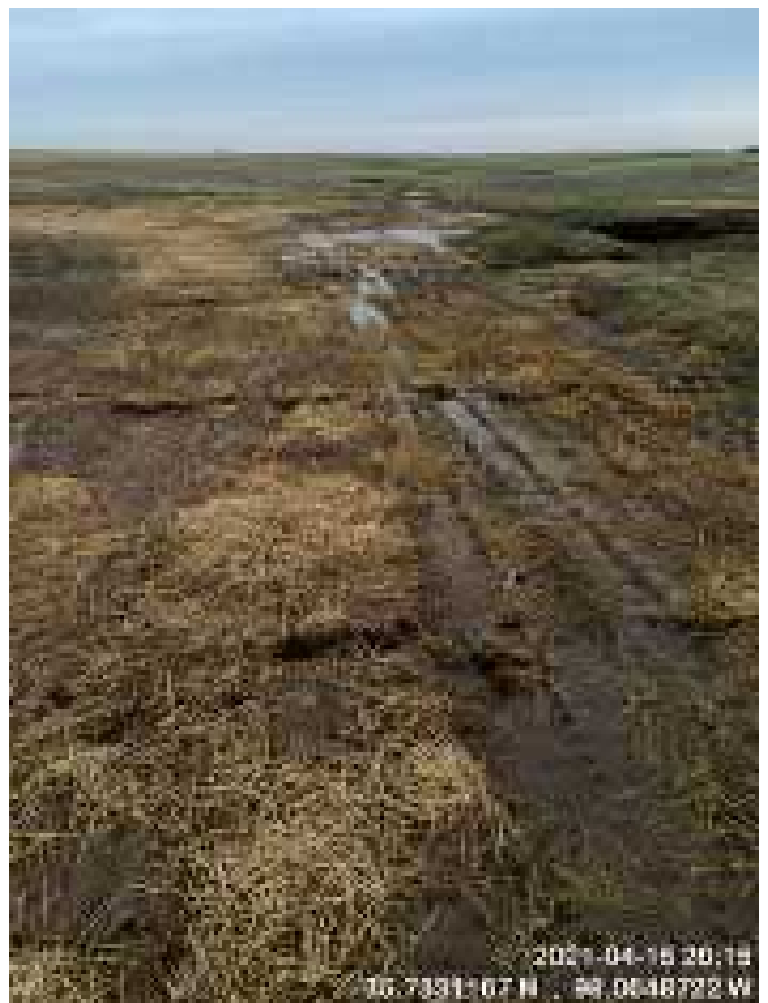
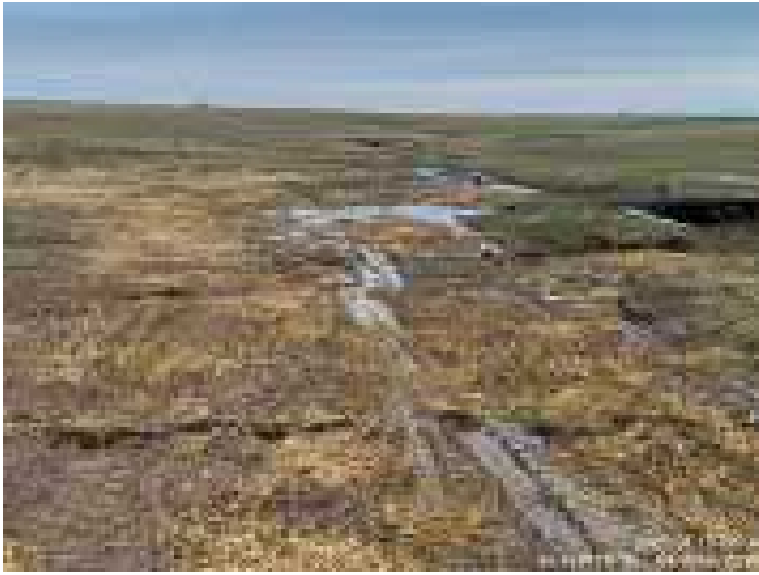
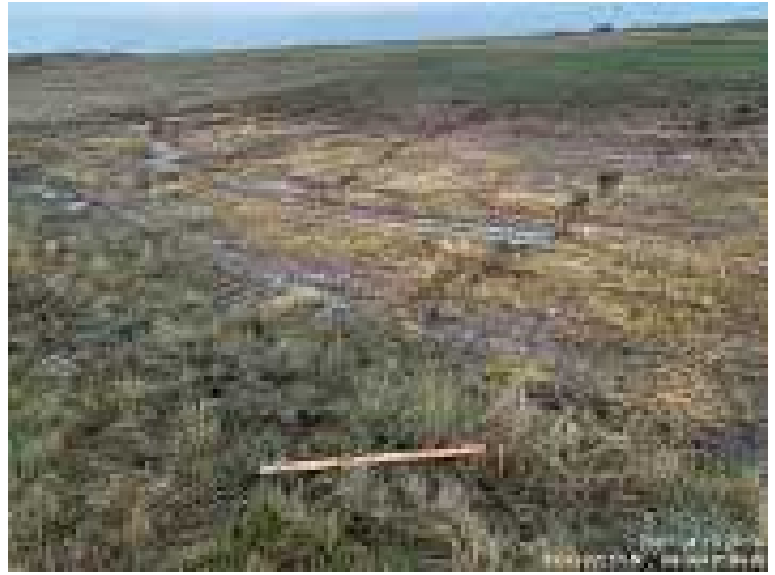
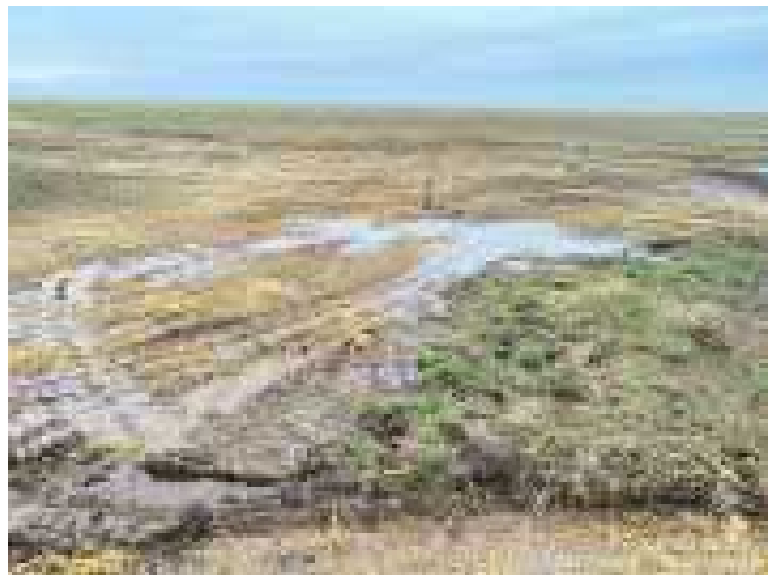
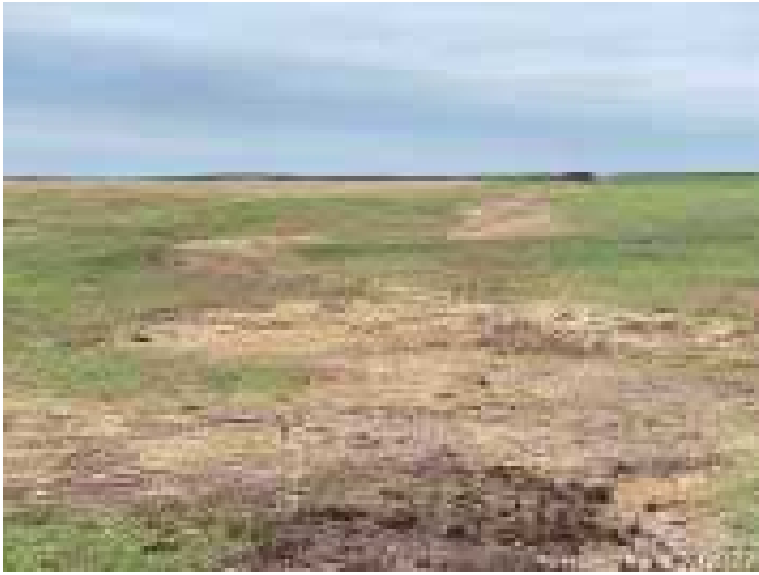
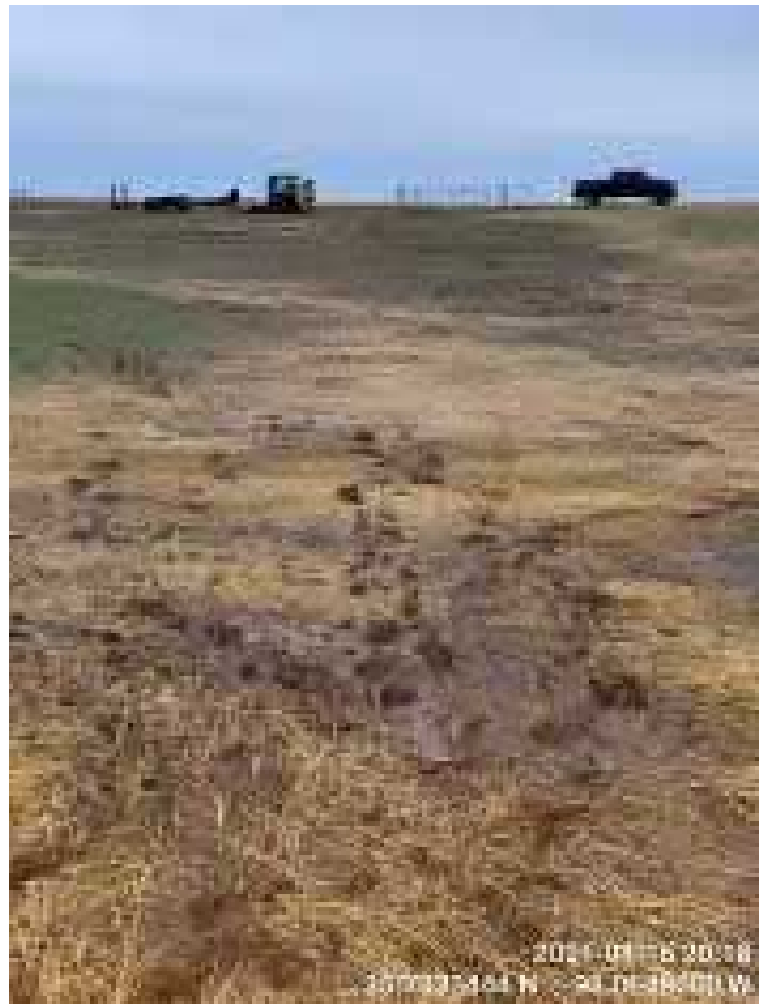
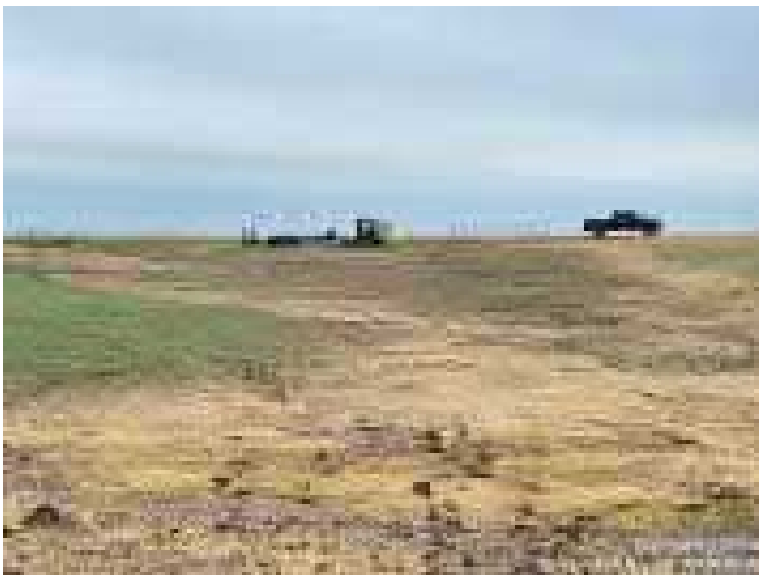
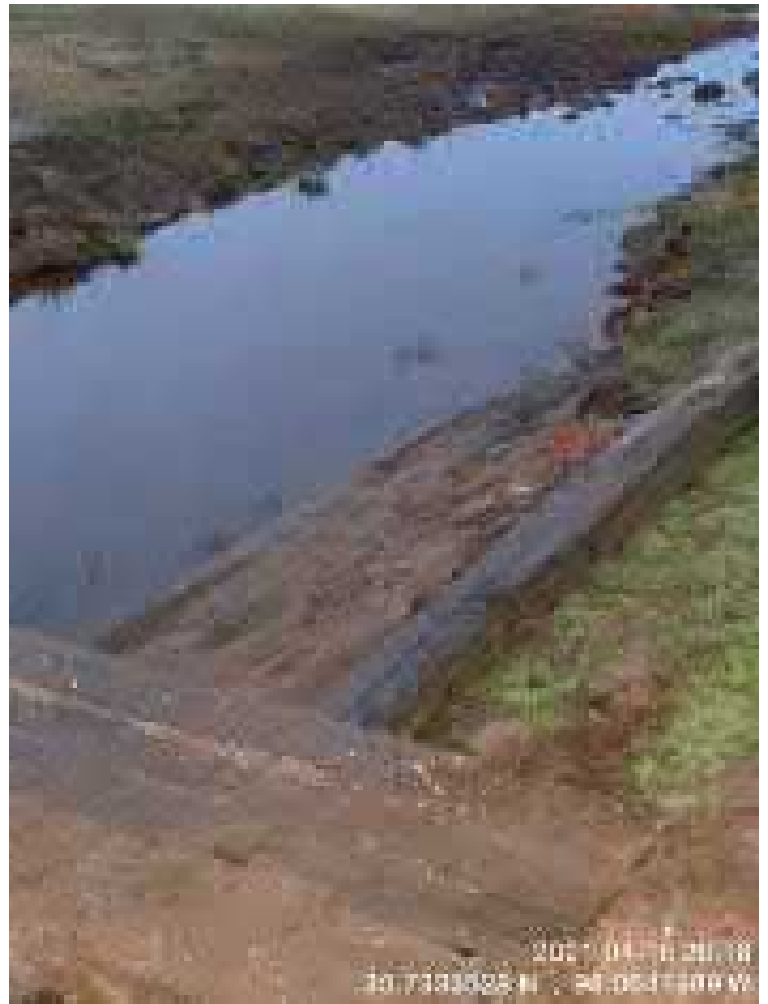
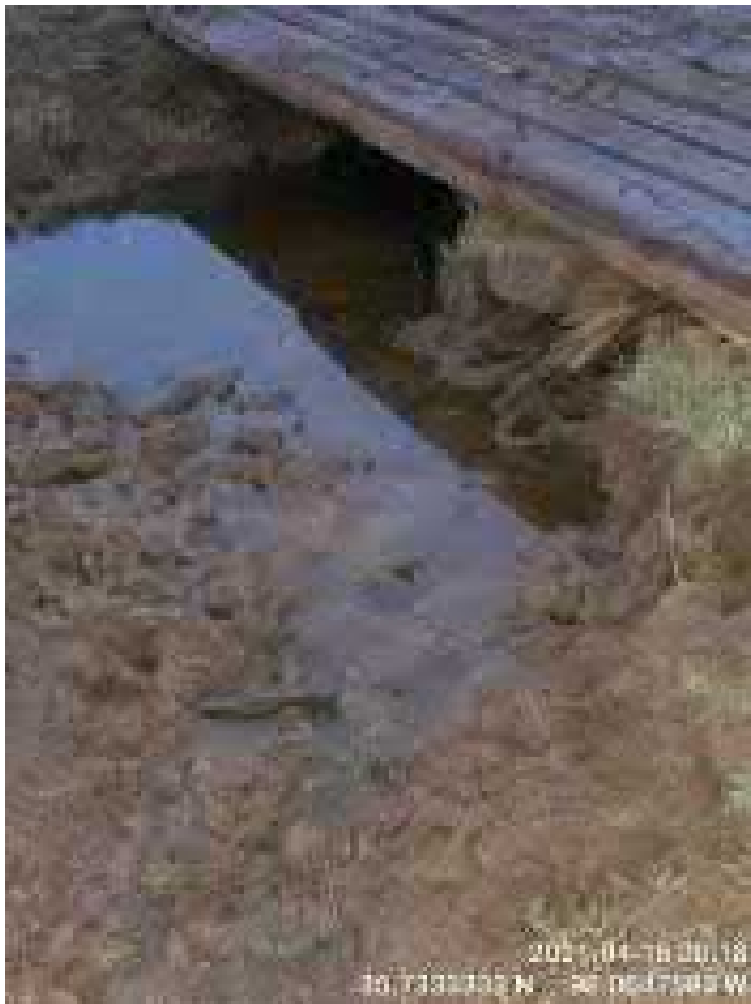
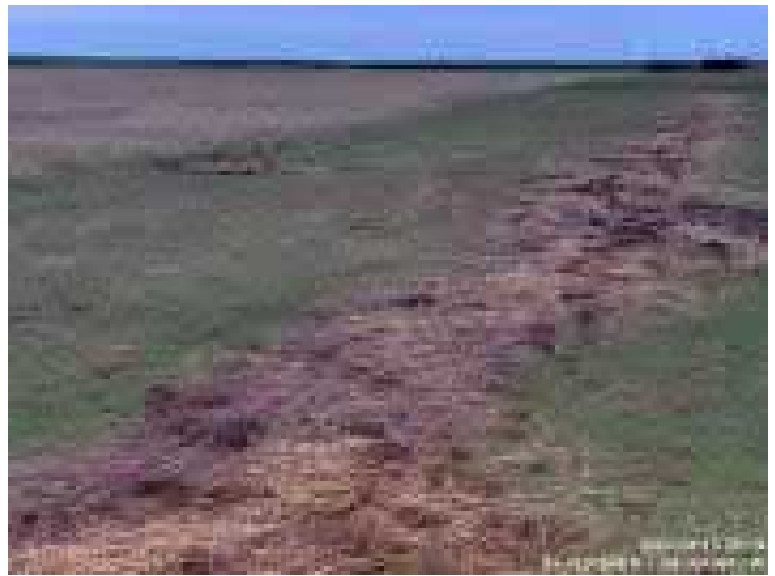
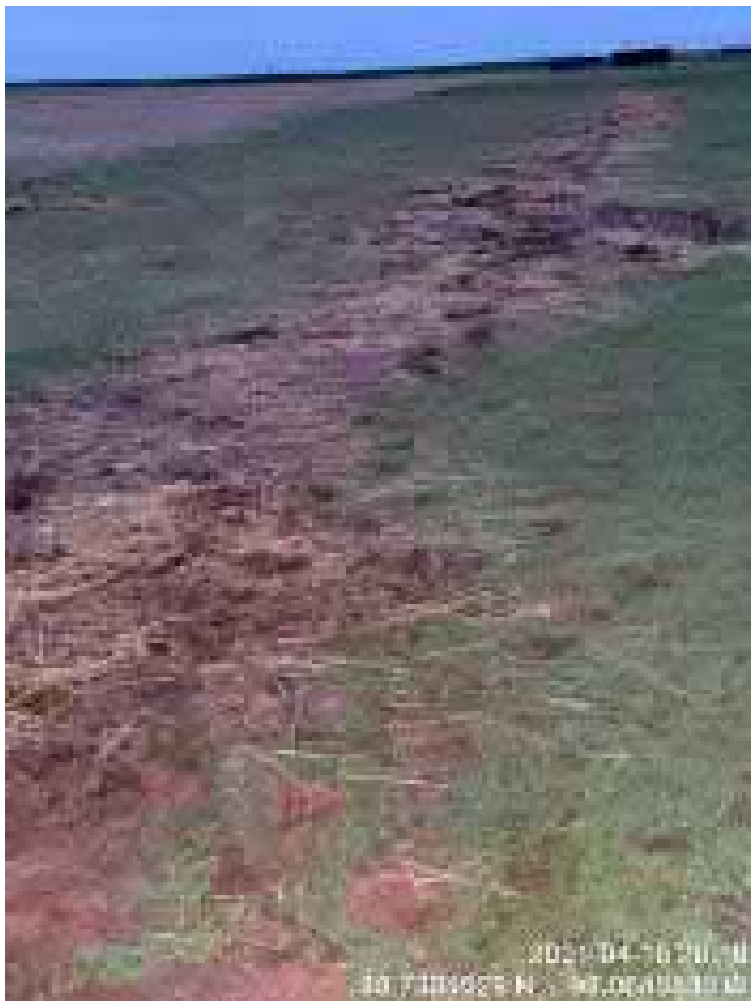
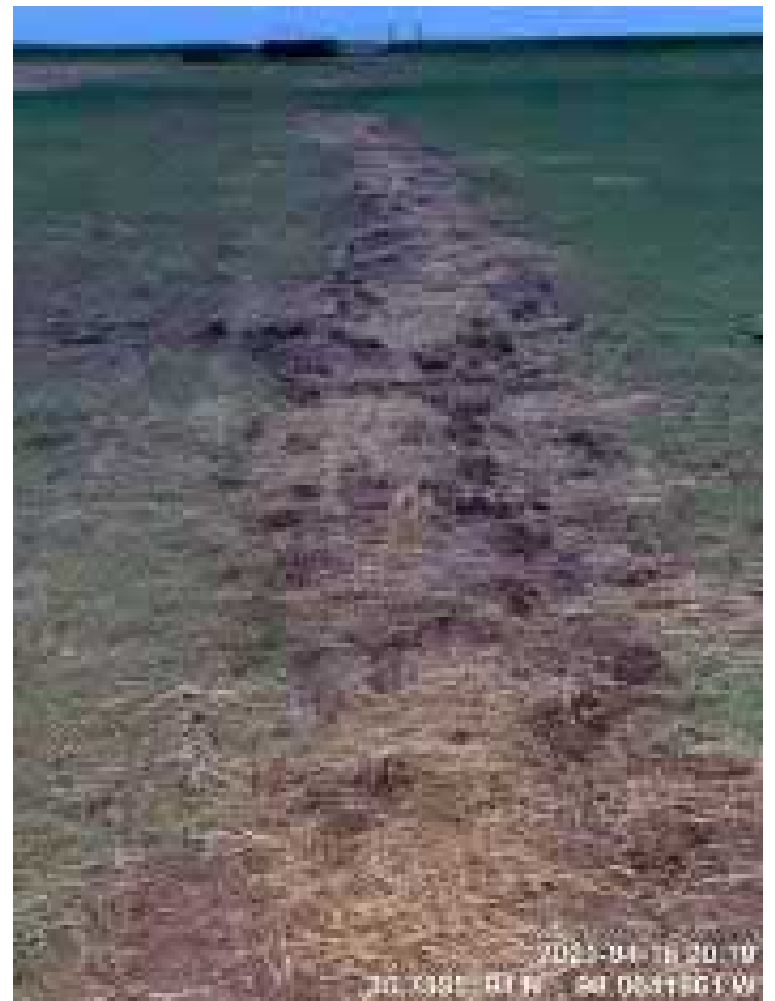
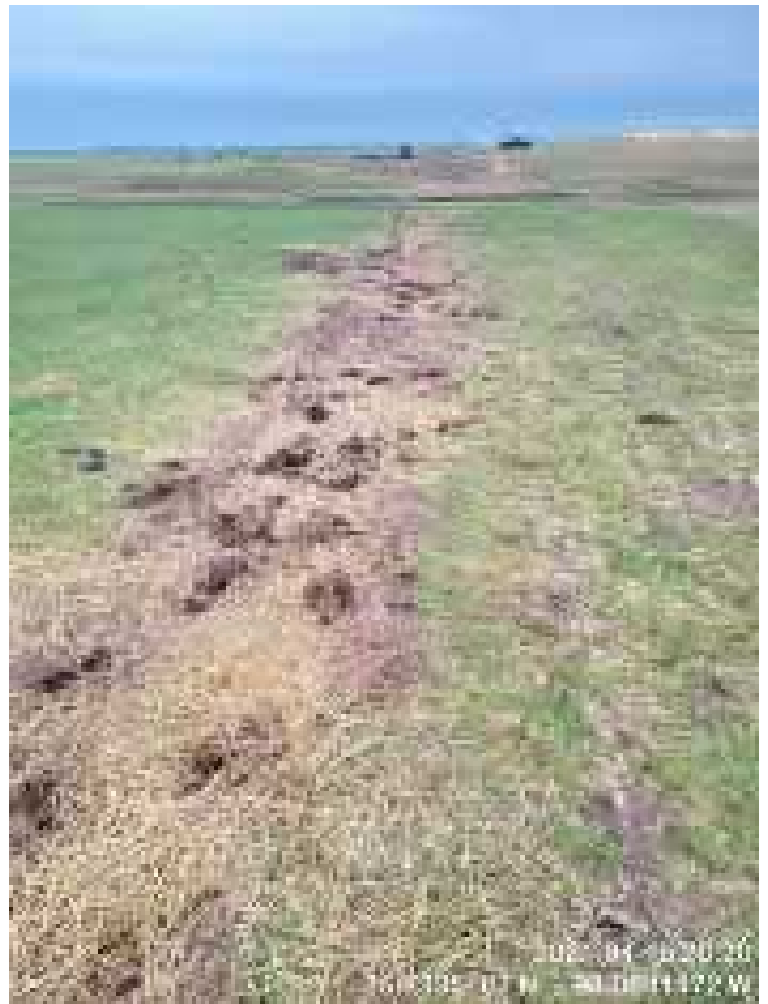
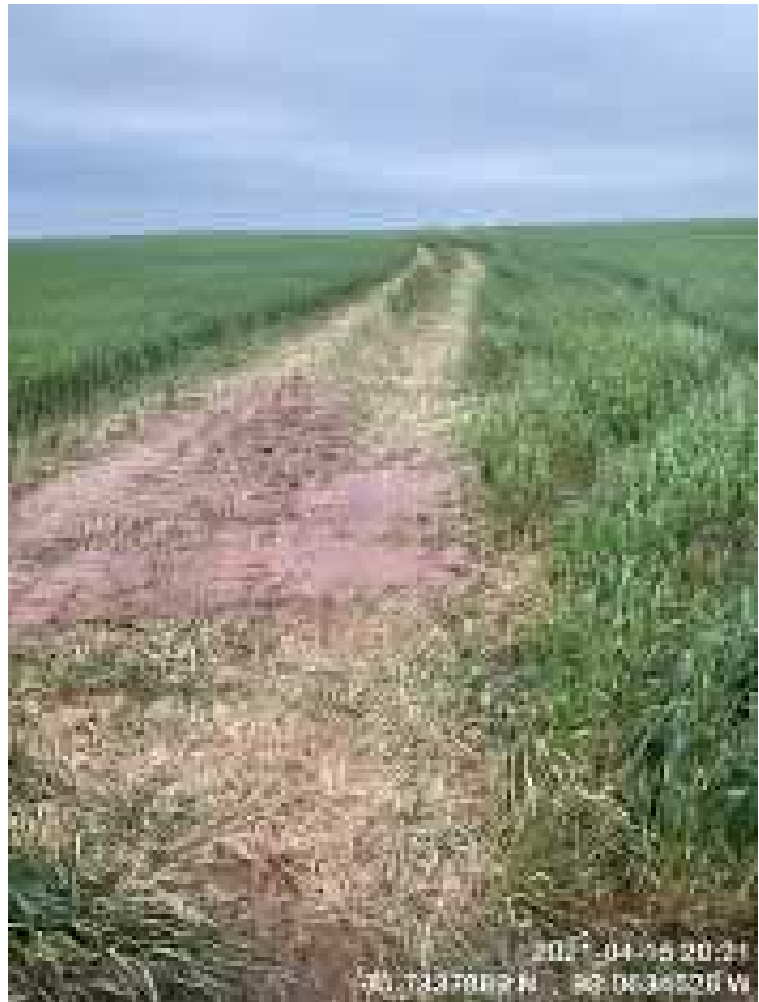
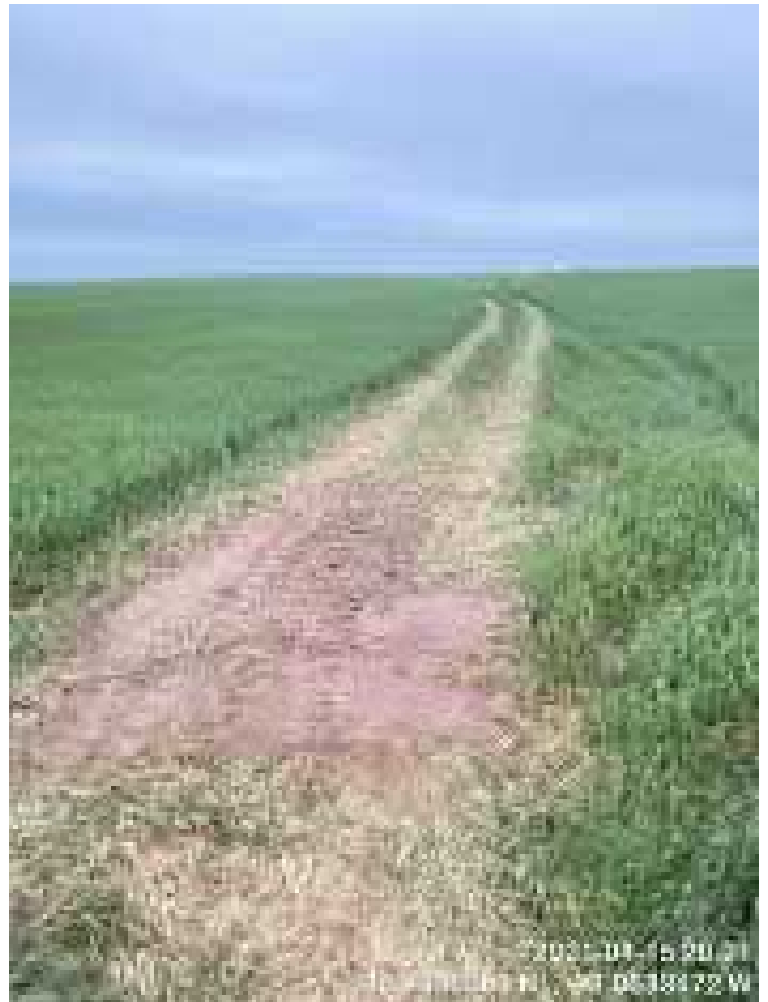
Attached are photos depicting the current condition throughout the Midship right-of-way. It is abundantly clear that Midship has plenty of restoration work left to complete. General work includes but is not limited to erosion control, soil decompaction, extreme levels of blasting rock, and grade restoration. Until either Midship or the landowner's contractor can complete the work, the landowners will continue to suffer.

- 5 Terraces are blocked by easement which is causing water to pond and disrupt farming operations.
- 1 terrace is crossed by easement twice, so 6 repairs total. Need to restructure terraces where they cross the easement so that the property drains properly.

- Drainage pattern west of CH 19.5 is blocked and causes ponding during rainfall. Drainage pattern needs to be restored to ensure proper flow. Contours of drainage pattern have not been properly restored.

- Alkali solids are surfacing from underground across portions of the tract due to prolonged ponding and soil saturation. This alters the soil's chemistry and will require additives to correct.
